2012 EVALUATION OF RECREATIONAL PARKS/PLAYGROUNDS

FOR
SAFETY INSPECTION – ADA COMPLIANCE

Borough of Tenafly
100 Riveredge Road
Tenafly, NJ 07670

MC Project No. TFB-048

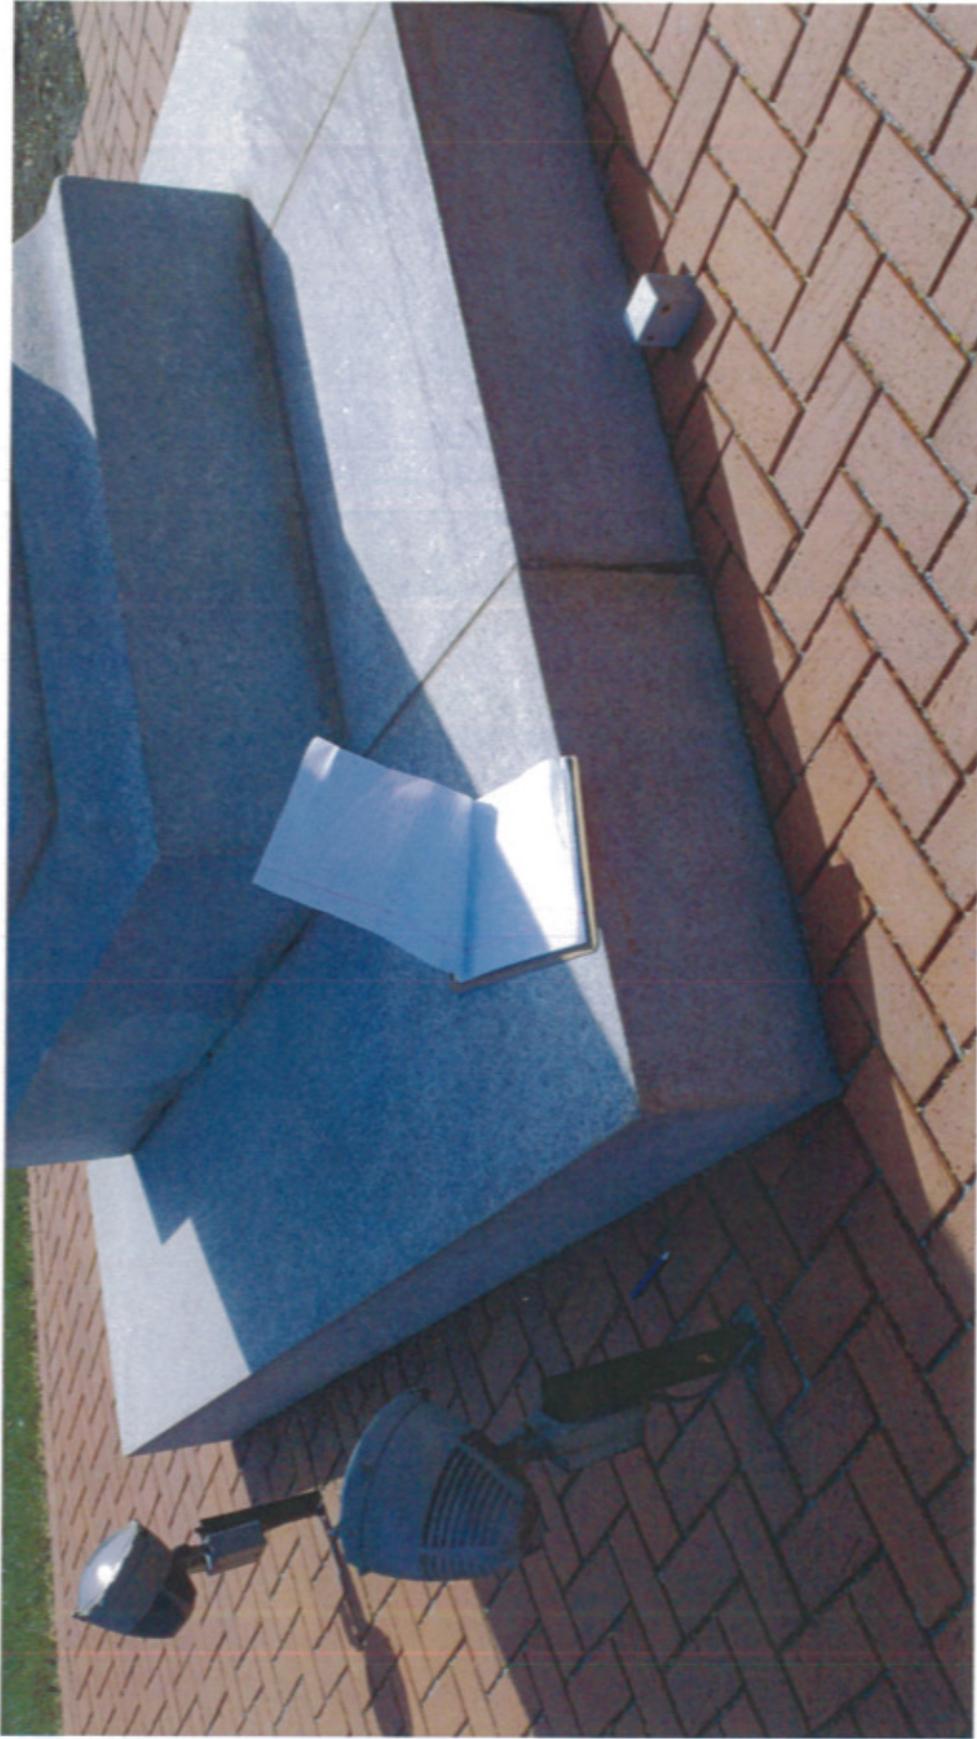
HUYLER PARK

REMOVE/RELOCATE ELECTRICAL COMPONENTS TO AVOID TRIPPING AND TEMPERATURE ISSUES WITH LIGHTS

4. There are many tripping nuisances in and around the memorial sculpture. Also, the electrical box should be reconstructed to be flush with the pavement surface and the lights should be replaced and relocated. These items are also a tripping nuisance, with the potential to get very hot and burn children's hands when illuminated. We suggest that the lights be relocated outside of the paved surface area. *(Please refer to enclosed photograph).*

The approximate cost to remediate this area with two (2) light fixtures and a new electrical box with paver repairs is \$2,900.

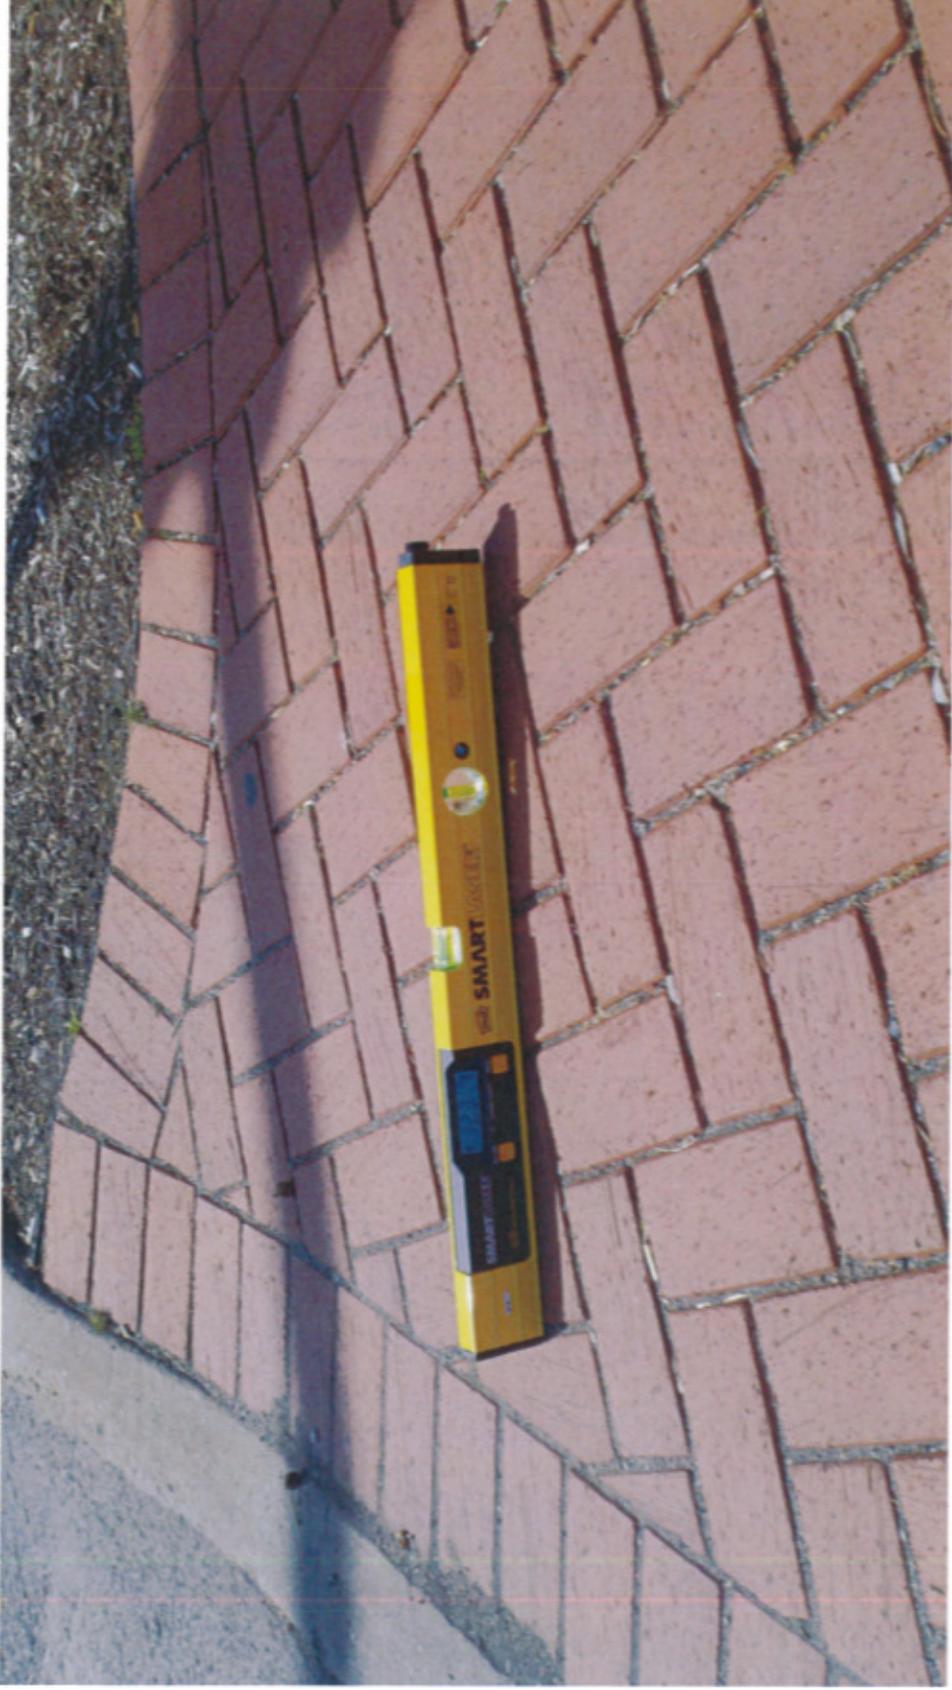
HUYLER PARK

HANDICAP RAMPS DO NOT COMPLY WITH ADA STANDARDS AND DO NOT CONTAIN TRUNCATED DOME MATERIAL

1. The walkways are brick pavers which look very nice. In order to bring the walkways into compliance with ADA Standards, the pavers must be re-set to provide 1' elevation change in 12', or less than 8.3%, with a maximum cross slope of 2%.

The approximate cost to remediate the ramp issue is \$7,000.

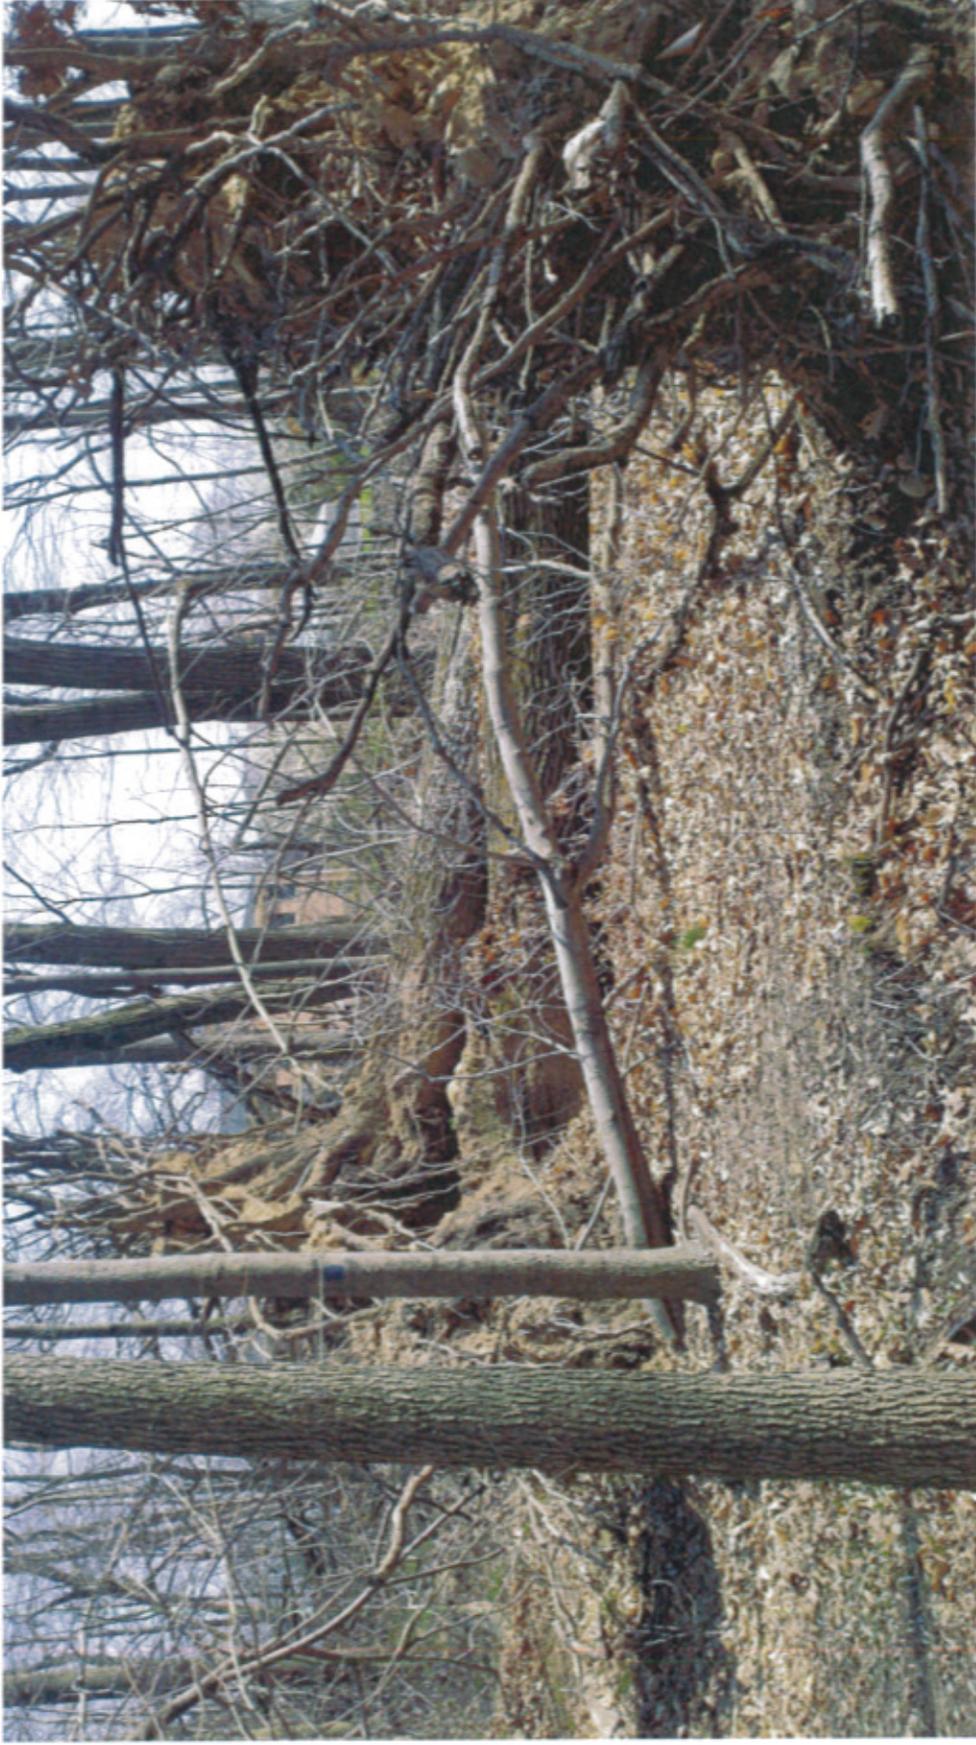
CHURCHHILL NATIVE PRESERVE

REMOVE FALLEN TREES FROM WALKWAY

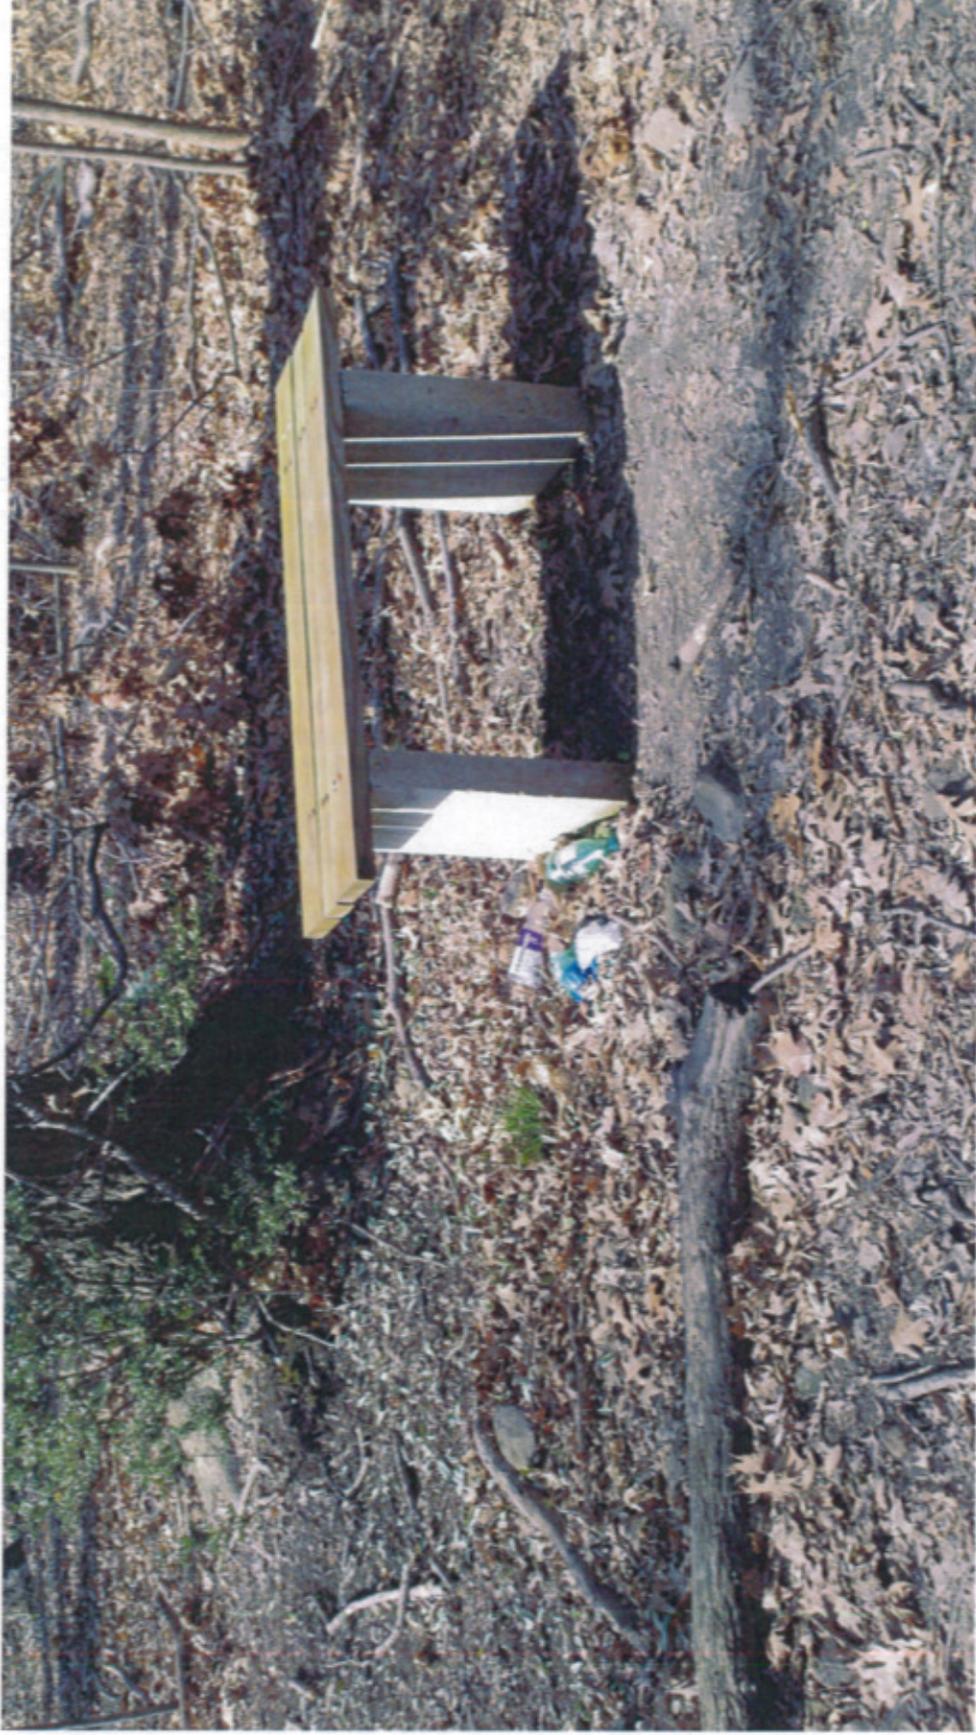
CHURCHHILL NATIVE PRESERVE

PROVIDE TRASH RECEPTACLES

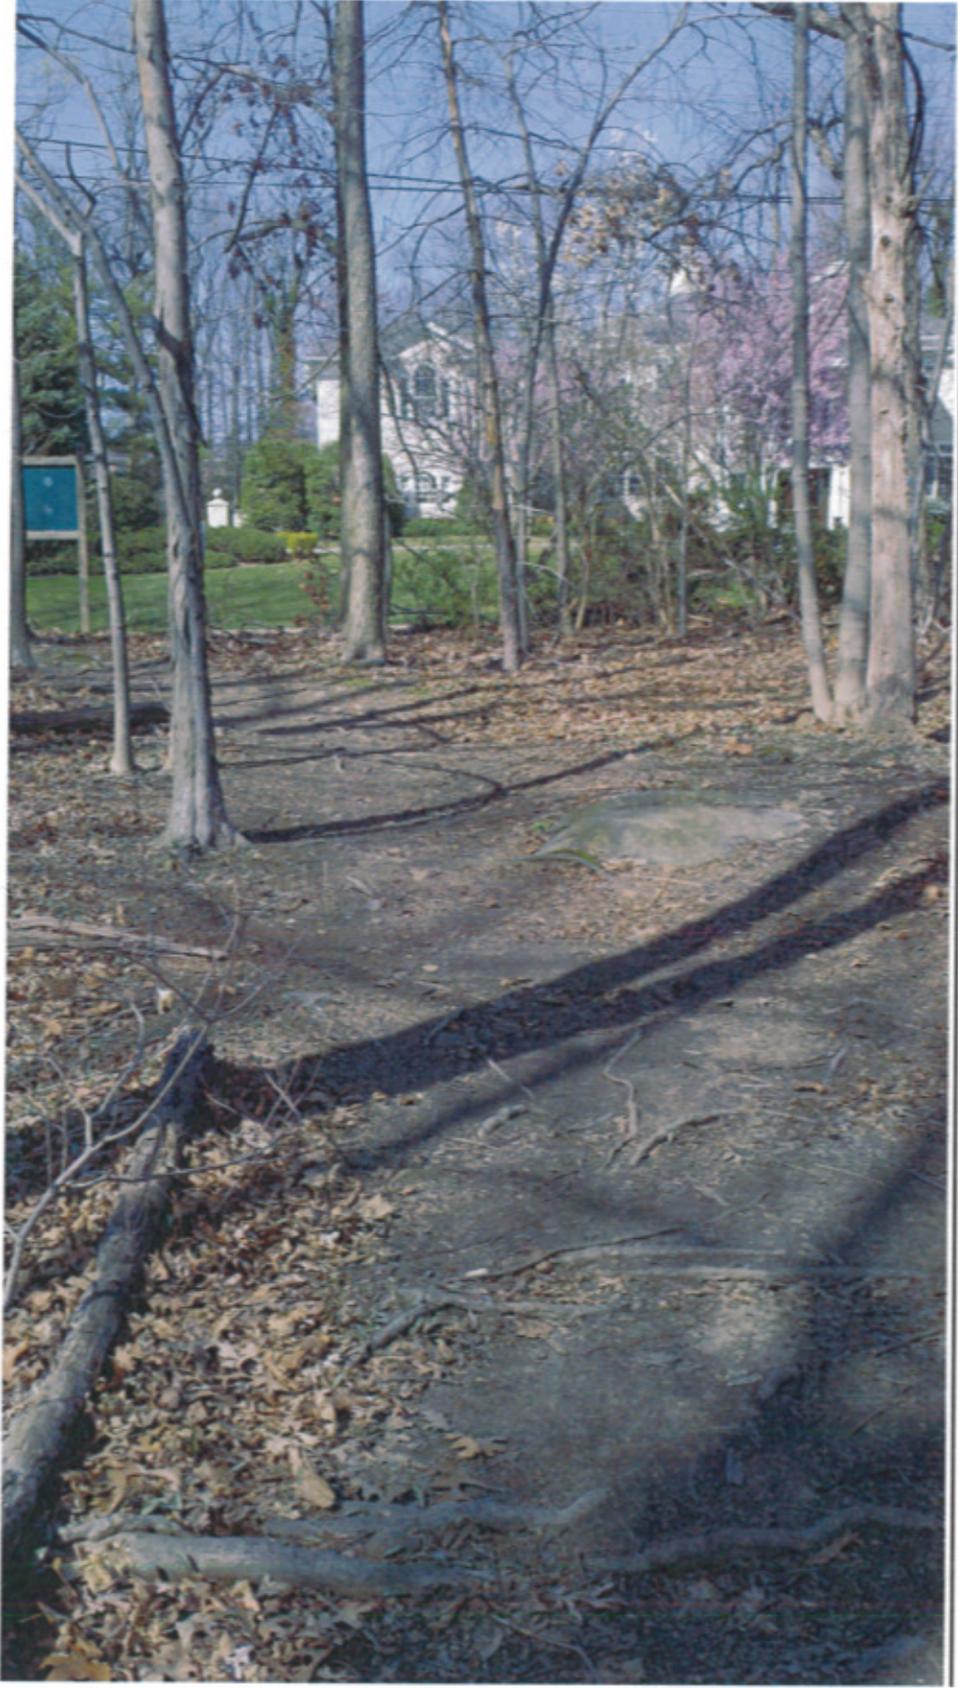
CHURCHHILL NATURE PRESERVE

REMOVE ROOTS FROM WALKWAY TO AVOID TRIPPING HAZARDS

1. Although the accessible routes cannot be made to conform to the general criteria for ADA compliance, safety requires a common sense approach. The pathways should be increased in width to 5', cleared of any vegetation, and exposed roots should be cut and removed.

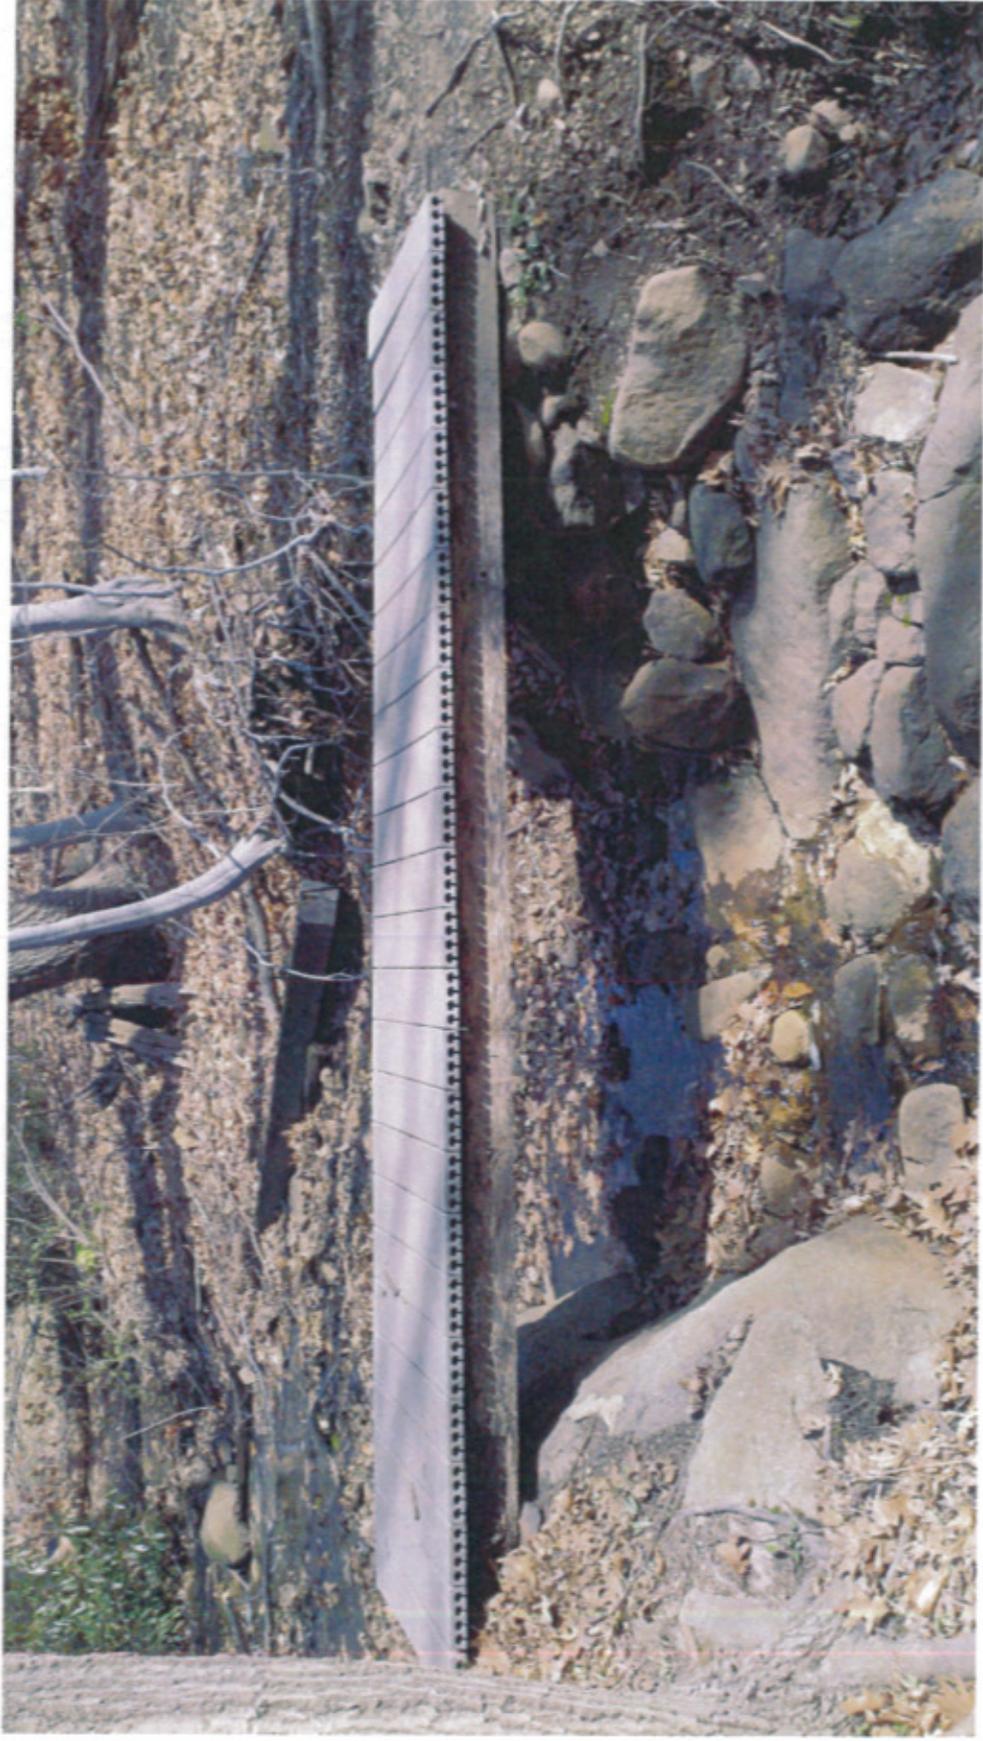
CHURCHHILL NATURE PRESERVE

PROVIDE SAFETY BARRIERS ALONG BRIDGE

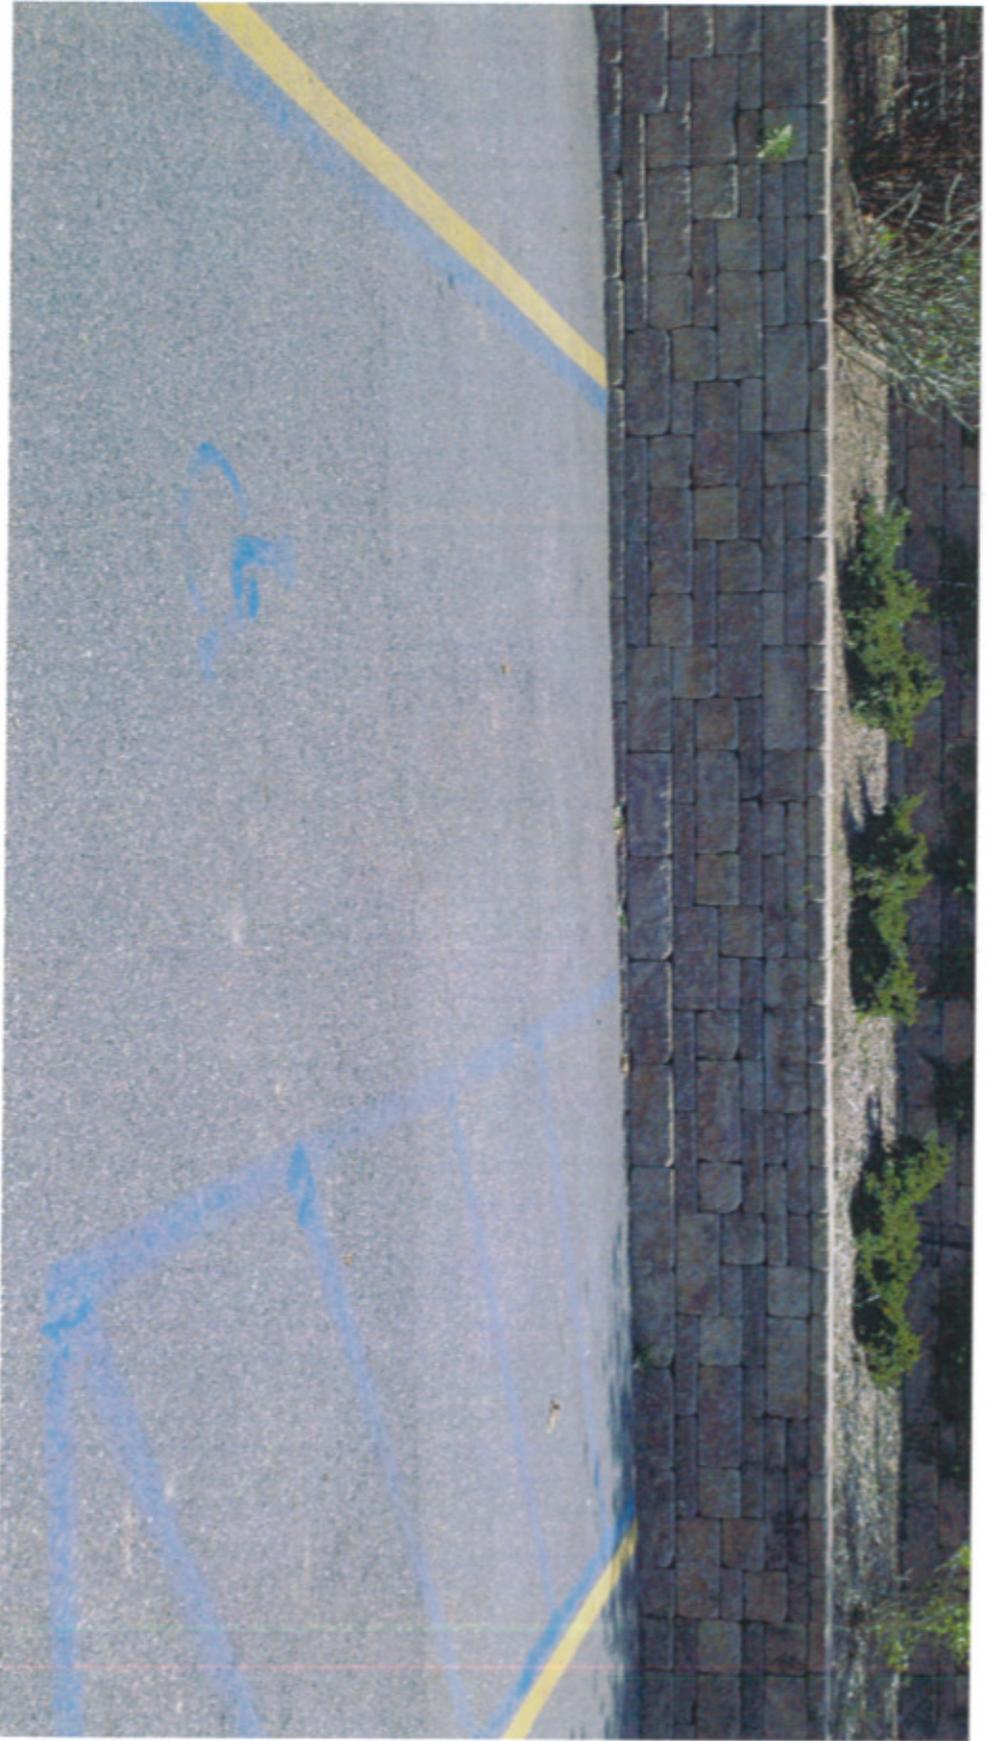
DAVIS JOHNSON PARK AND GARDENS

REPAINT HANDICAP STALLS AND PROVIDE SIGNAGE

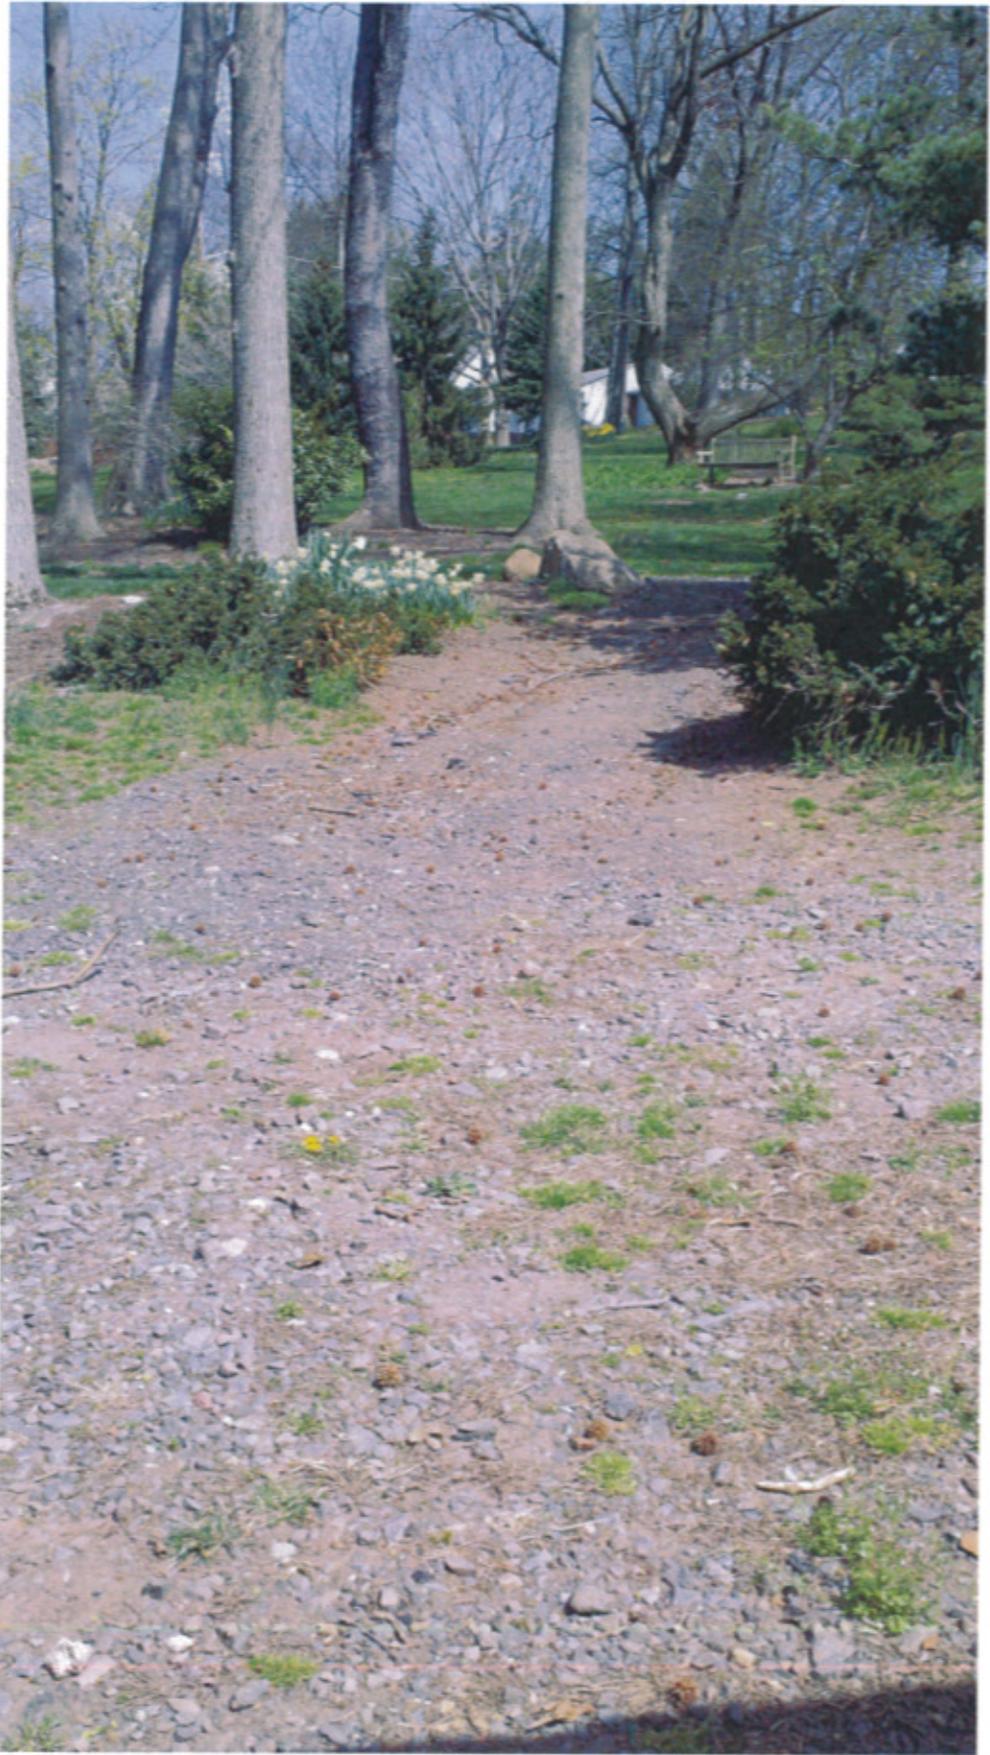
DAVIS JOHNSON PARK AND GARDENS

MODIFY ACCESSIBLE ROUTE; MATERIAL TO COMPLY WITH ADA STANDARDS

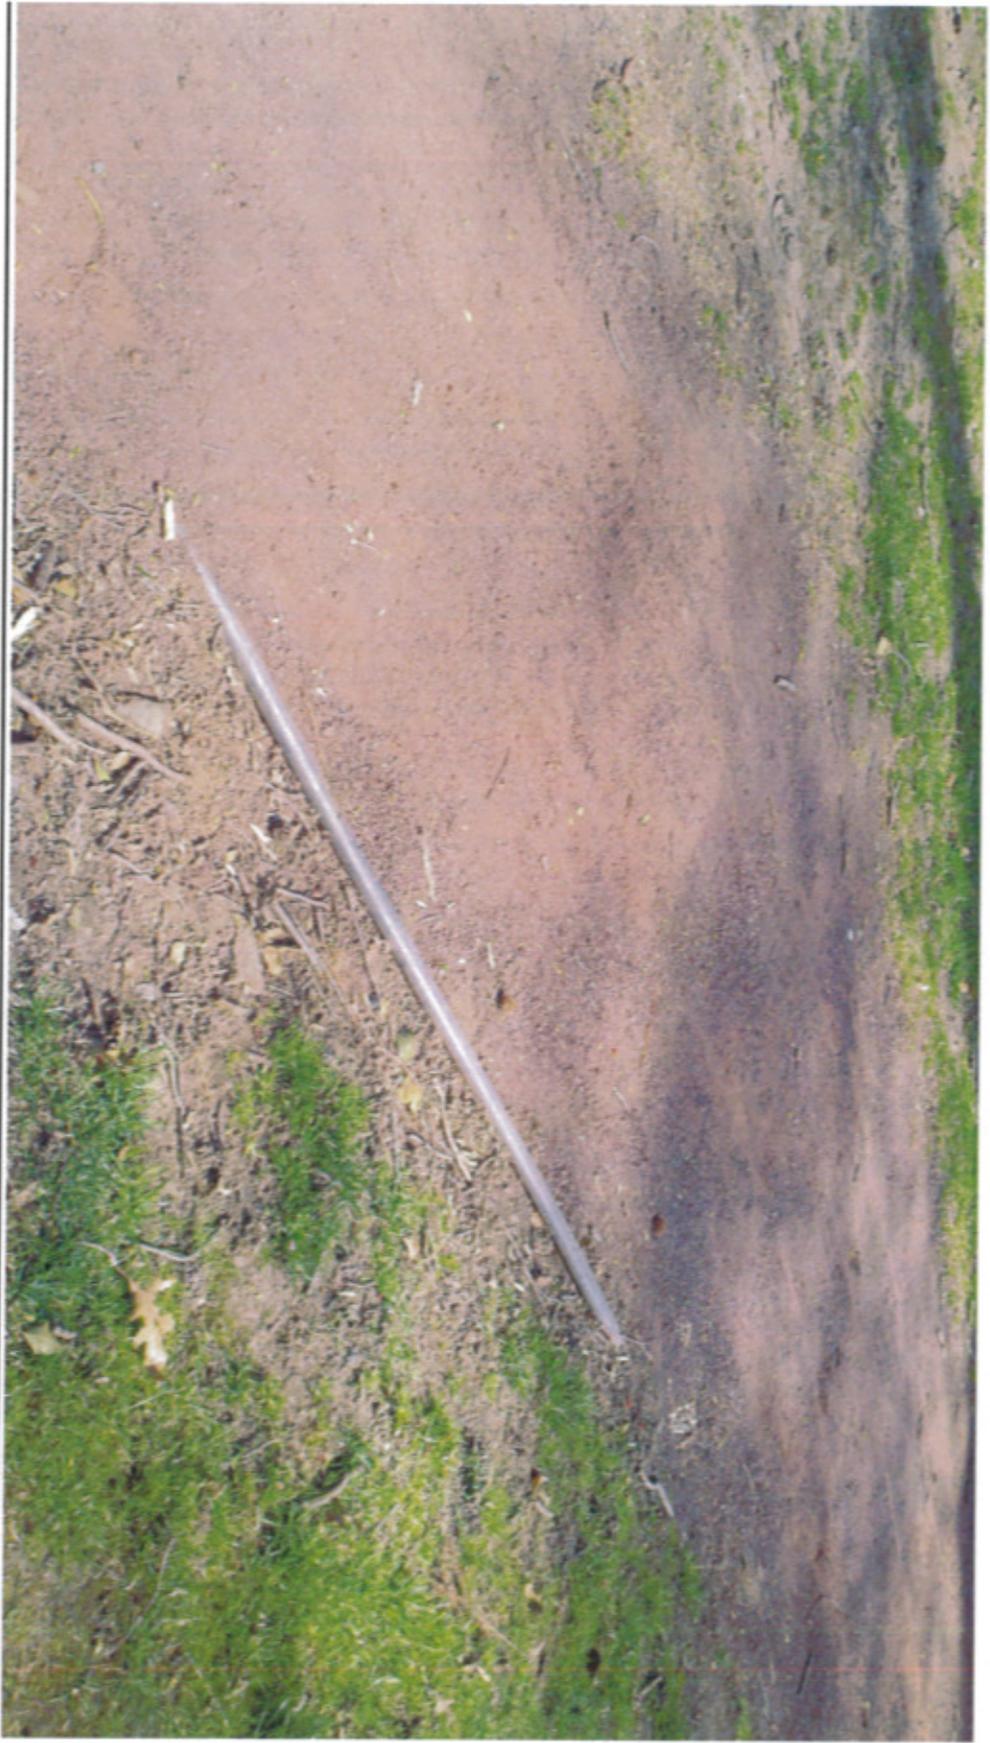
DAVIS JOHNSON PARK AND GARDENS

REMOVE EXPOSED IRRIGATION PIPES FROM WALKWAY

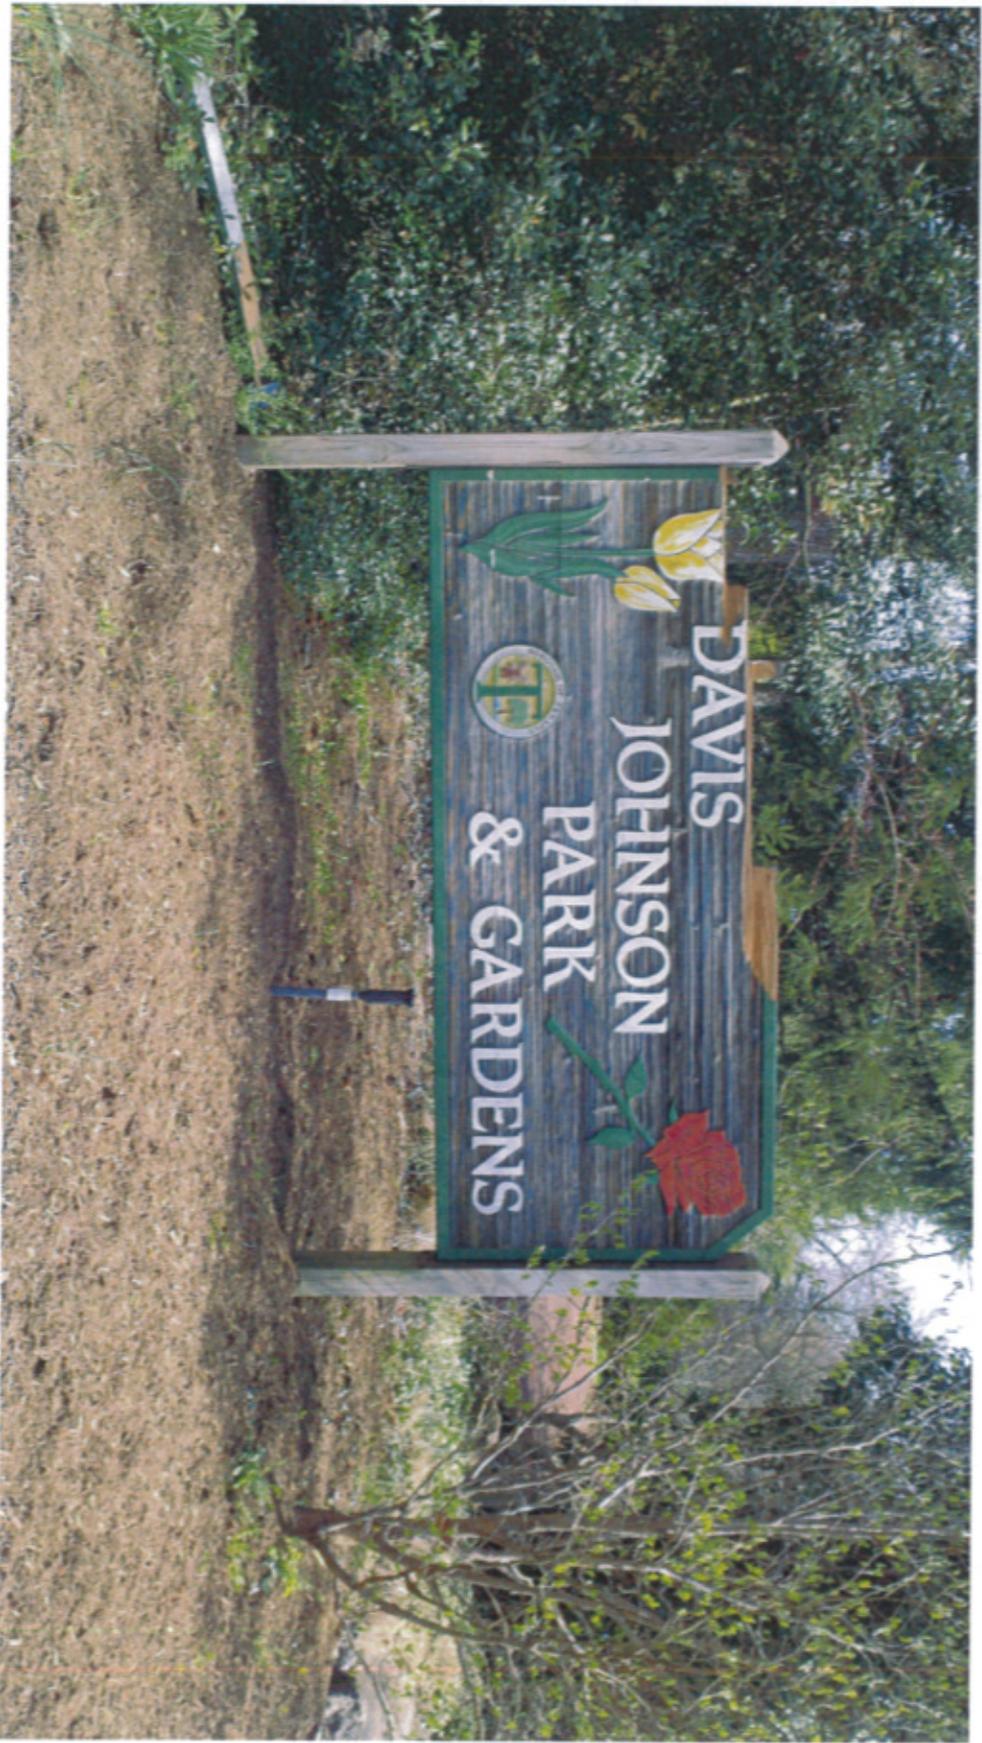
DAVIS JOHNSON PARK AND GARDENS

REPAIR SIGN; CONVEYS IMPROPER IMAGE

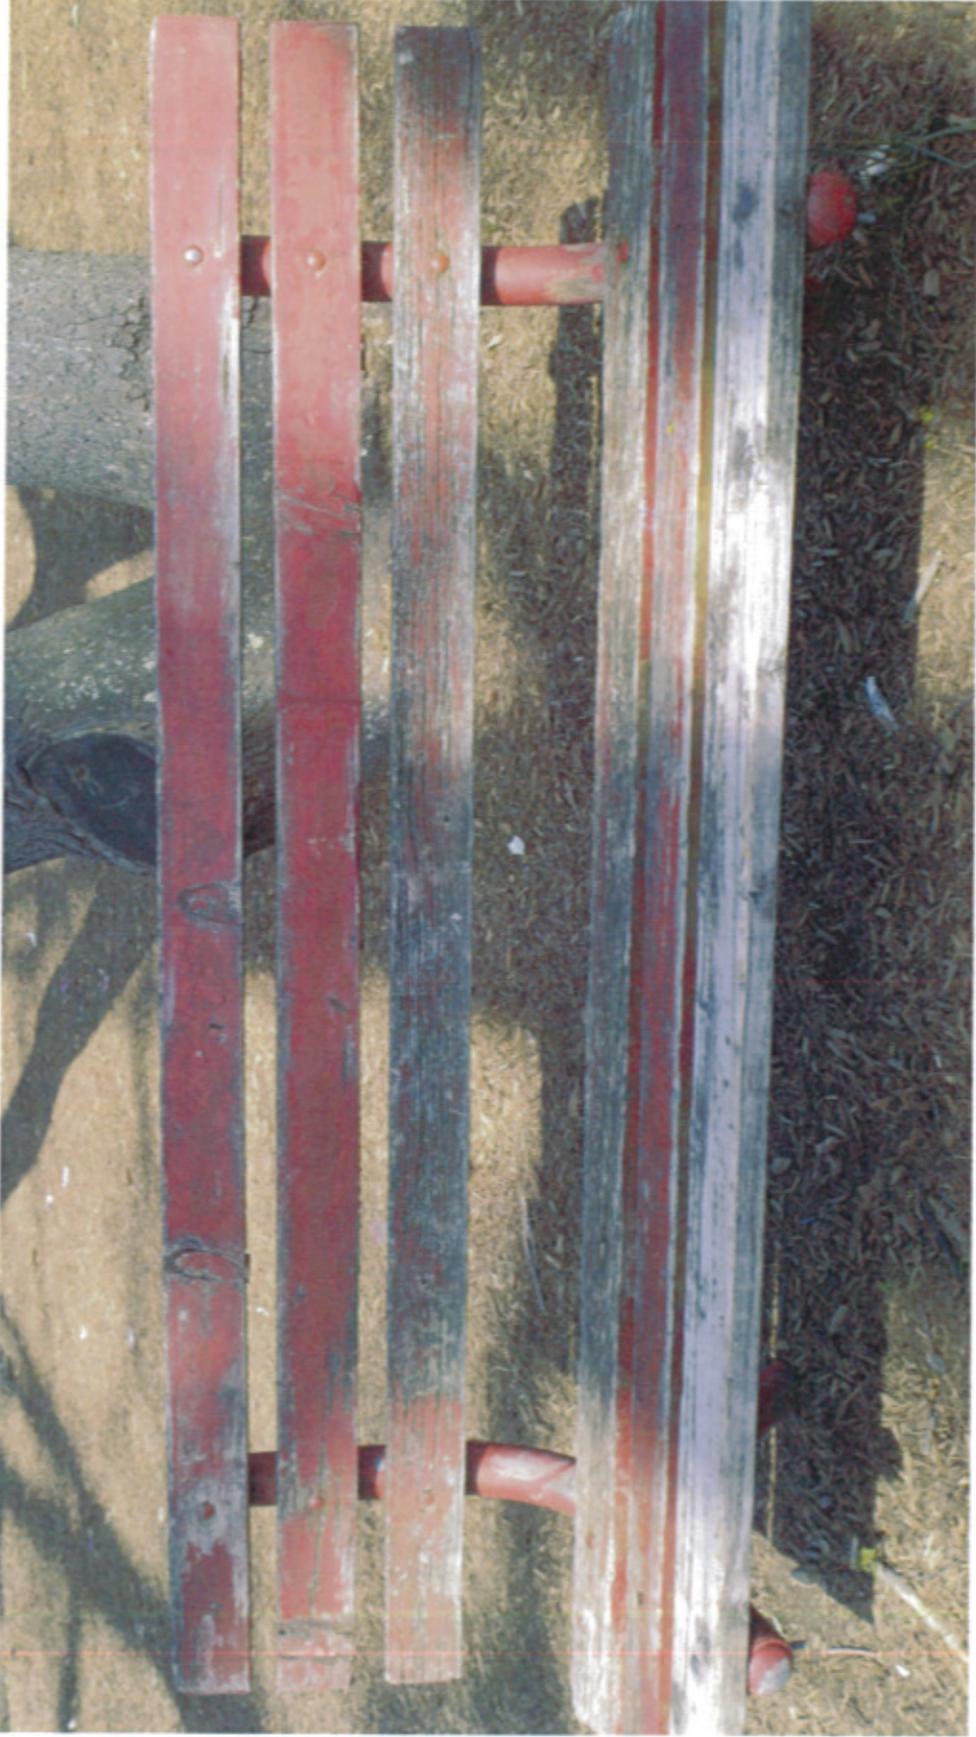
FROGGY PLAYGROUND

OLD SITE AMENITIES SHOULD BE REMOVED

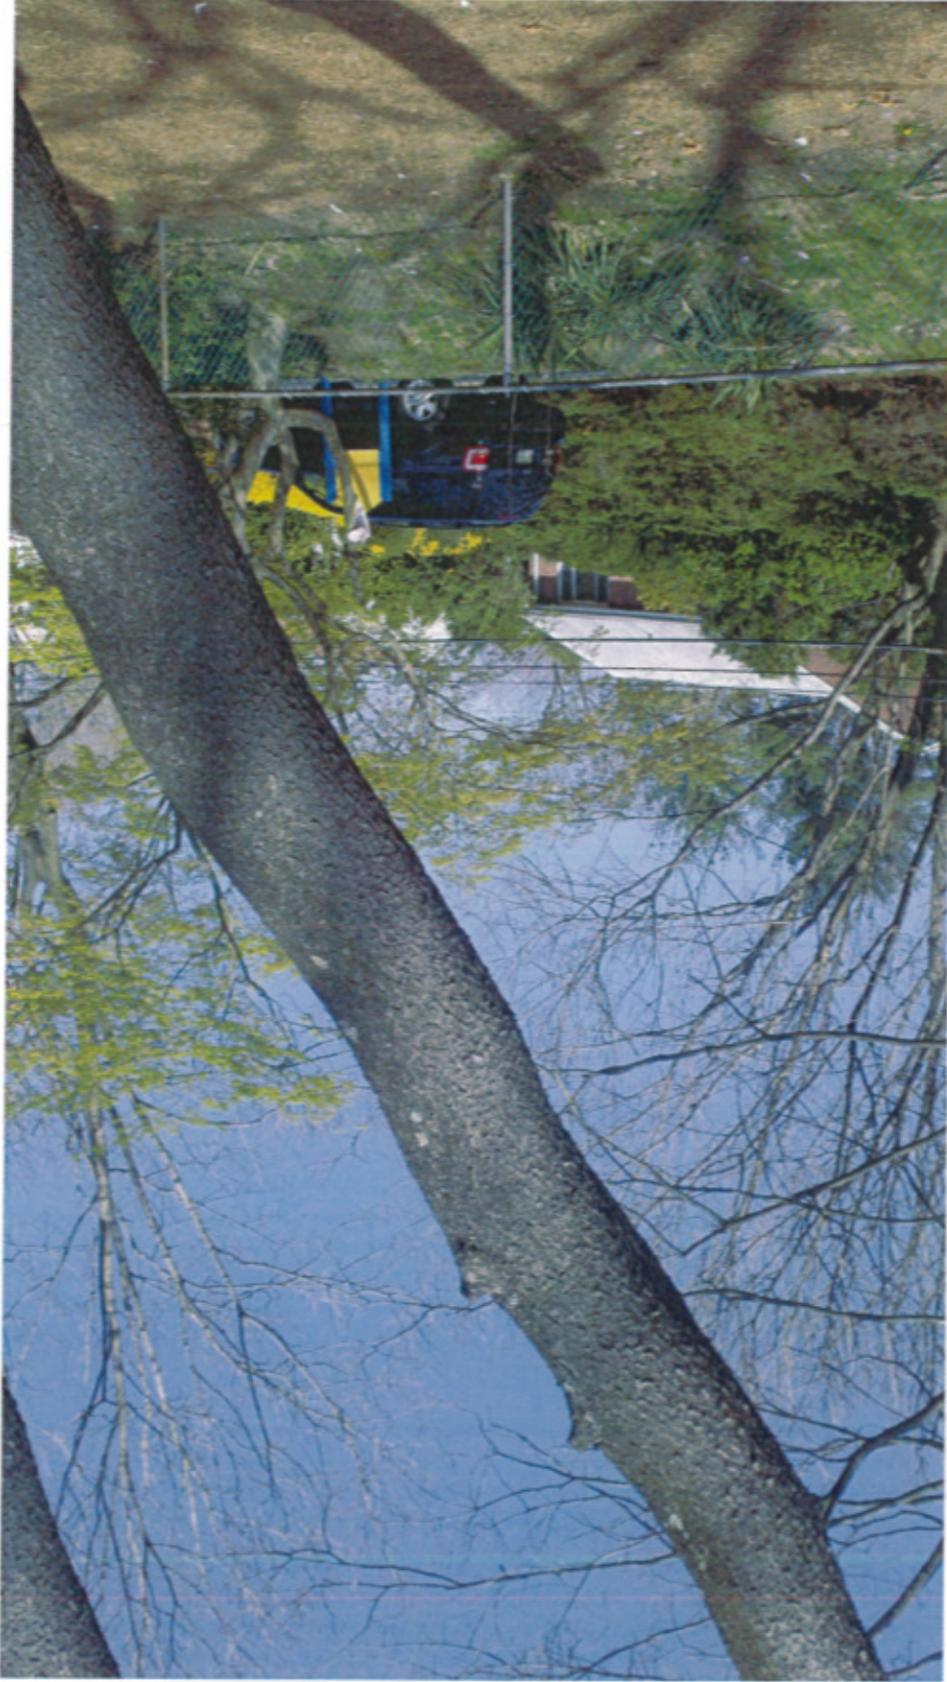
FROGGY PLAYGROUND

TREES LEANING BEYOND AN ACCEPTABLE STANDARD, SHOULD BE REMOVED TO AVOID A HAZARDOUS CONDITION

1. There are several dead trees and trees in poor condition that should be removed as soon as possible. They present significant hazards to park patrons.

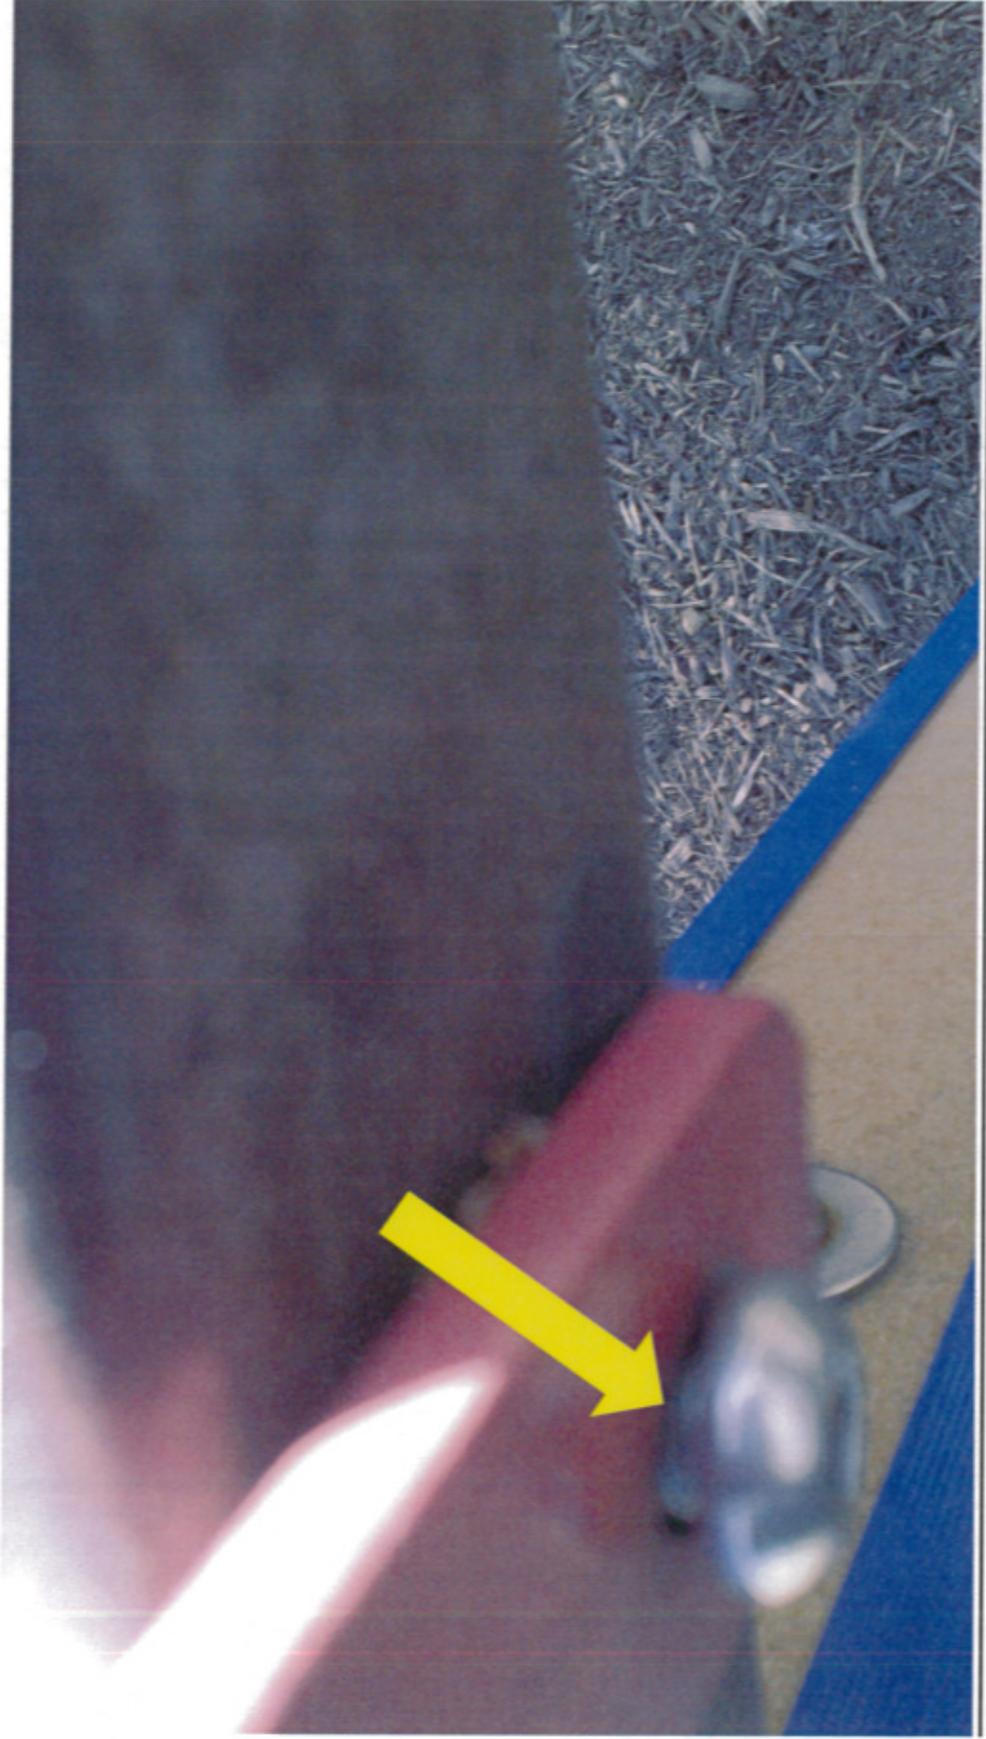
FROGGY PLAYGROUND

LOOSE BOLT AND STRIPPED BOLTS THROUGHOUT PARK
