2012 EVALUATION OF RECREATIONAL PARKS/PLAYGROUNDS

FOR
SAFETY INSPECTION – ADA COMPLIANCE

Borough of Tenafly
100 Riveredge Road
Tenafly, NJ 07670

MC Project No. TFB-048

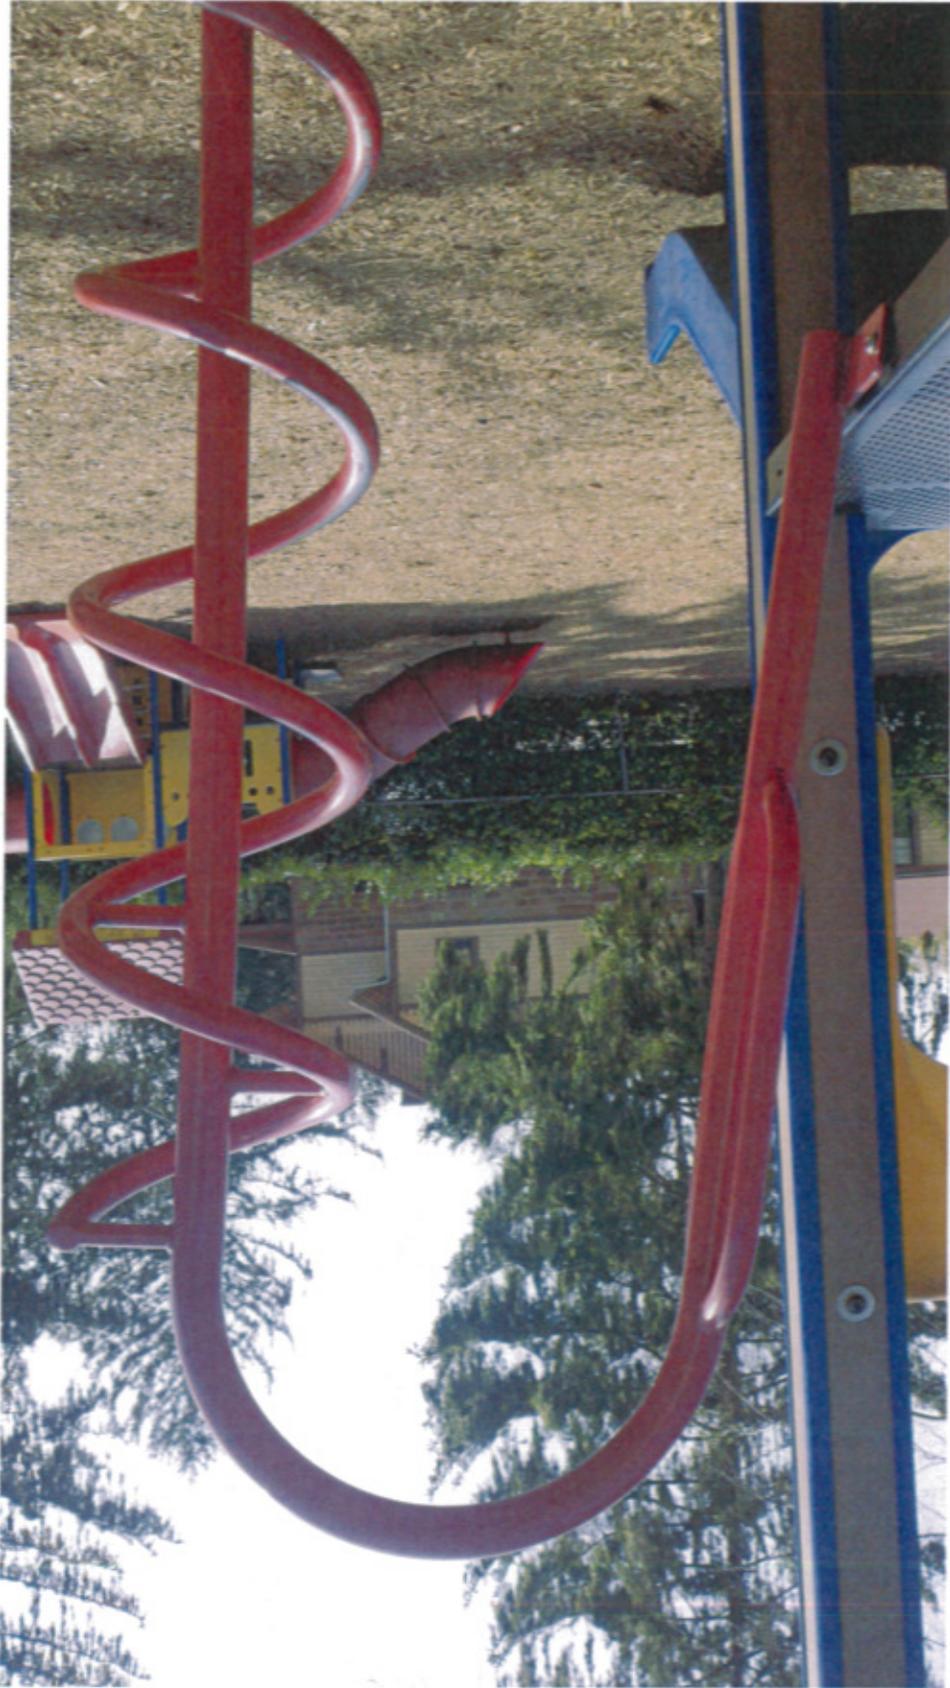
FROGGY PLAYGROUND

DAMAGED SPIRAL CLIMBER WITH LOOSE BOLT ATTACHMENT

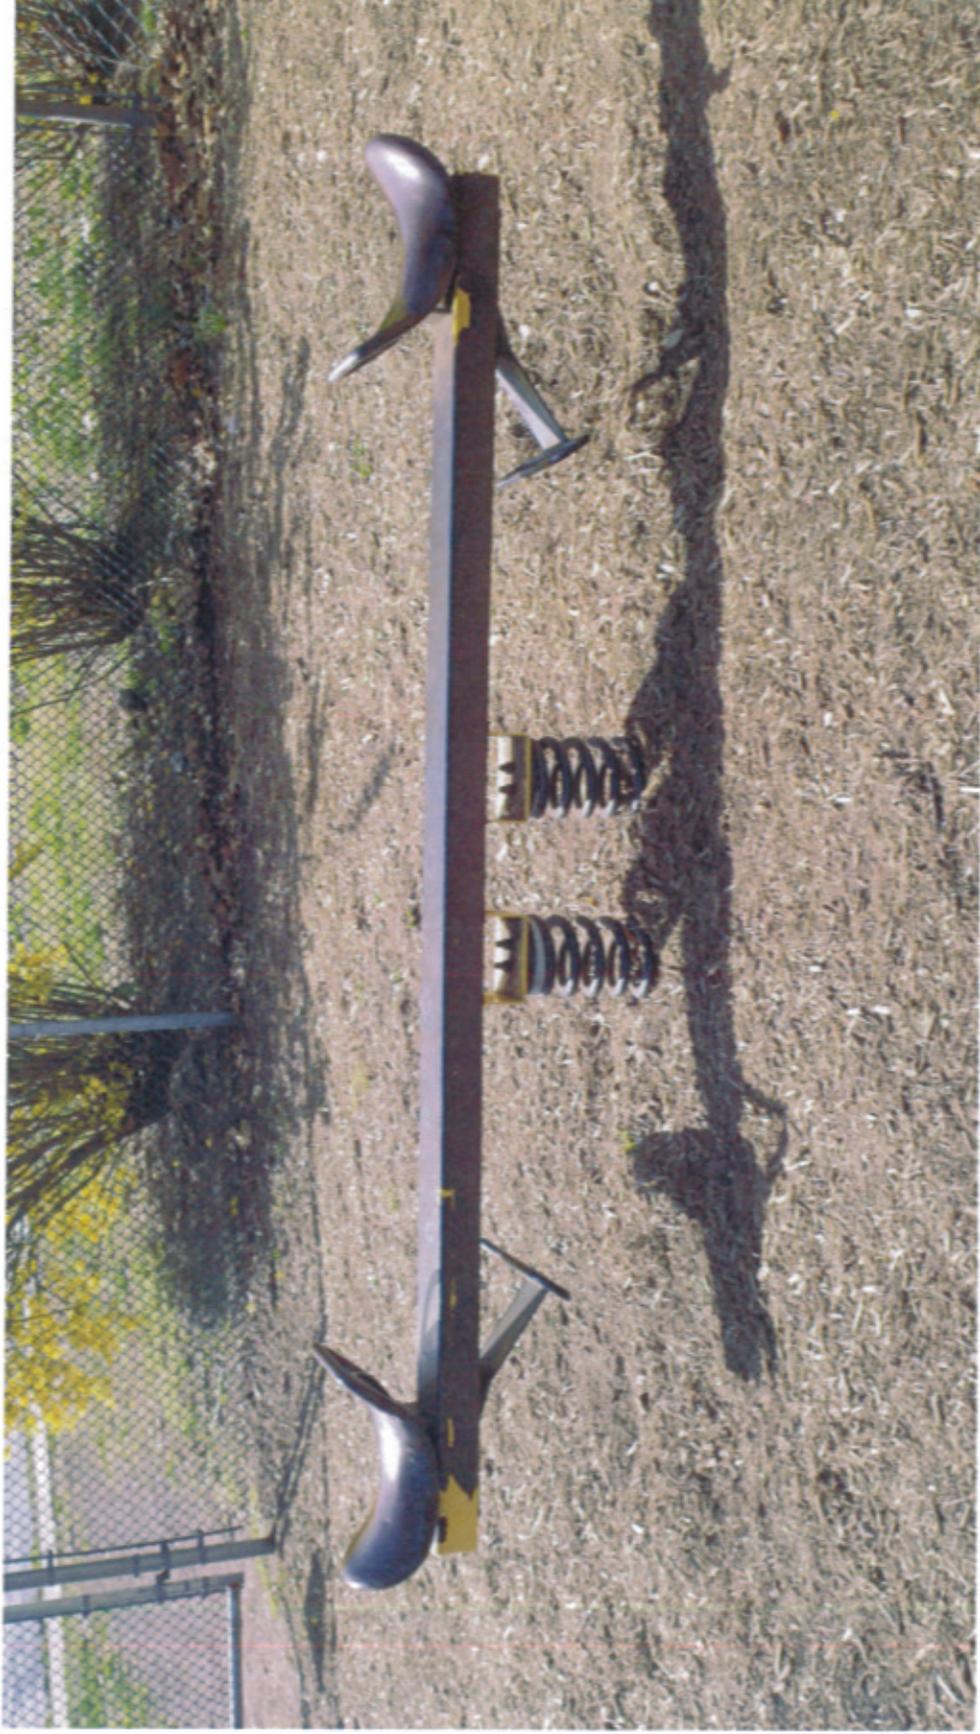
FROGGY PLAYGROUND

OUT OF DATE EQUIPMENT IN POOR CONDITION WITHOUT SAFETY COVERS

Our suggestion is to replace the play equipment, construct new stairs and a new accessible route with parking stall.

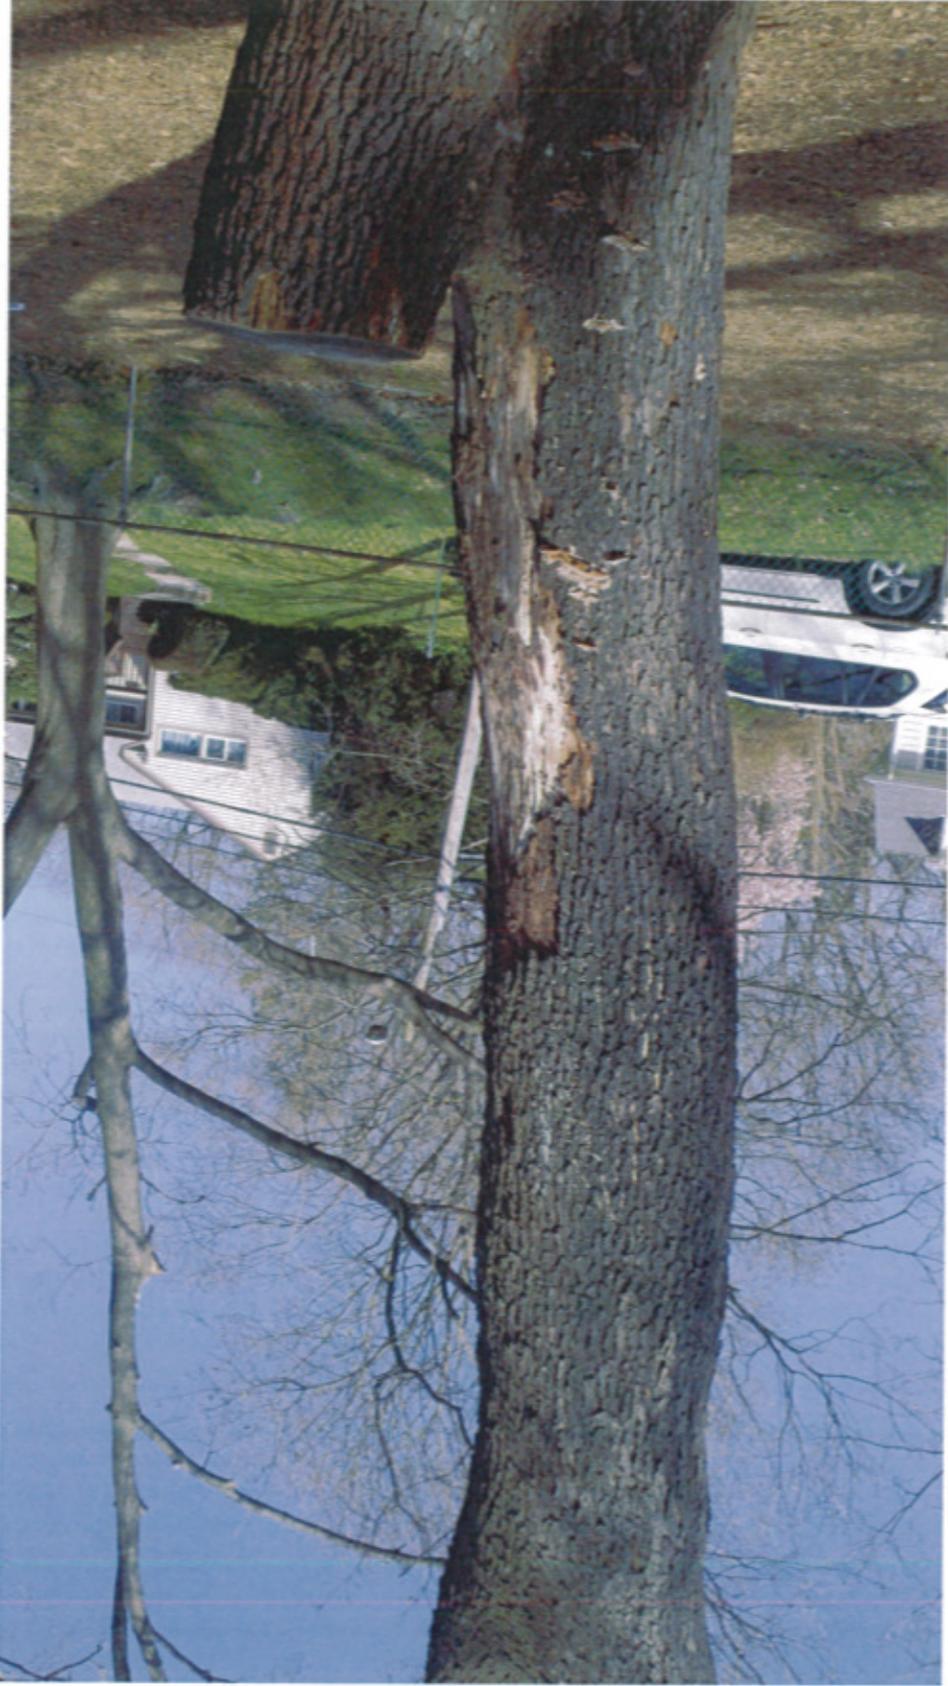
FROGGY PLAYGROUND

DEAD TREES WITHIN THE PLAY AREA OF THE PARK POSE A PRIORITY 1 HAZARD AND SHOULD BE REMOVED

1. There are several dead trees and trees in poor condition that should be removed as soon as possible. They present significant hazards to park patrons.

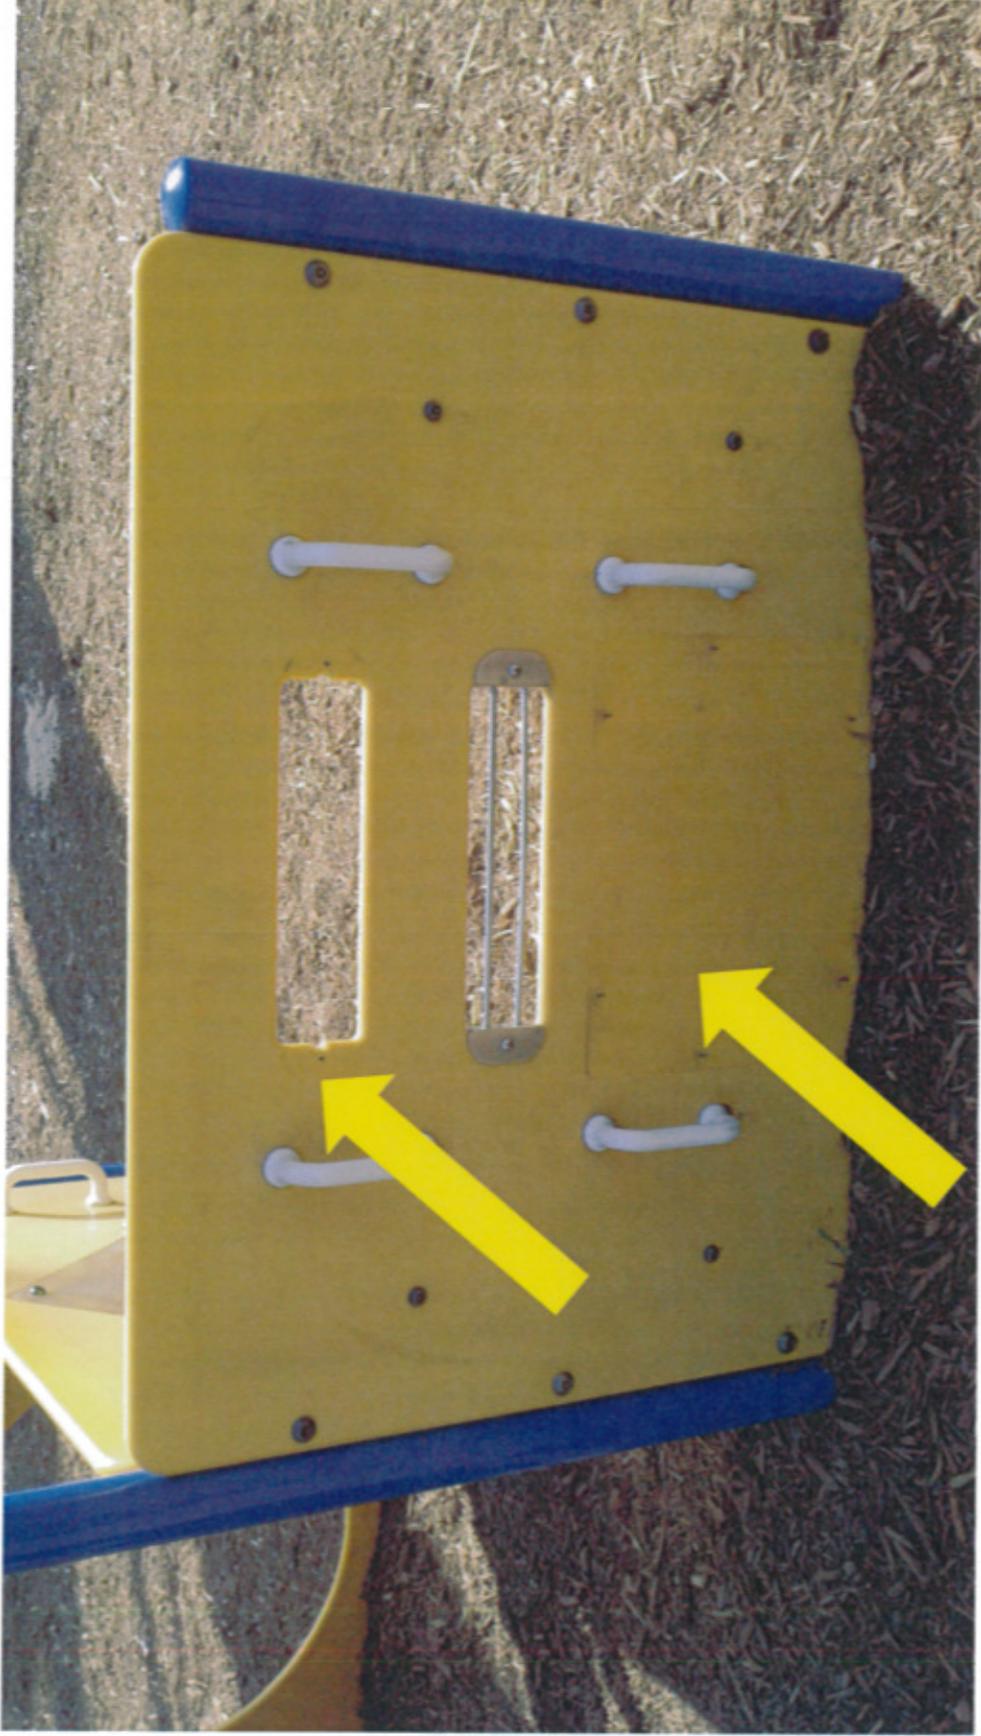
FROGGY PLAYGROUND

MISSING COMPONENTS ON PLAY STRUCTURE

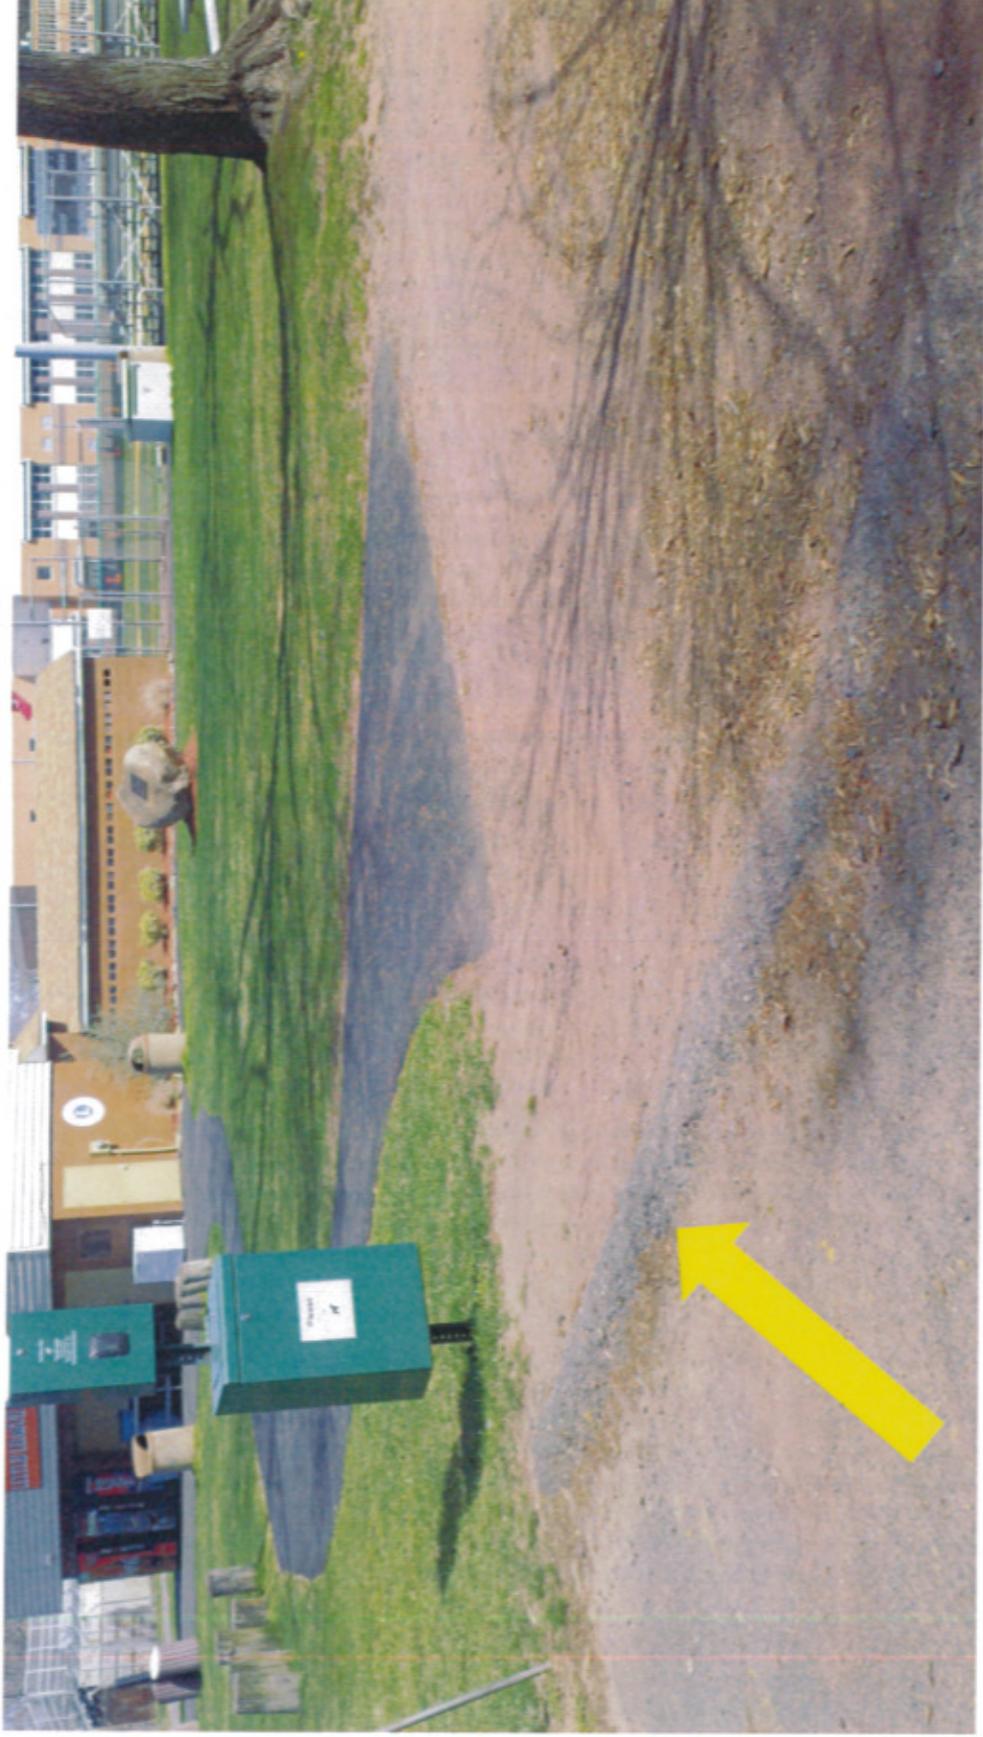
ROOSEVELT COMMON PLAYGROUND

AREA DOES NOT PROVIDE AN UNINTERRUPTED ADA COMPLIANT PATH WAY

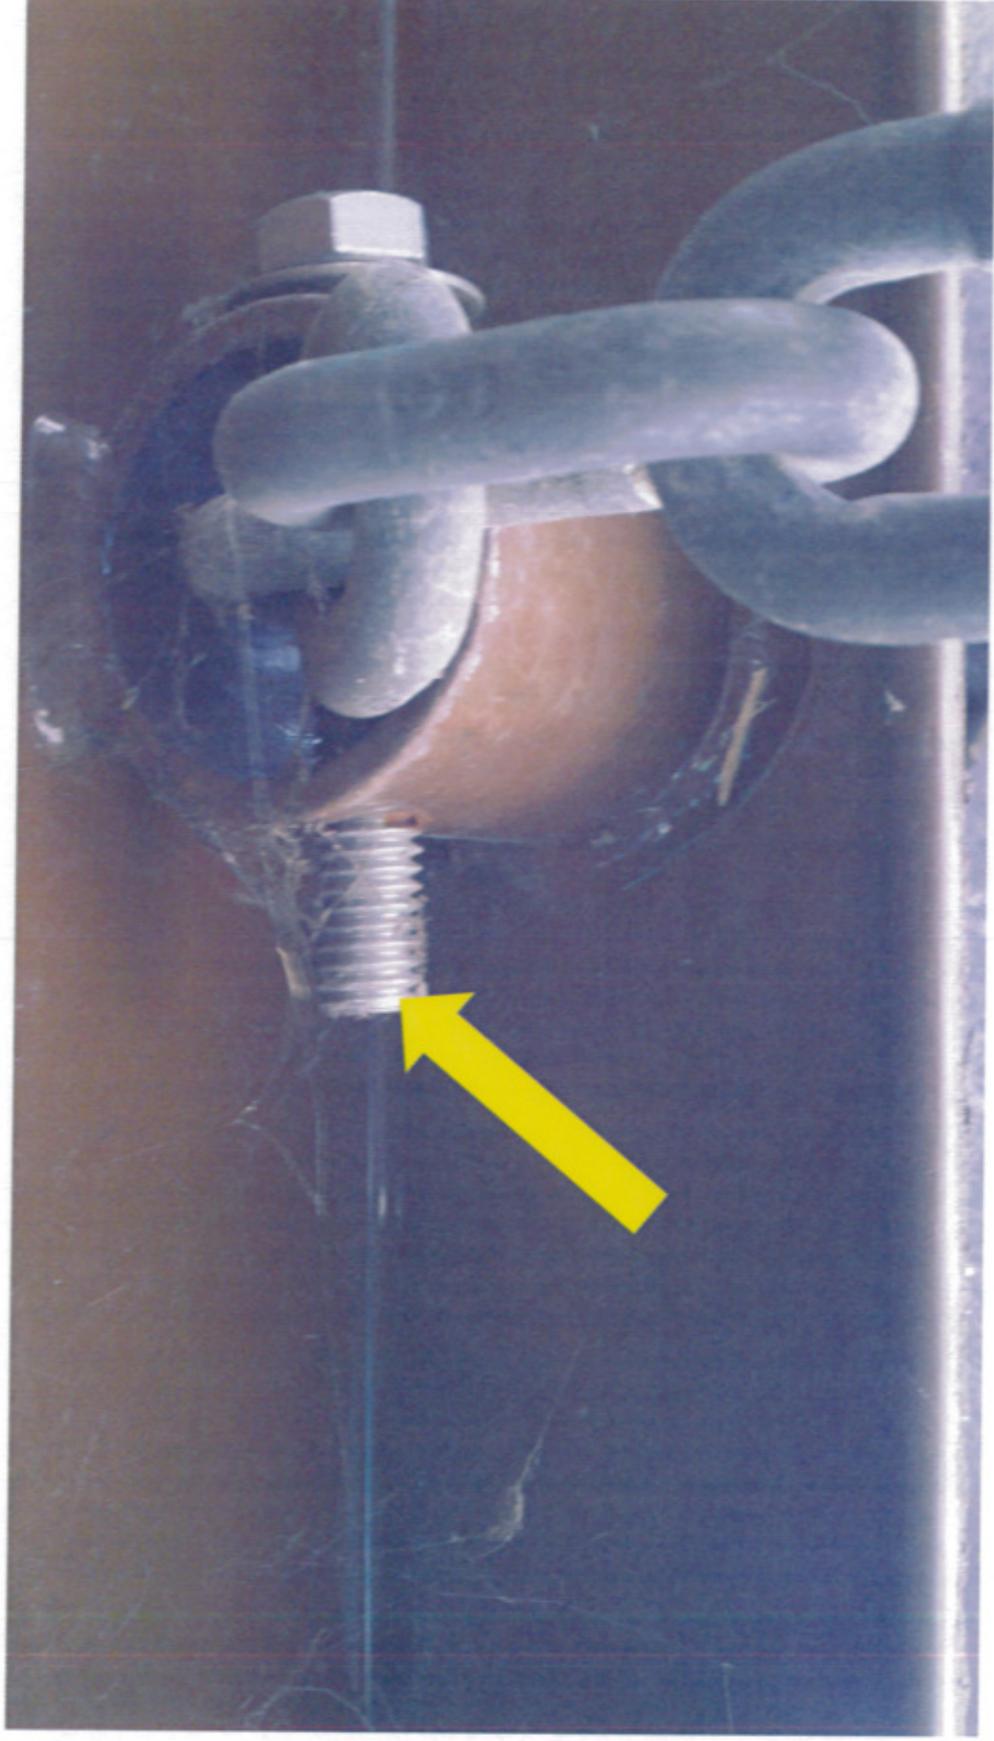
ROOSEVELT COMMON PLAYGROUND

REPLACE NUT ON CLADDER BRIDGE CHAIN

3. The composite play structure is in very good condition with the exception of the cladder bridge section of the structure. If the chain supports could be tightened up, the bridge will not have to be replaced.

If the cladder bridge requires replacement parts and installation would cost approximately \$4,000.

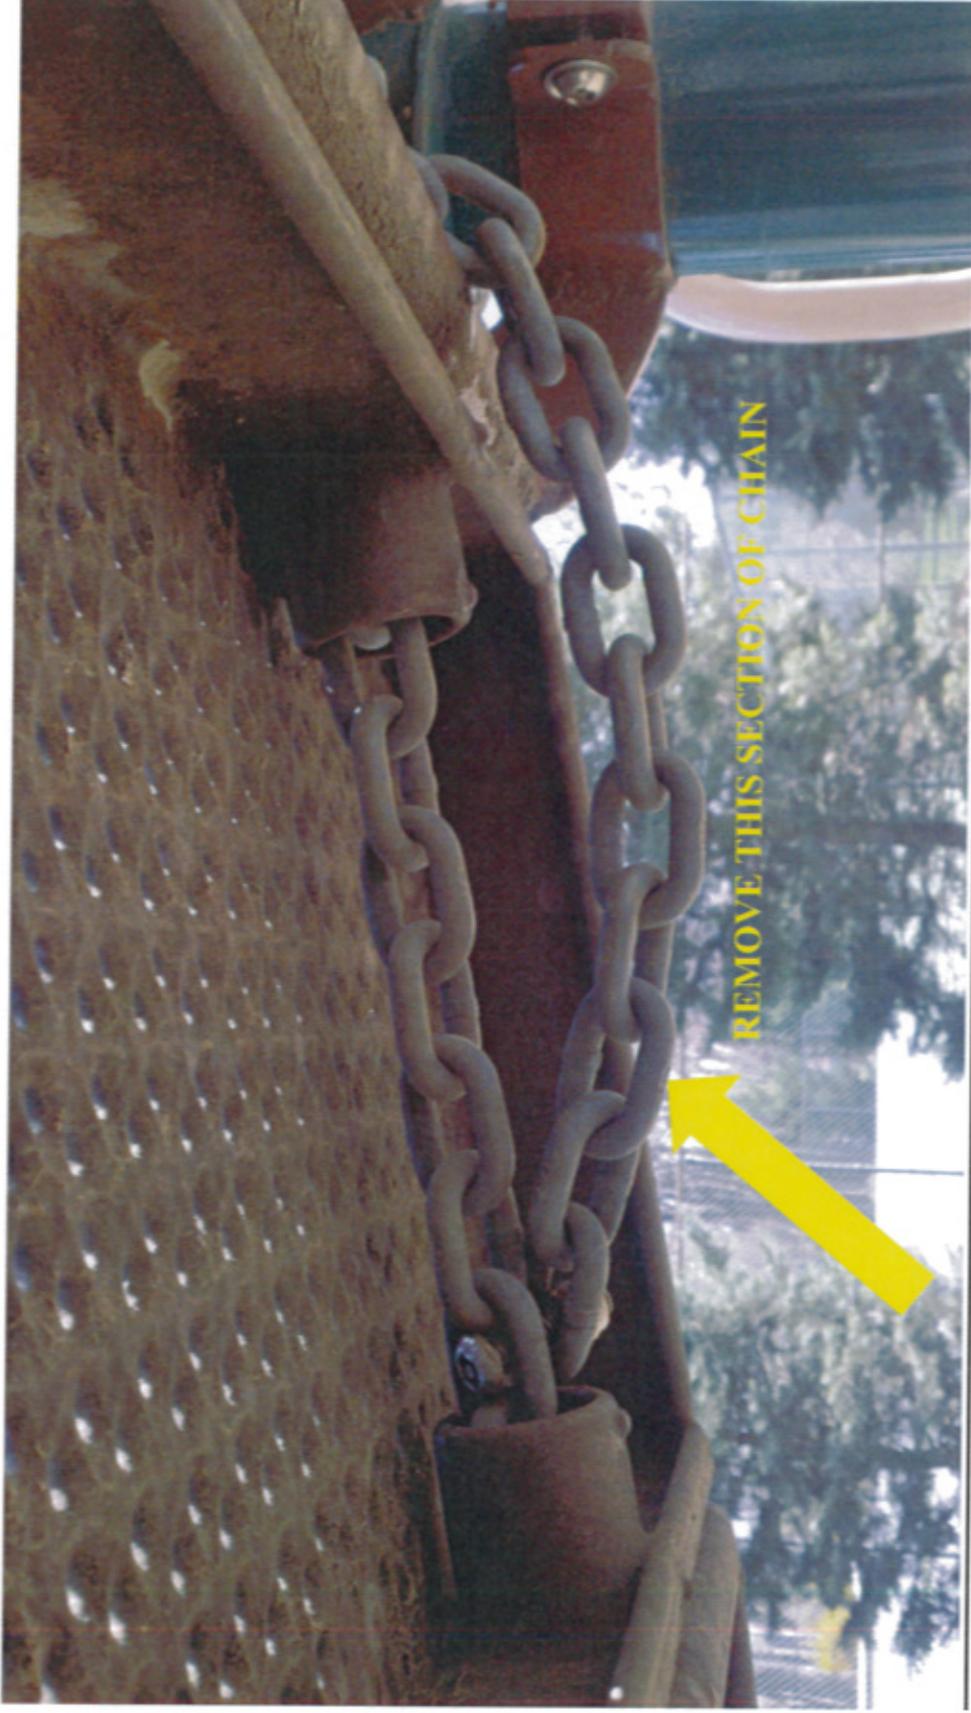
ROOSEVELT COMMON PLAYGROUND

**DO NOT PERFORM REPAIRS TO CLADDER BRIDGES WHICH DO NOT FOLLOW
MANUFACTURER GUIDELINES**

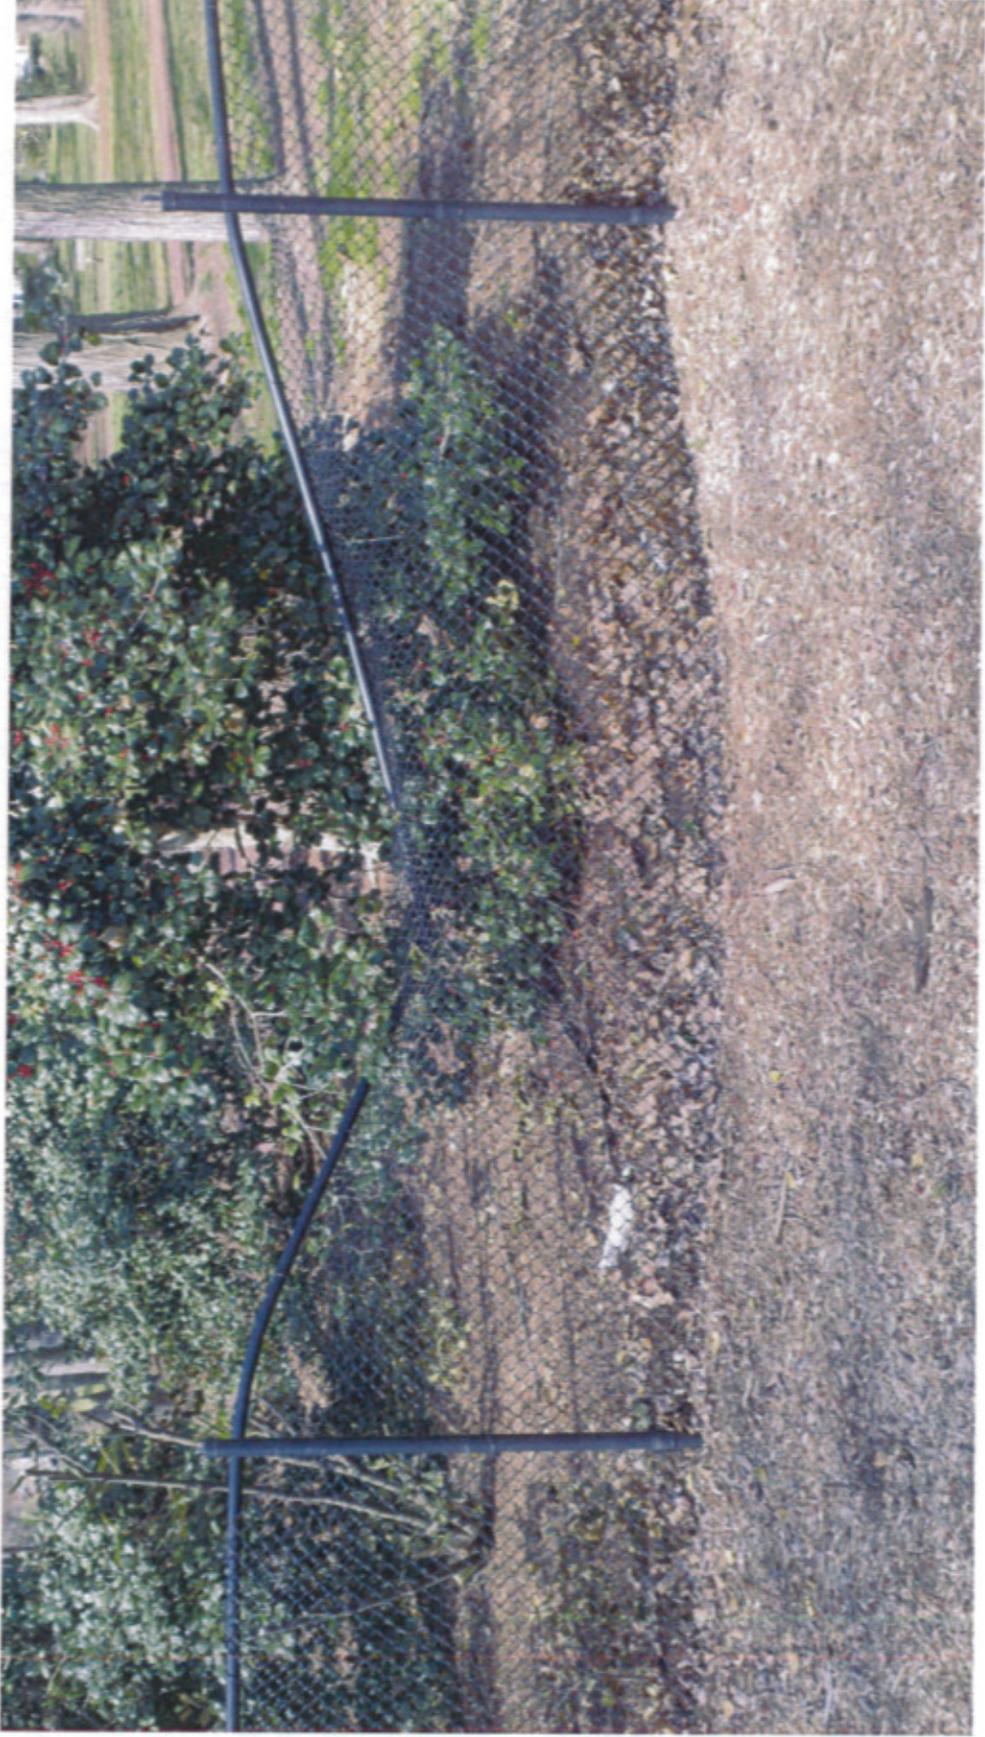
ROOSEVELT COMMON PLAYGROUND

REPAIR OR REPLACE FENCING AROUND PLAYGROUND

1. Replace damaged fencing throughout the park. All gates should be 60" to comply with required clearance for mobility and flow.

We estimate the cost of the replacement and repairs to be approximately \$5,200.

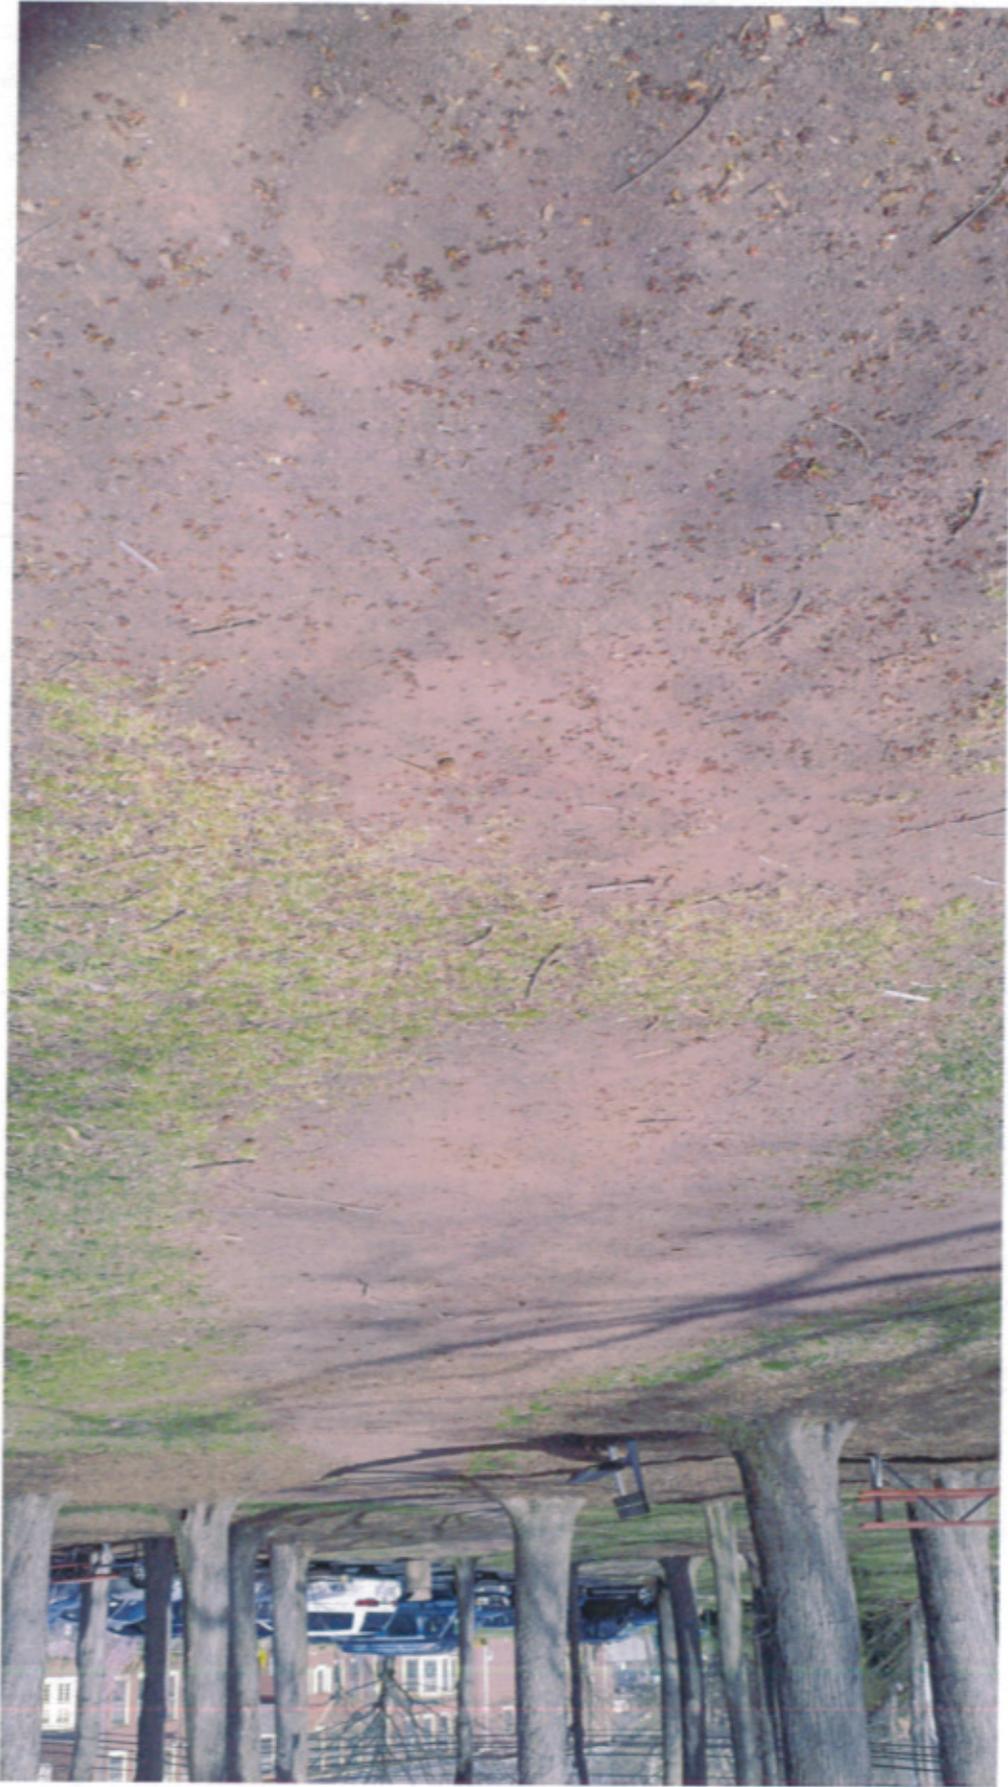
ROOSEVELT COMMON PLAYGROUND

PROVIDE ACCEPTABLE ADA COMPLIANT PATHWAY SYSTEM

4. Trail repair, expansion and surfacing changes to comply with ADA Standards from the picnic area to the Griffin Park play structure would cost approximately \$5,400.

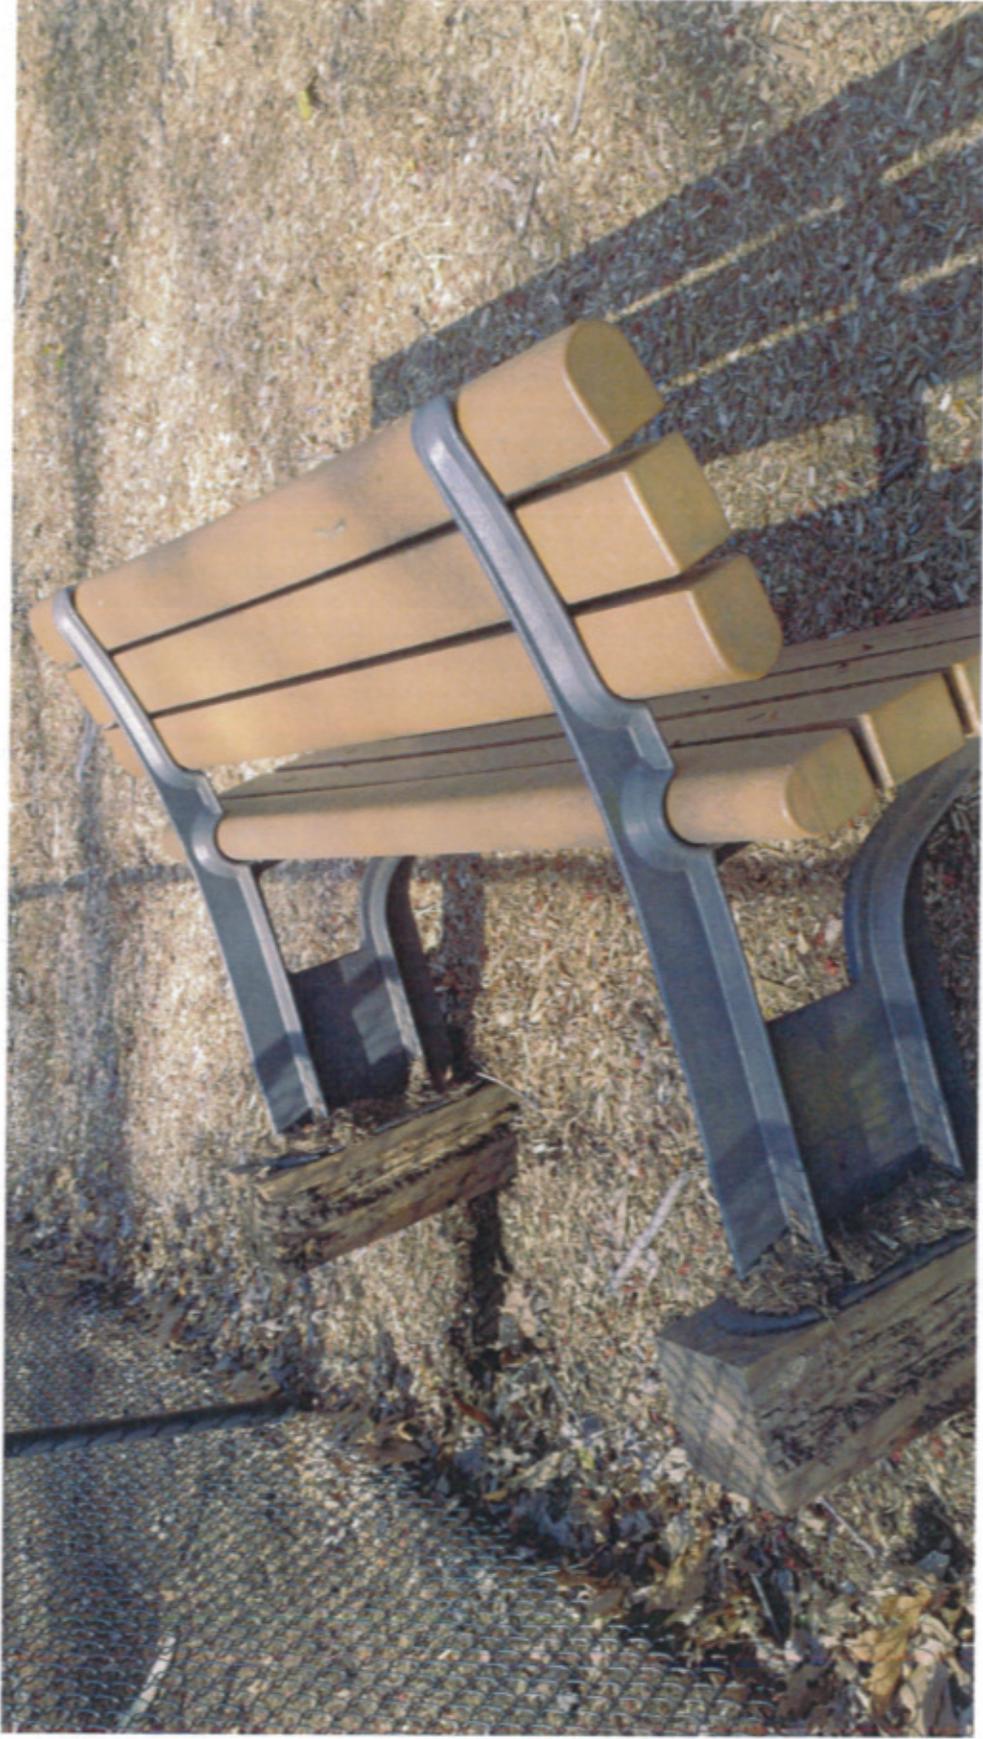
ROOSEVELT COMMON PLAYGROUND

PROVIDE PROPER FOOTING FOR BENCHES

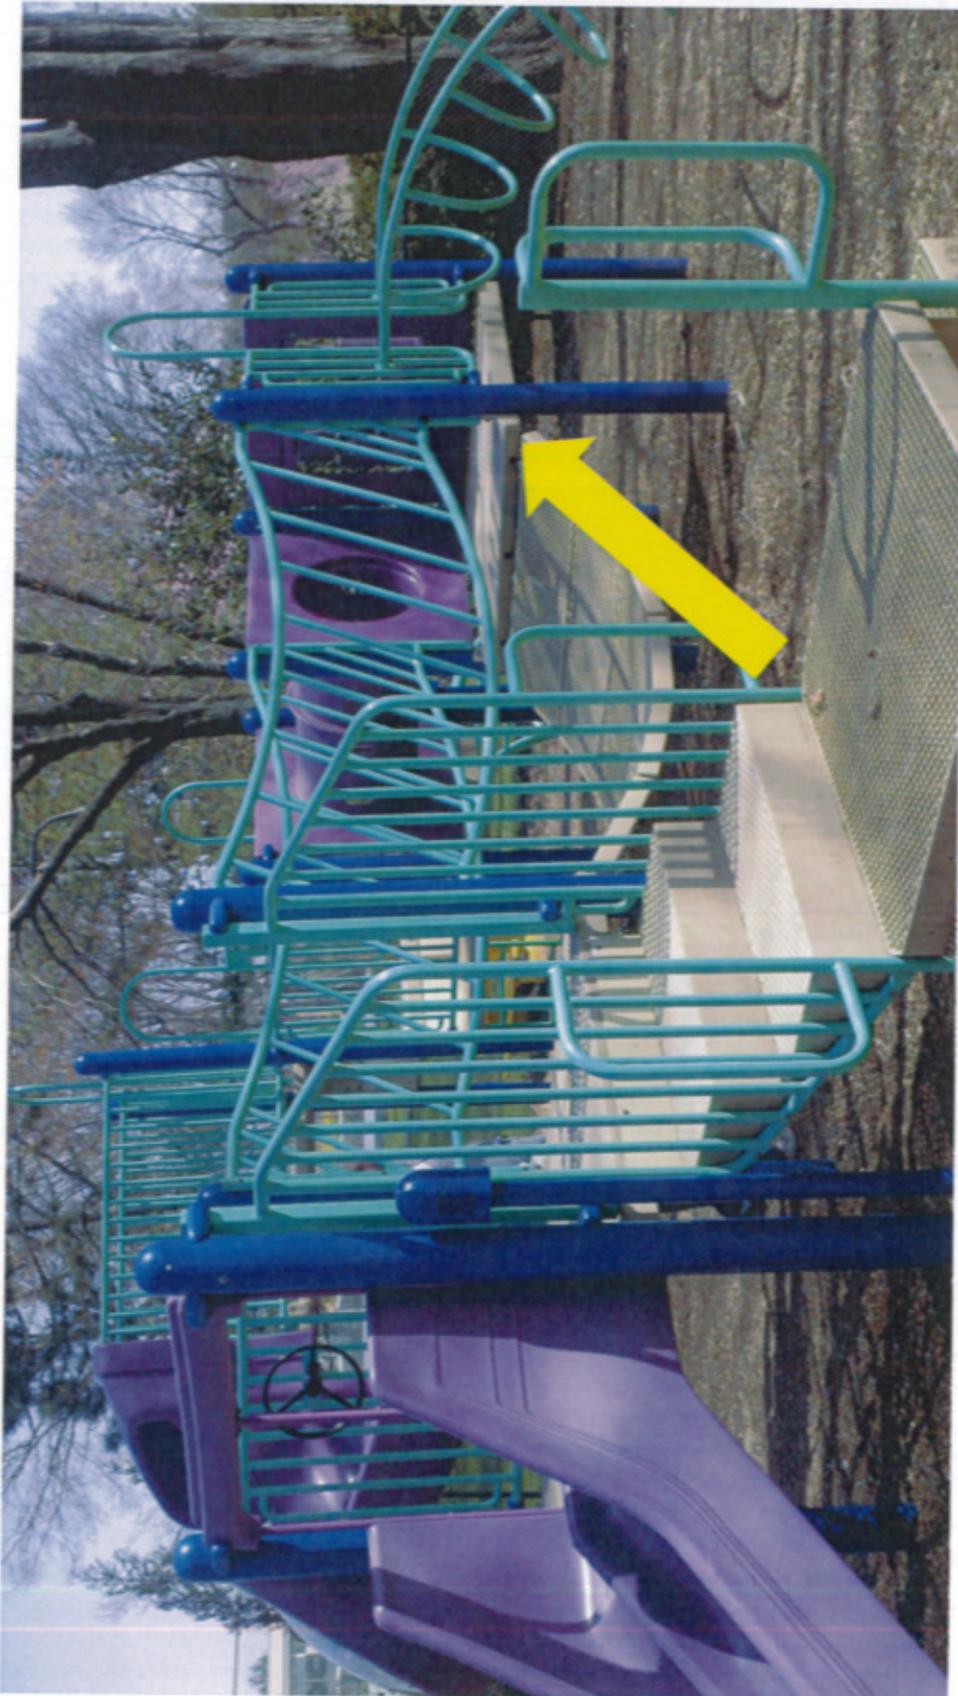
GRIFFIN PARK

CHAIN ON CLADDER BRIDGE MUST BE TIGHTENED TO AVOID CHILDREN FROM GETTING THEIR FINGERS CRUSHED

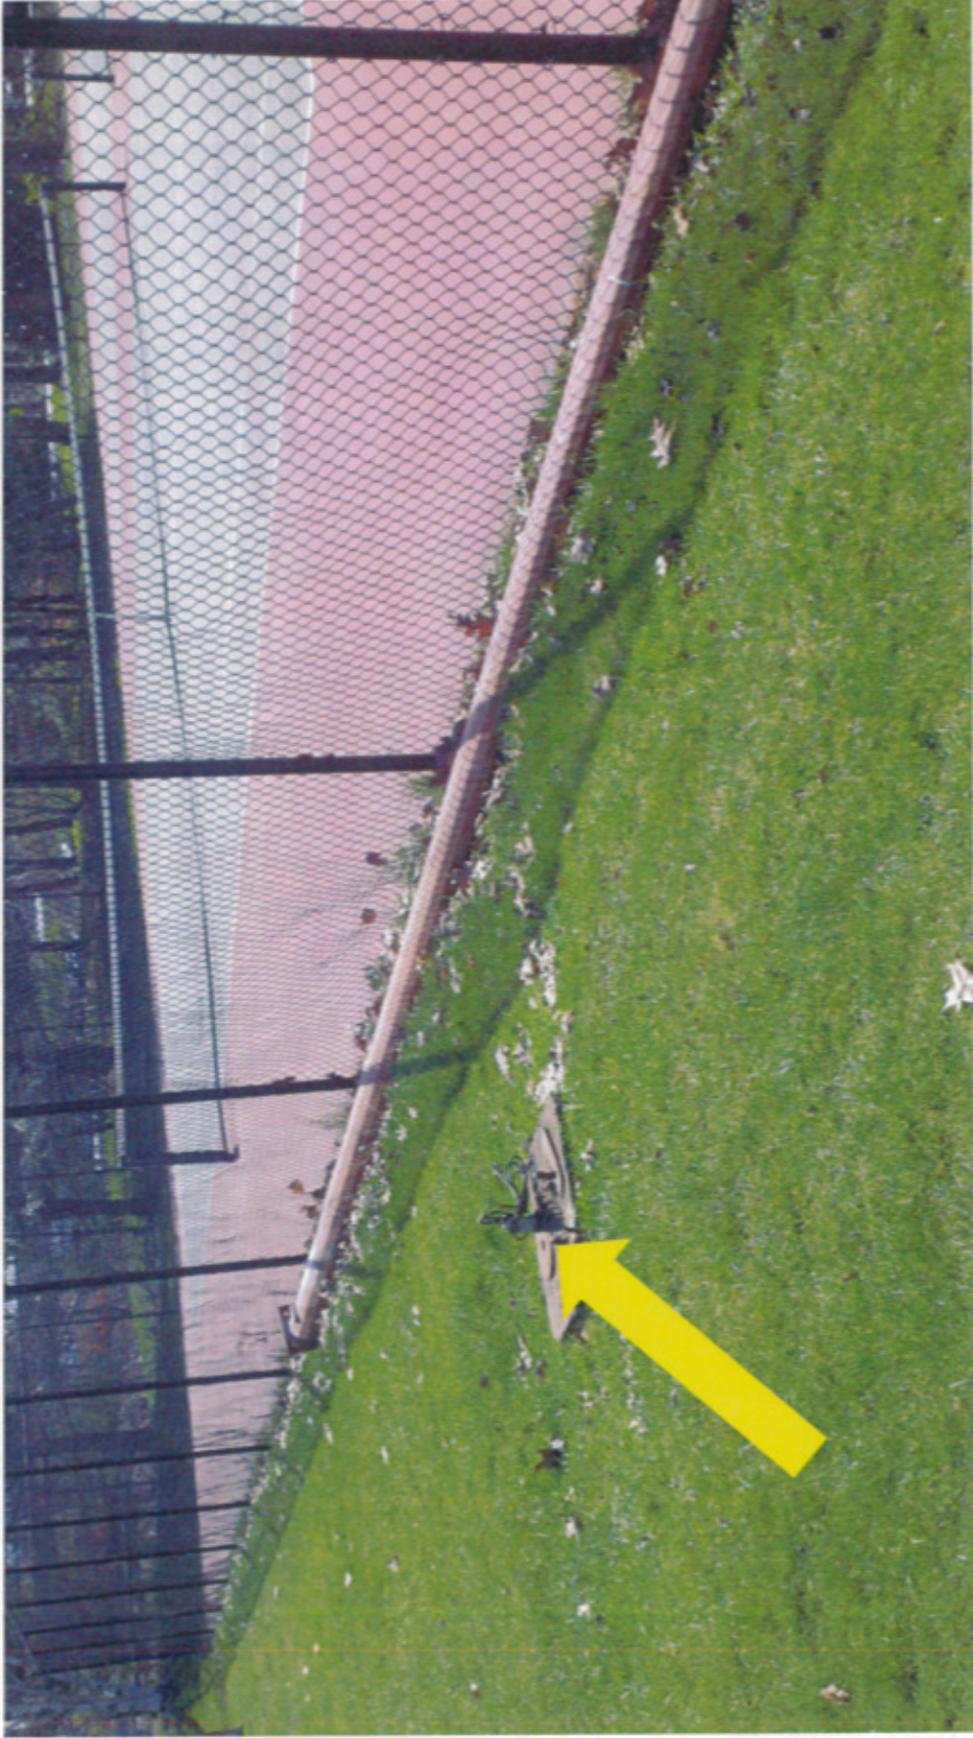
GRIFFIN PARK

EXPOSED WIRES AND OTHER PROTRUSIONS

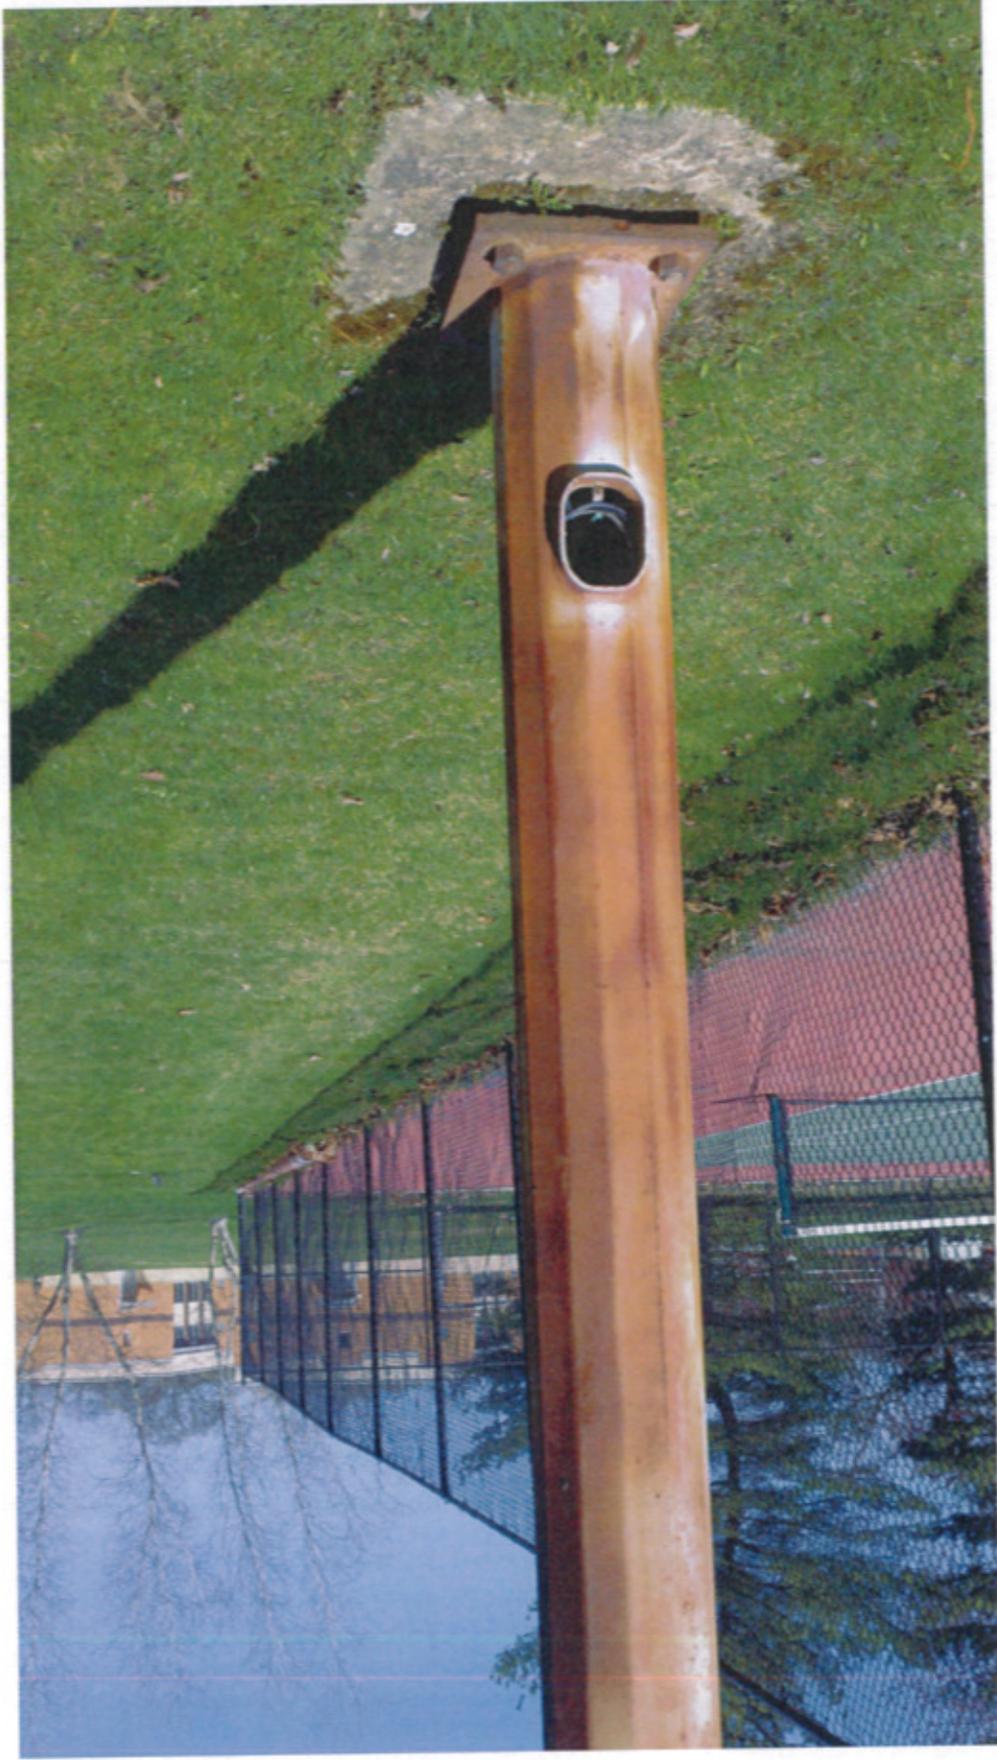
GRIFFIN PARK

OPEN ELECTRICAL PANELS
