2012 EVALUATION OF RECREATIONAL PARKS/PLAYGROUNDS

FOR
SAFETY INSPECTION – ADA COMPLIANCE

Borough of Tenafly
100 Riveredge Road
Tenafly, NJ 07670

MC Project No. TFB-048

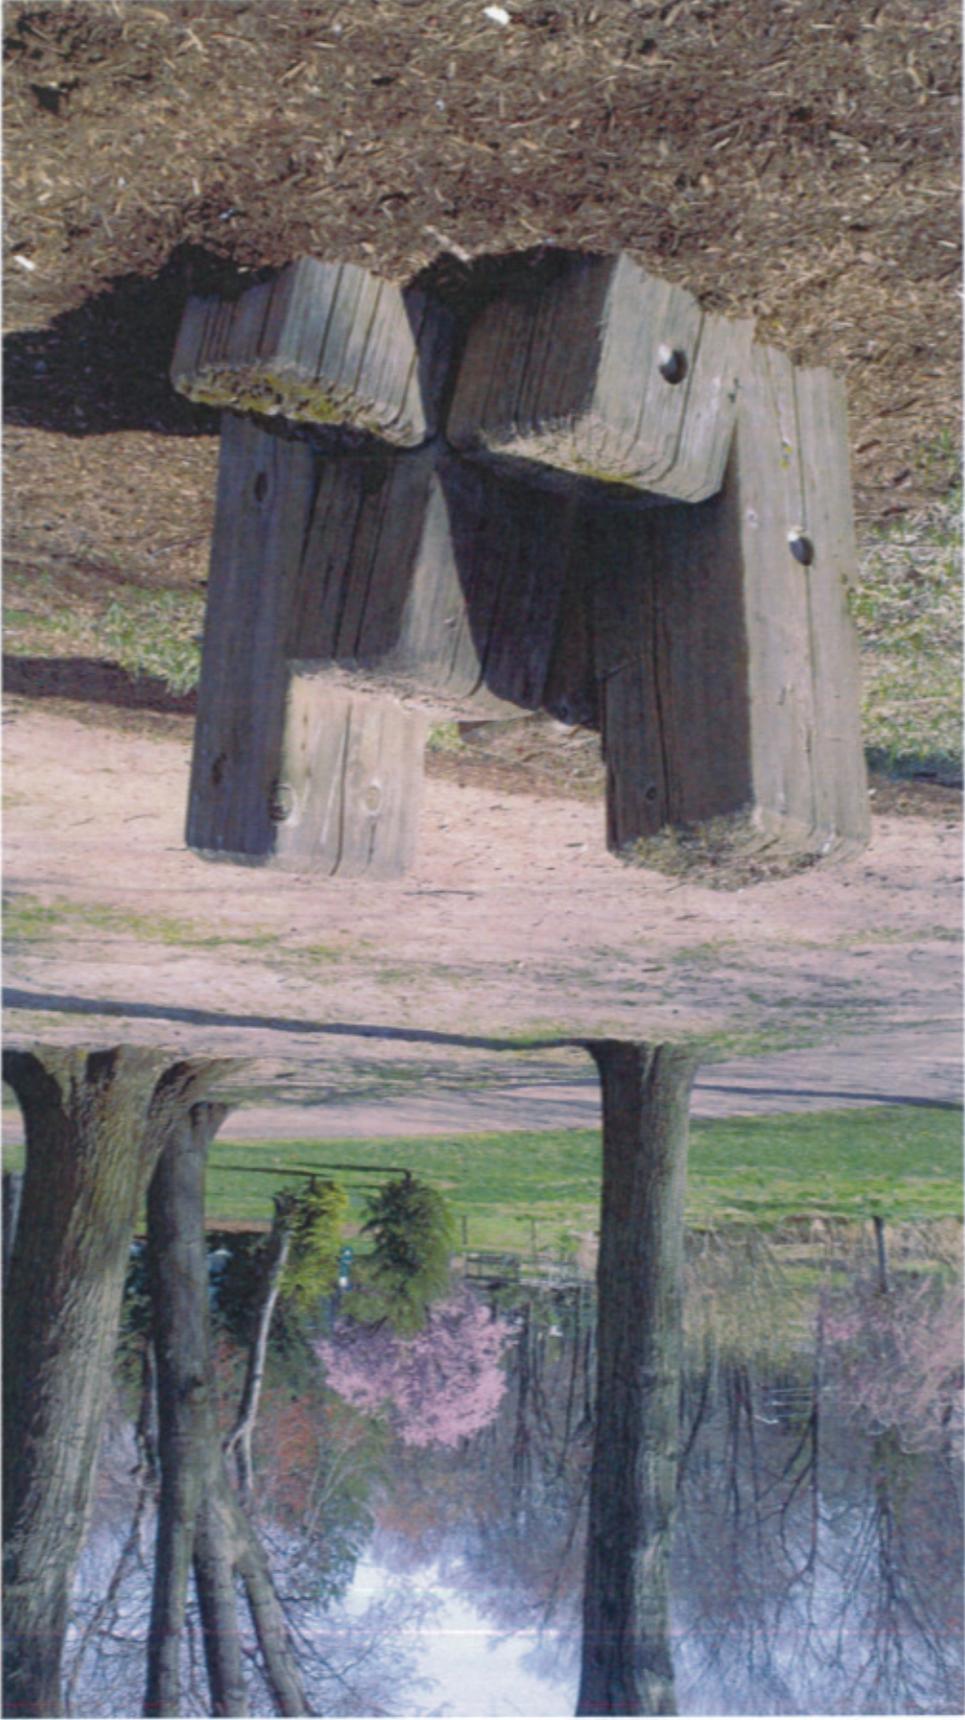
GRIFFIN PARK

REMOVE DECAYING CLIMBING STRUCTURES WITH INADEQUATE FALL ZONE SURFACE

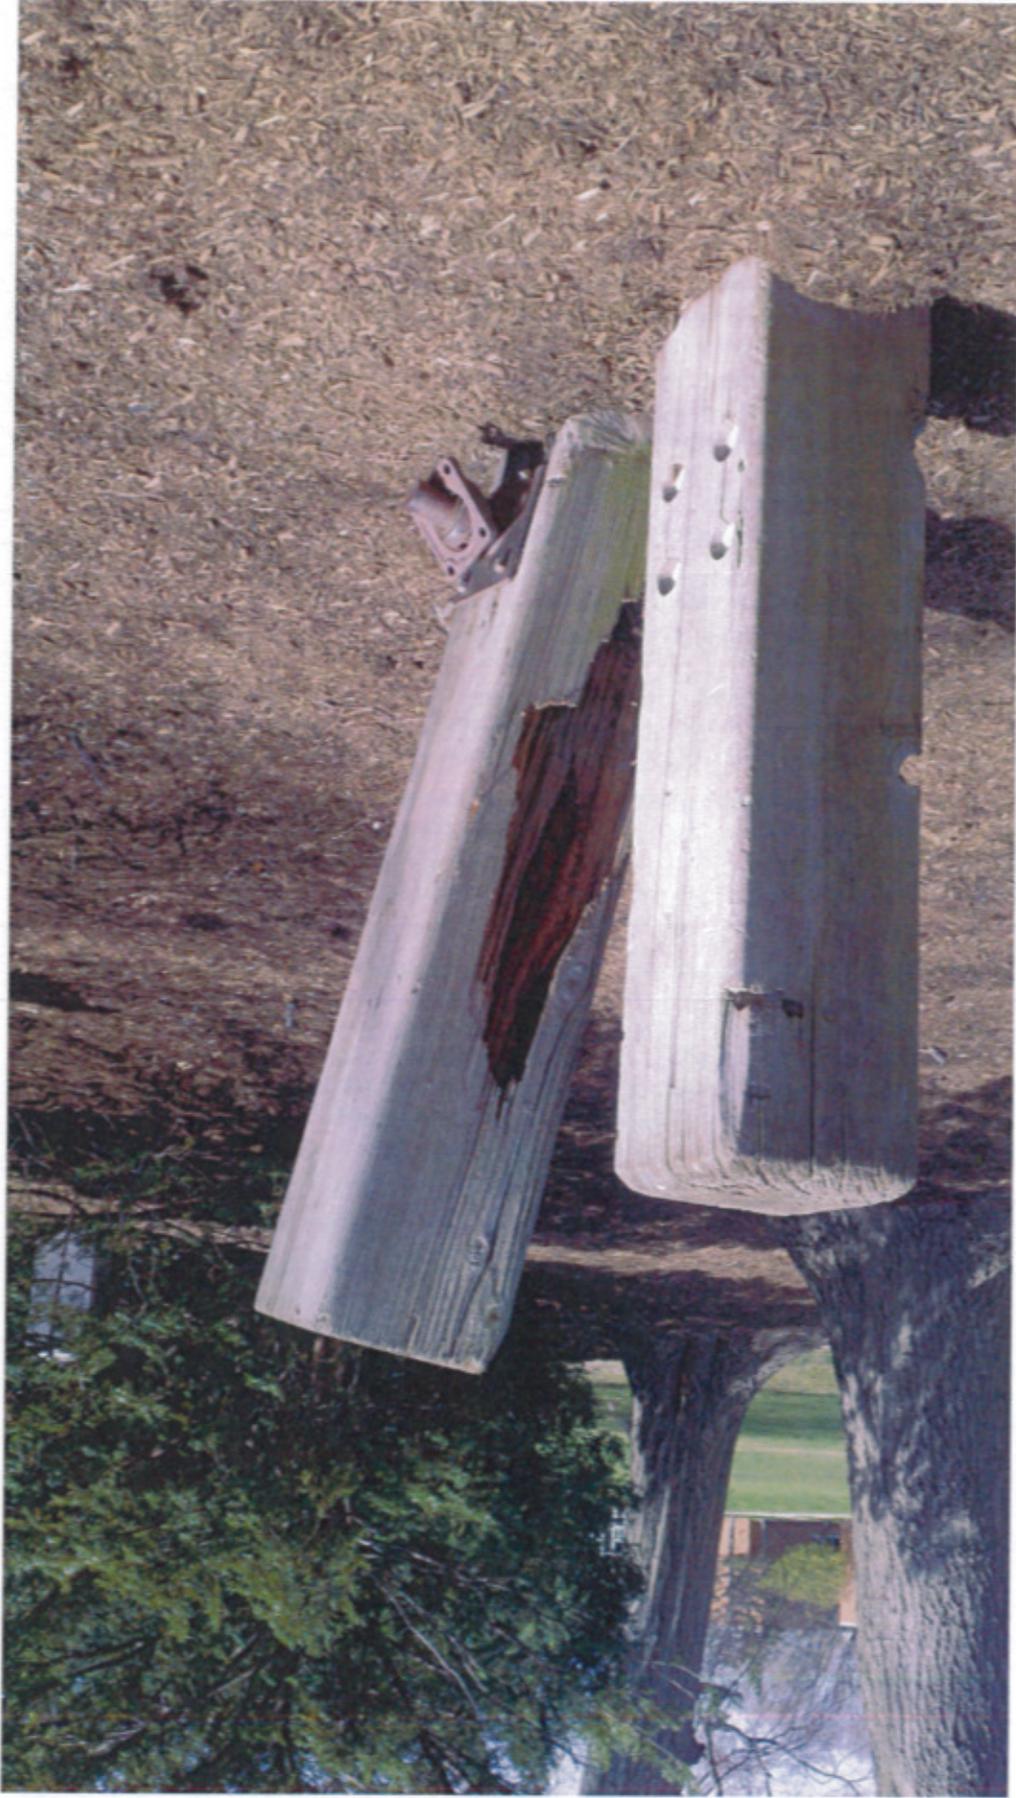
GRIFFIN PARK

REMOVE DECAYING CLIMBING STRUCTURE

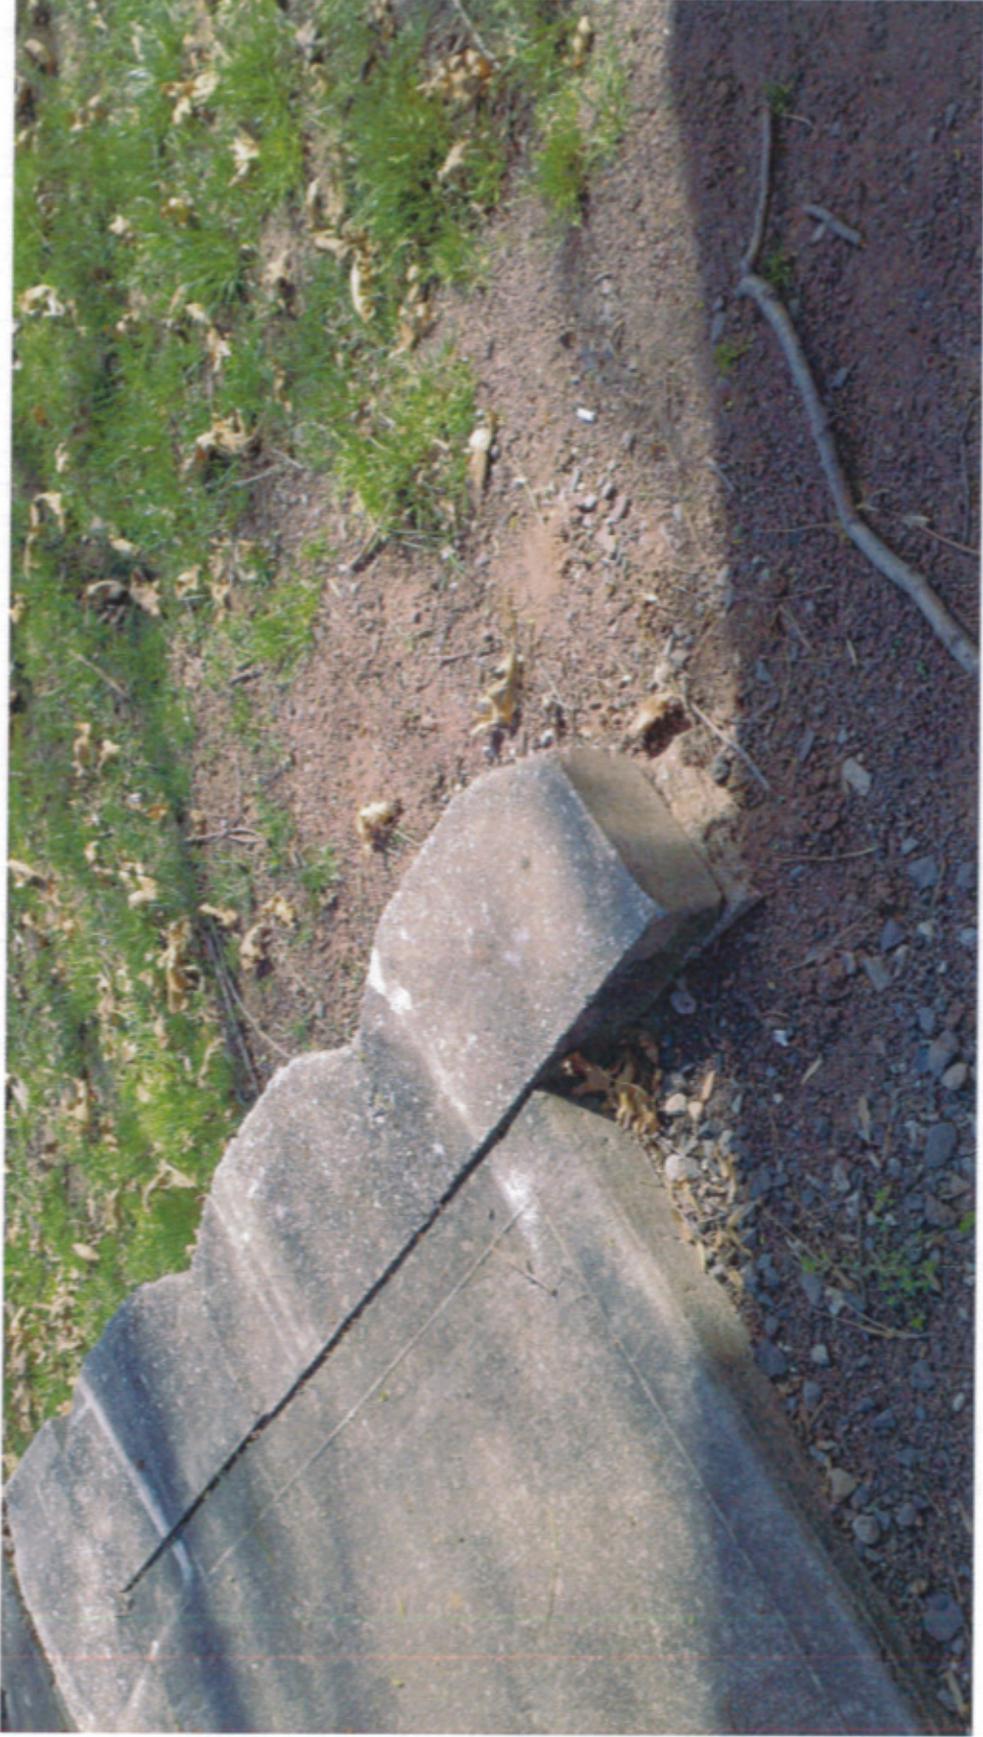
SUNNYSIDE PARK

REPAIR TRIPPING HAZARDS TO AVOID INJURIES

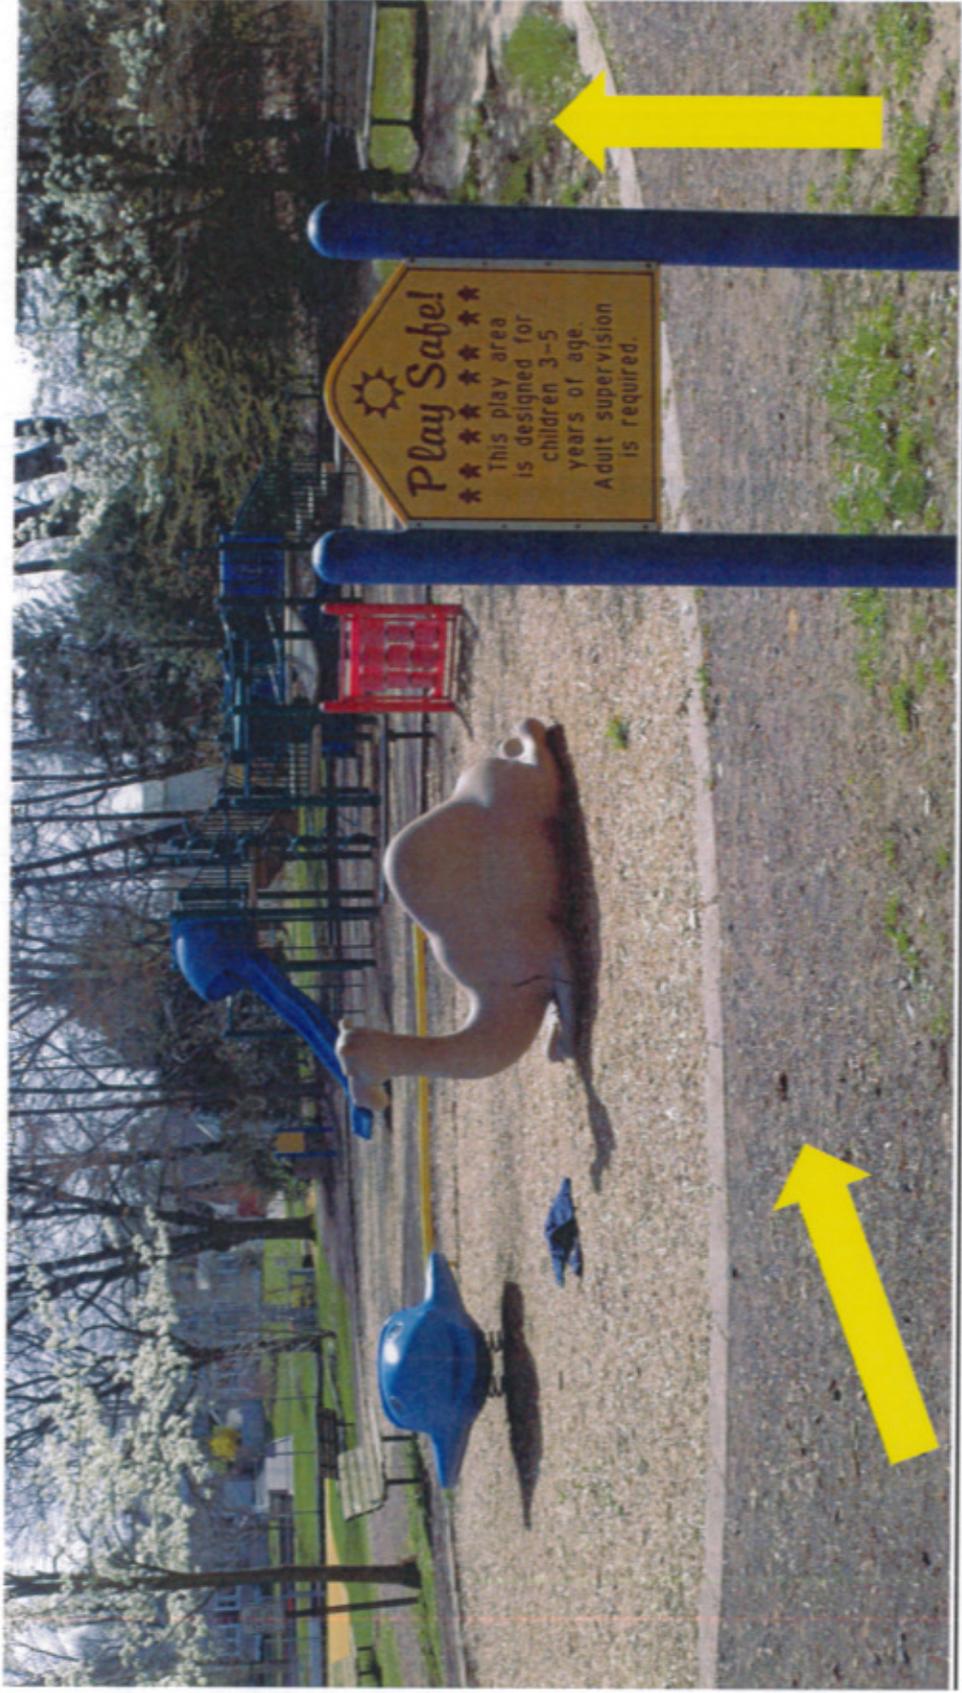
SUNNYSIDE PARK

PROVIDE REQUIRED MAINTENANCE AND SUPPLEMENT PLAY SURFACE ON REGULAR BASIS

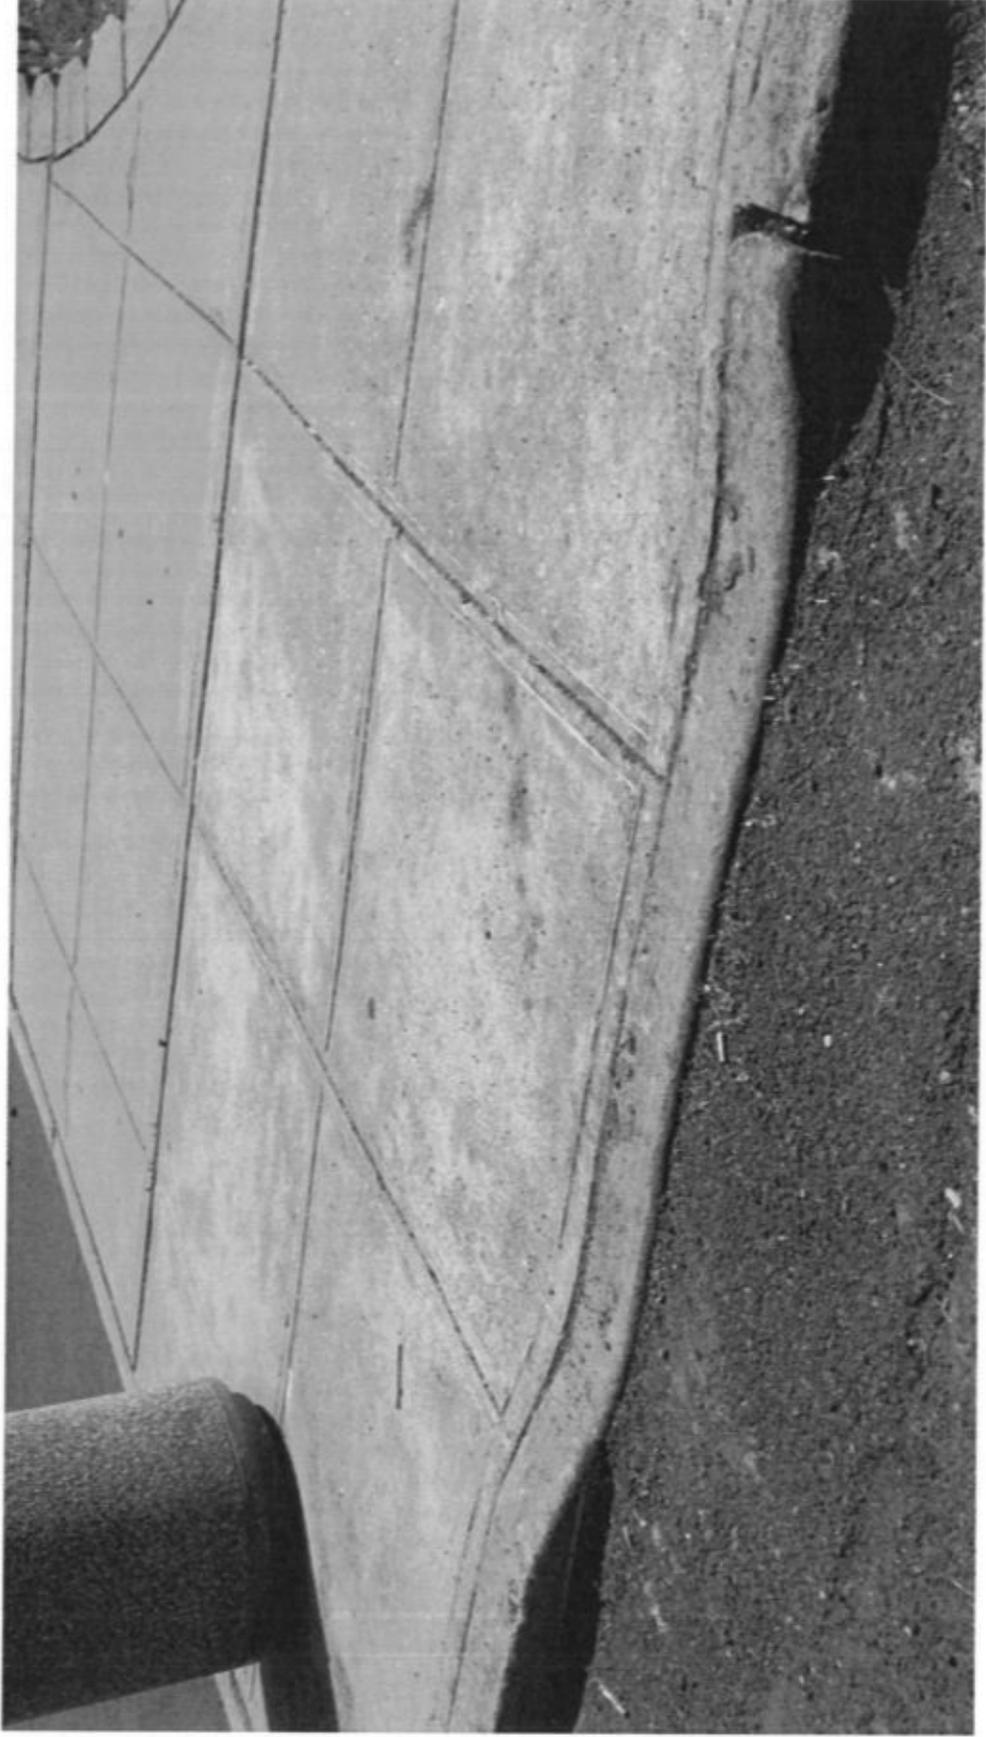
SUNNYSIDE PARK

EXCEEDS ADA SLOPE STANDARDS AND DOES NOT PROVIDE TRUNCATED DOME MATERIAL

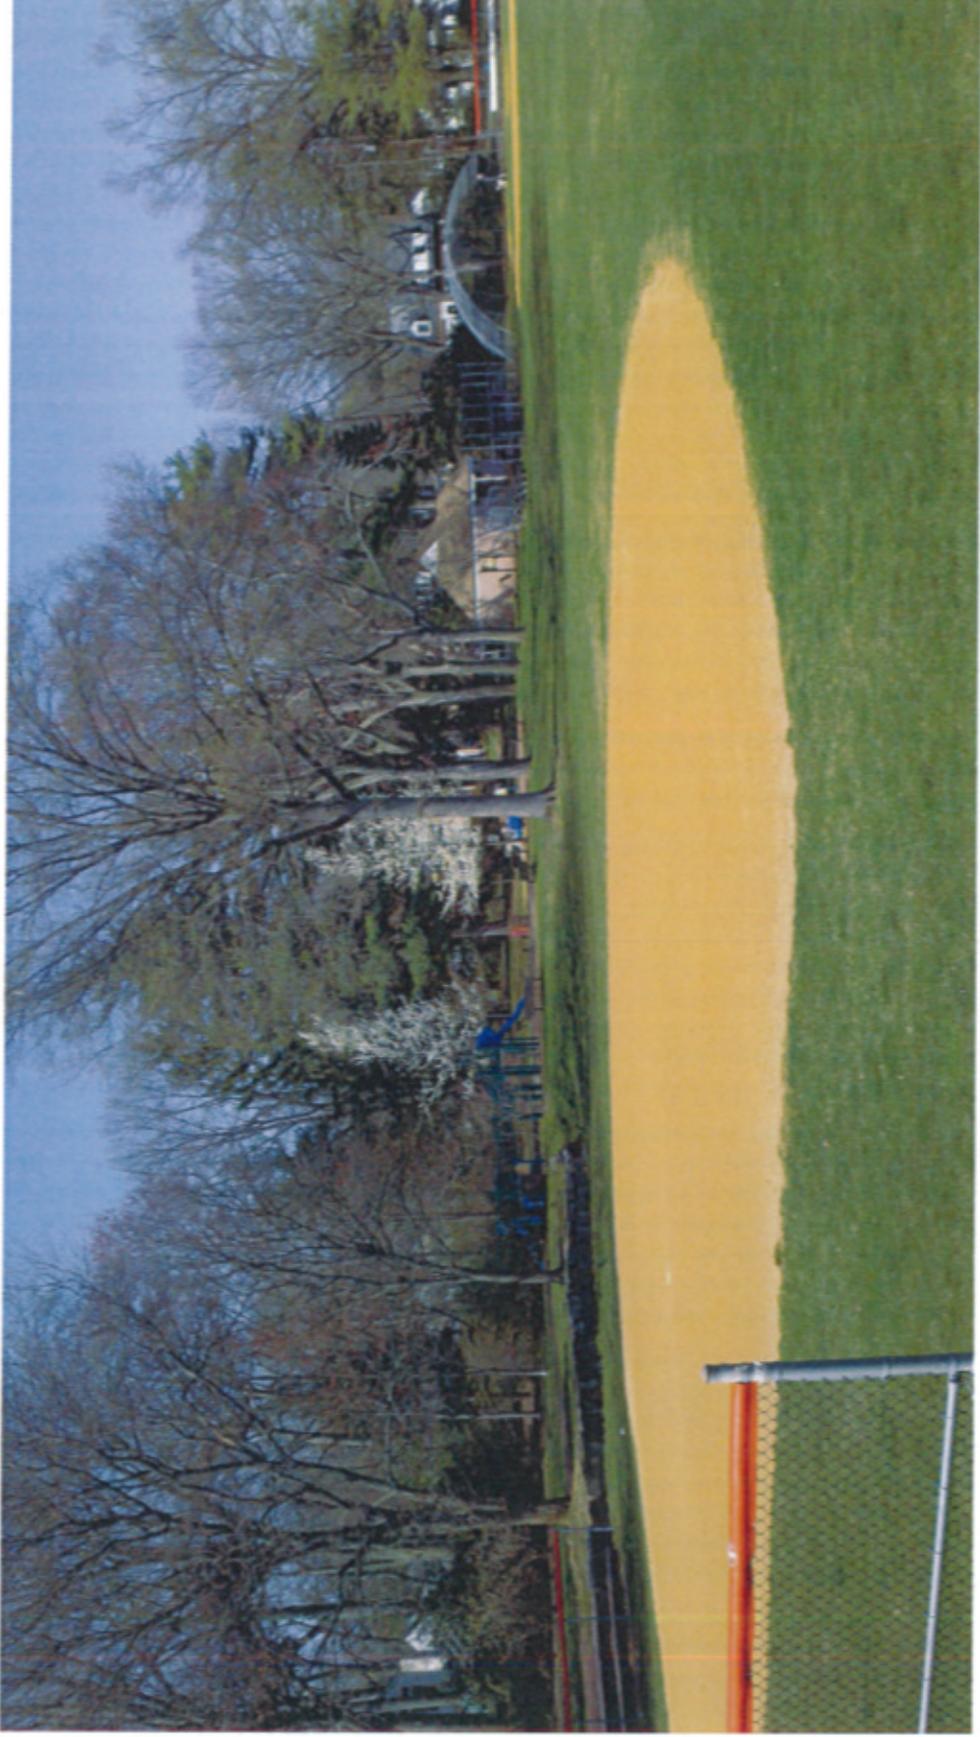
SUNNYSIDE PARK

REPAIR LIP IN TURF FROM INFIELD MIX MIGRATION

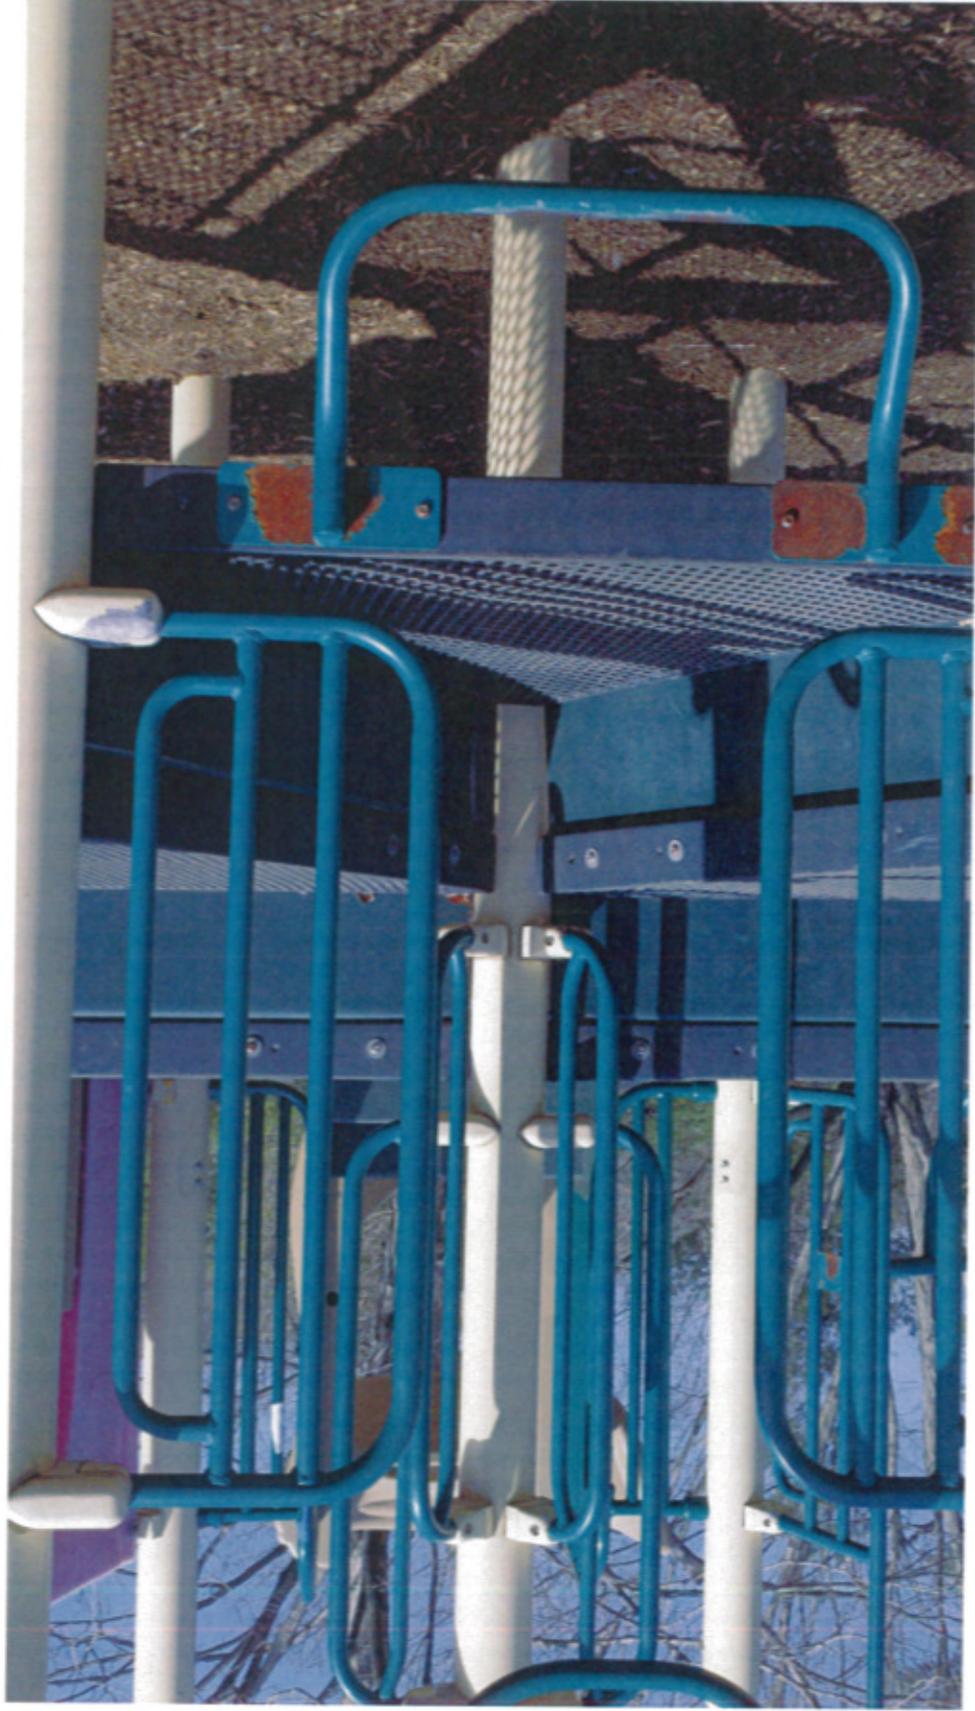
WALNUT PARK

CONTROL RUST AND CORROSION TO AVOID STEP UP FROM BREAKING WHEN A CHILD IS CLIMBING TO PLATFORM

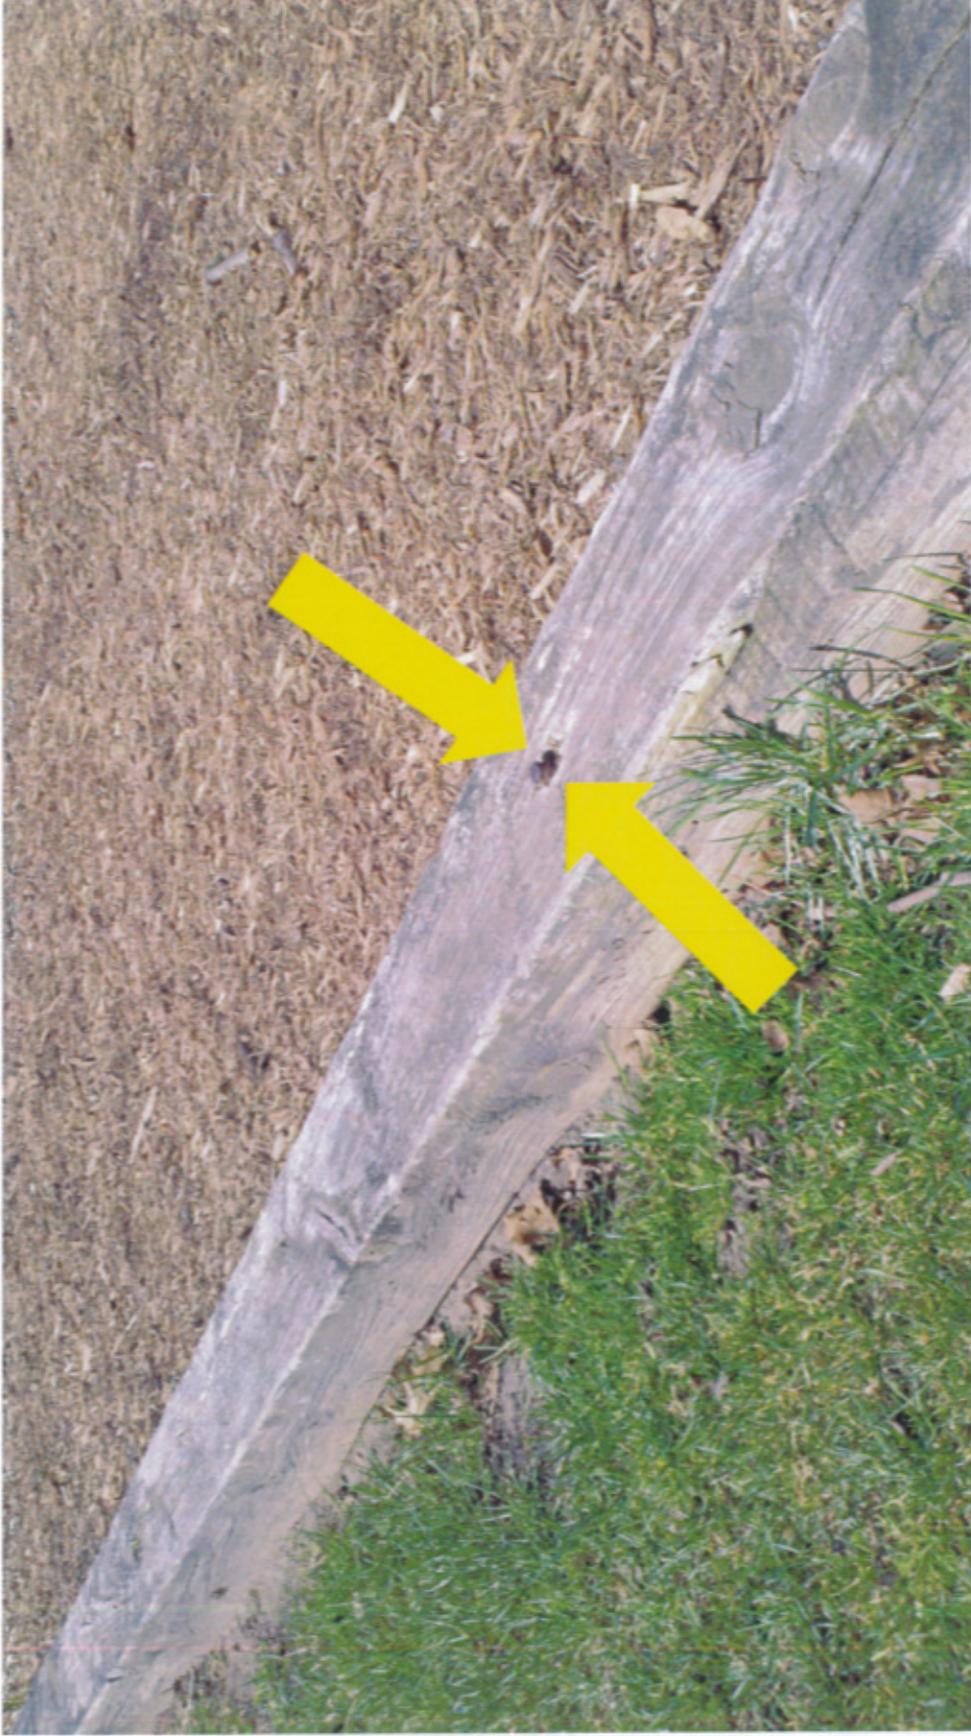
WALNUT PARK

RESET STEEL BARS TO AVOID PUNCTURE INJURY

5. The inlet structure requires that soil be placed around the structure to avoid injury. The concrete slab with exposed steel rebar should be removed, replaced and repaired.

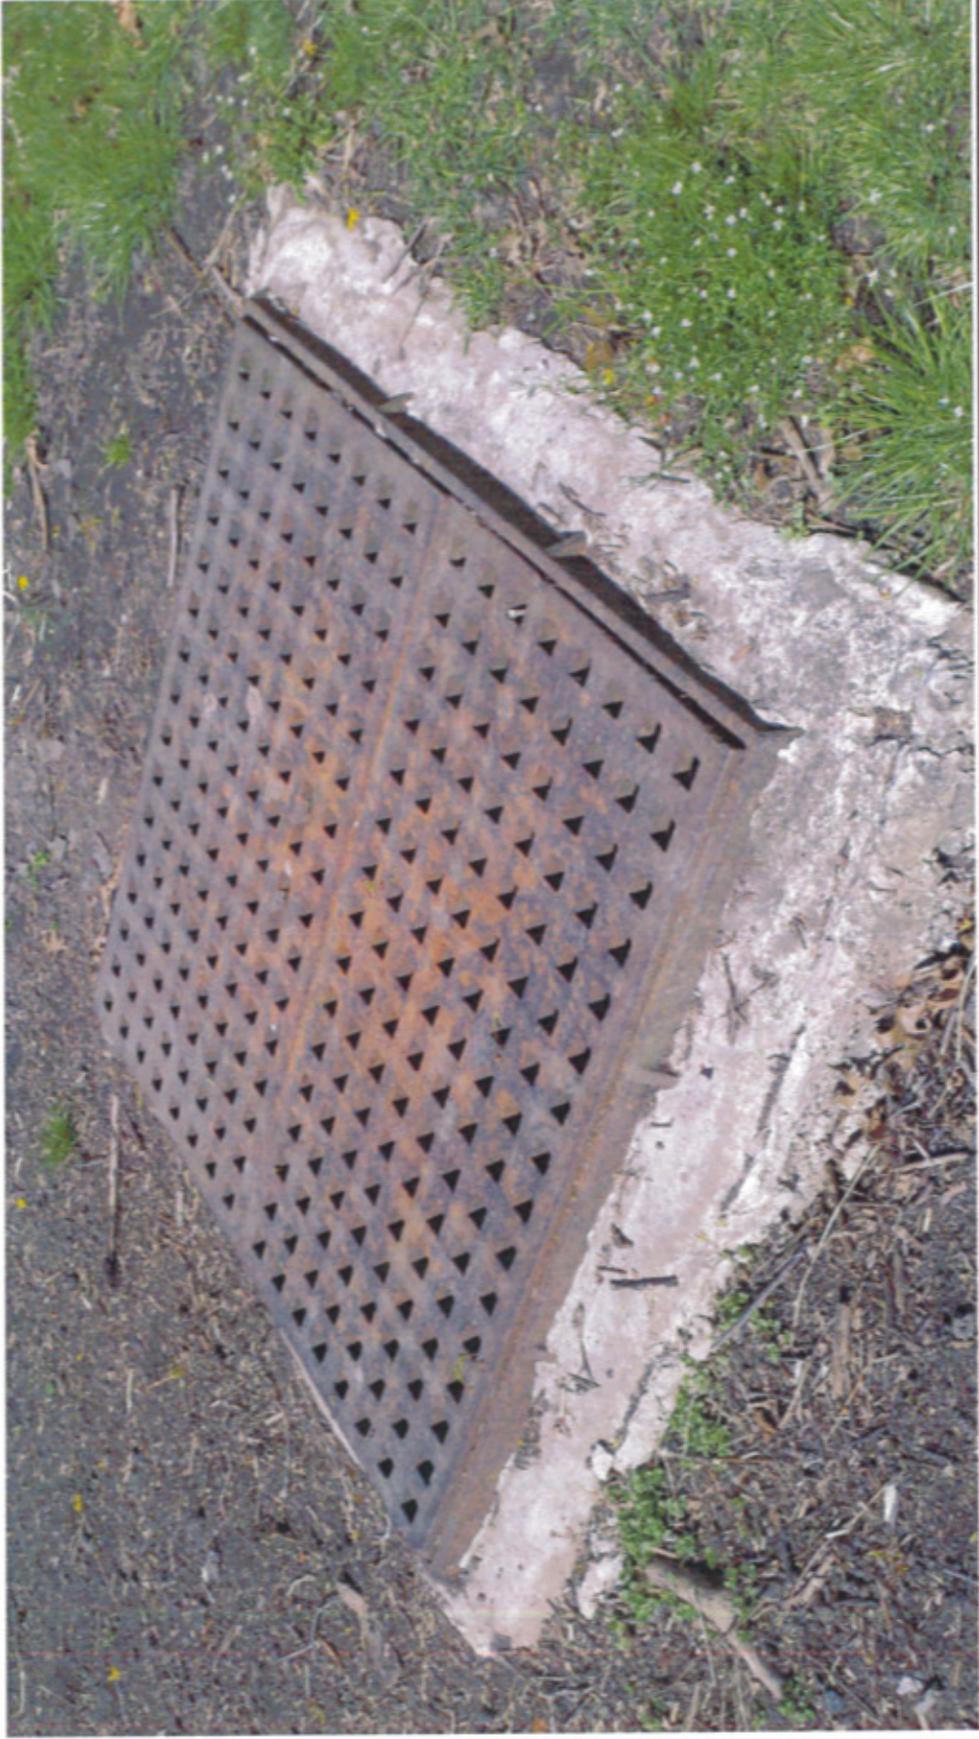
WALNUT PARK

ELEVATE SOIL AROUND STRUCTURE TO AVOID EXPOSED FOOTING

The cost for modification, repairs and materials would be approximately \$1,200.

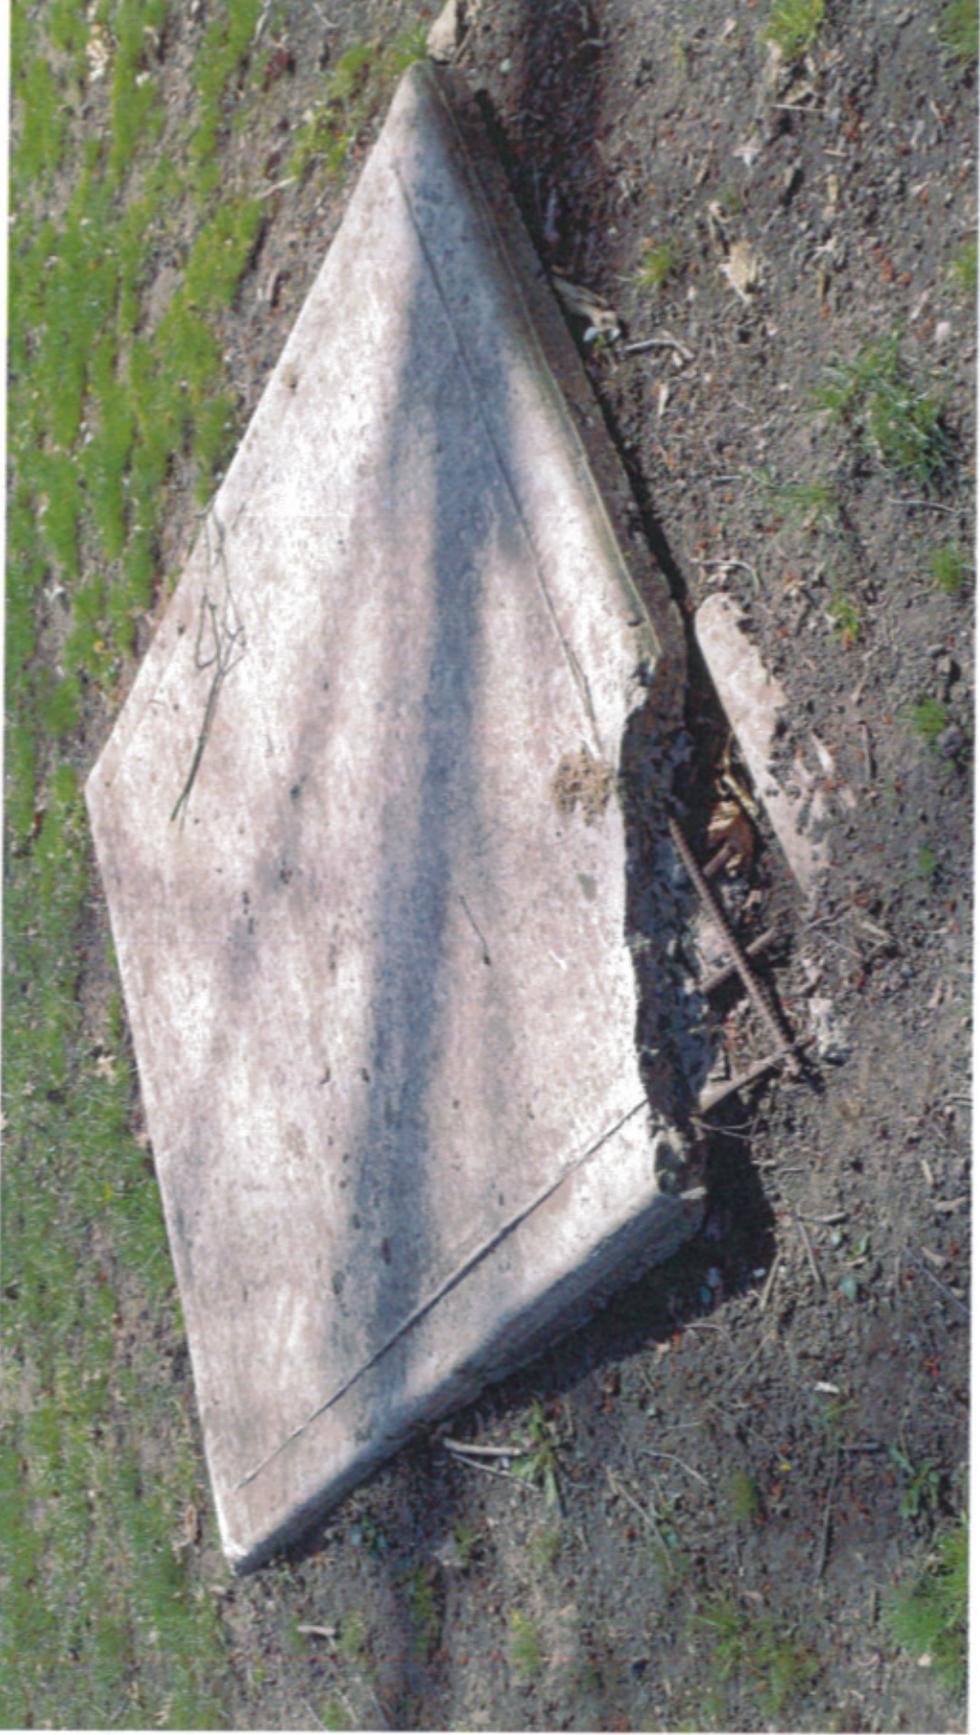
WALNUT PARK

REMOVE, REPLACE, OR REPAIR – SAFETY ISSUES

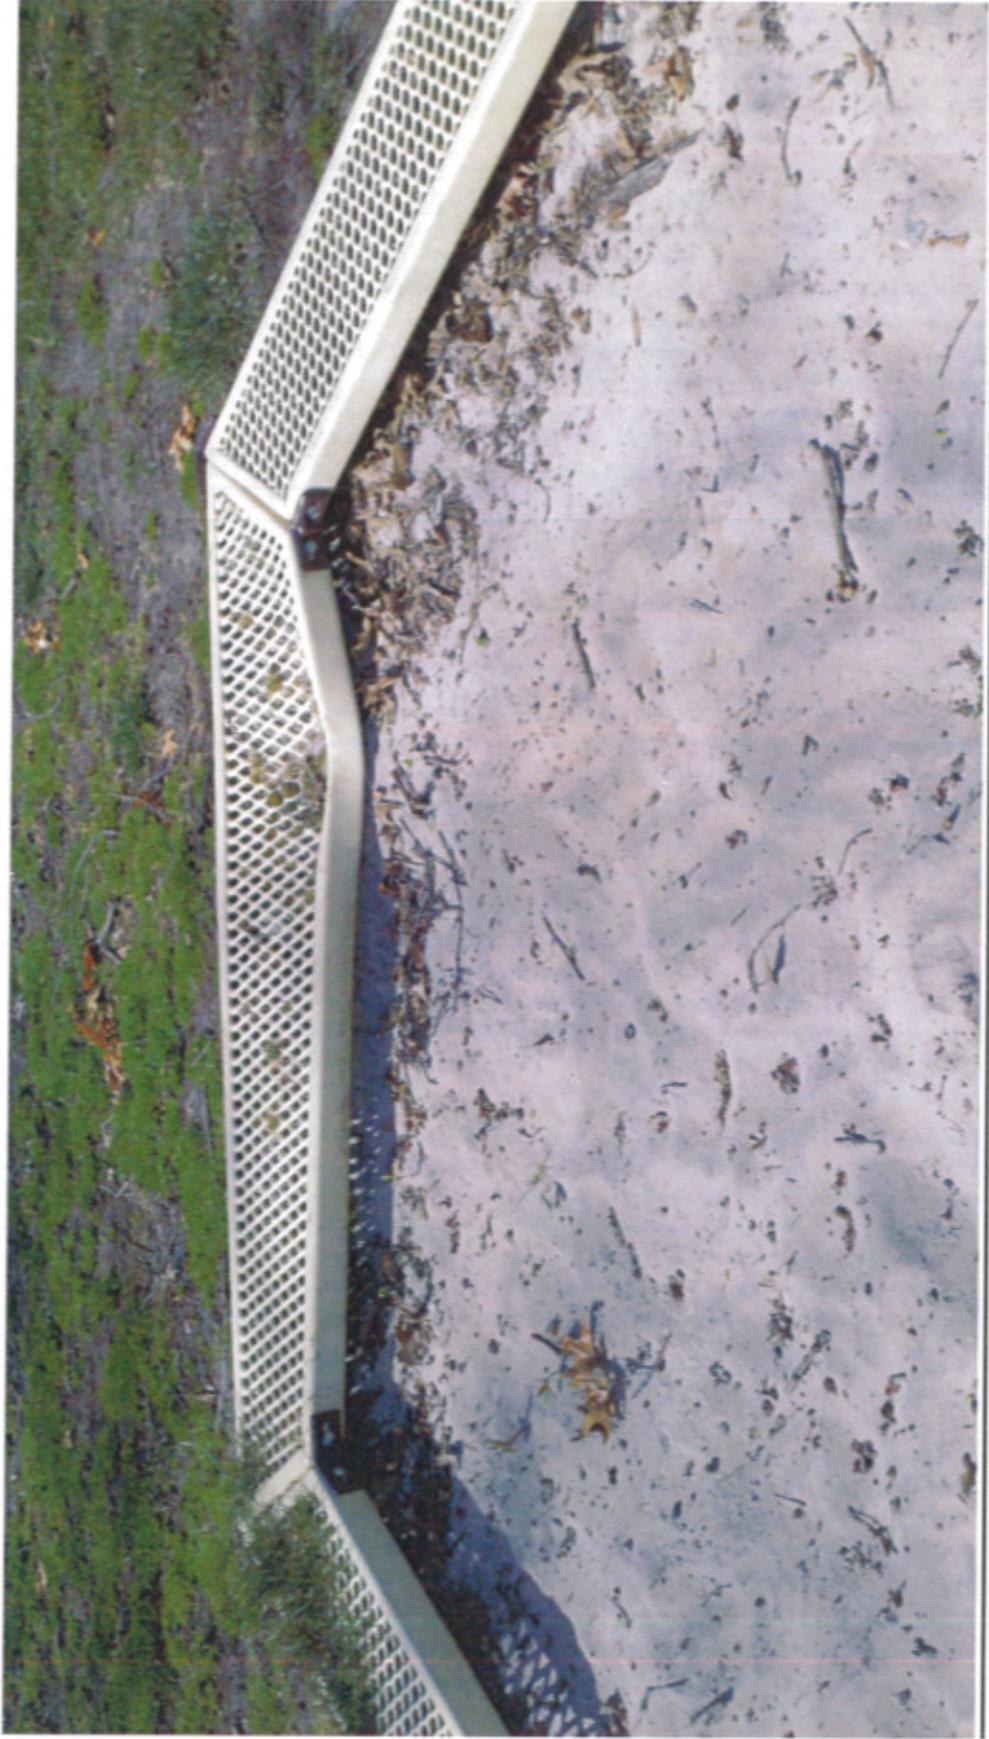
WALNUT PARK

DAMAGED, SAND IN POOR CONDITION WITH LITTLE MAINTENANCE – REPAIR OR REMOVE

2. Replace seat on sandbox.

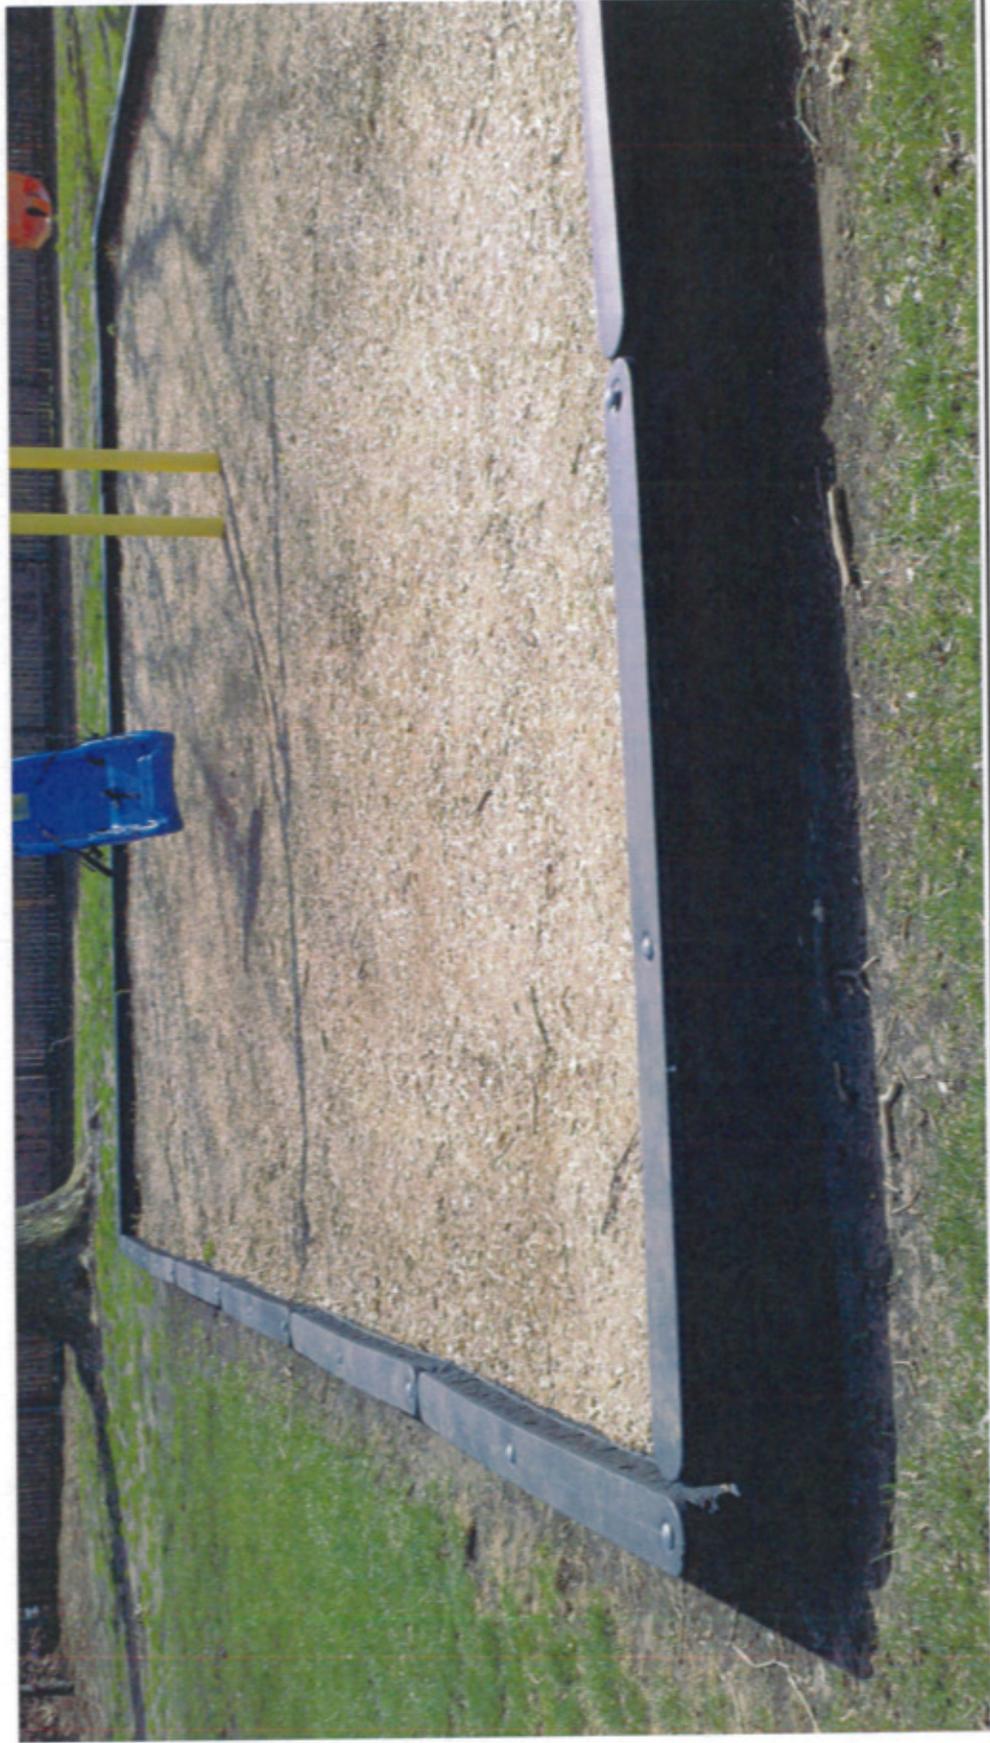
WALNUT PARK

NO CONNECTIVE LINK OR HANDICAP ACCESS

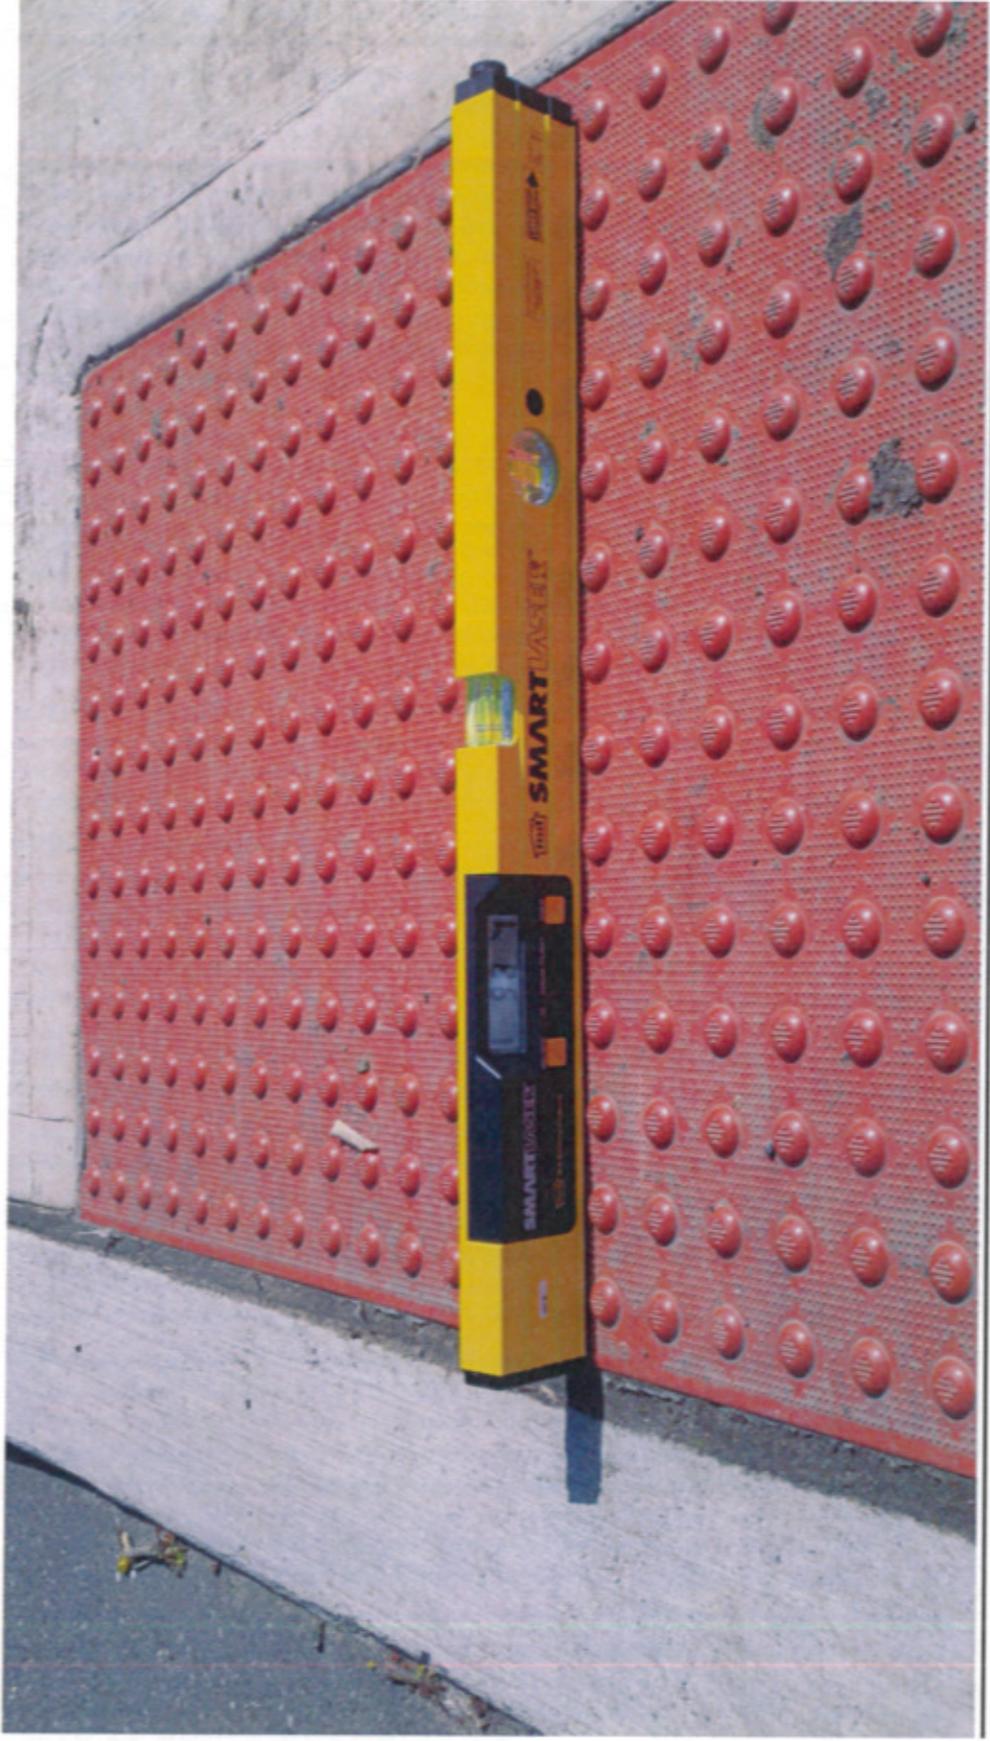
WALNUT PARK

RAMP EXCEEDS ADA STANDARDS

1. The walkway and ramp should be removed and replaced.
