2012 EVALUATION OF RECREATIONAL PARKS/PLAYGROUNDS

FOR
SAFETY INSPECTION – ADA COMPLIANCE

Borough of Tenafly
100 Riveredge Road
Tenafly, NJ 07670

MC Project No. TFB-048

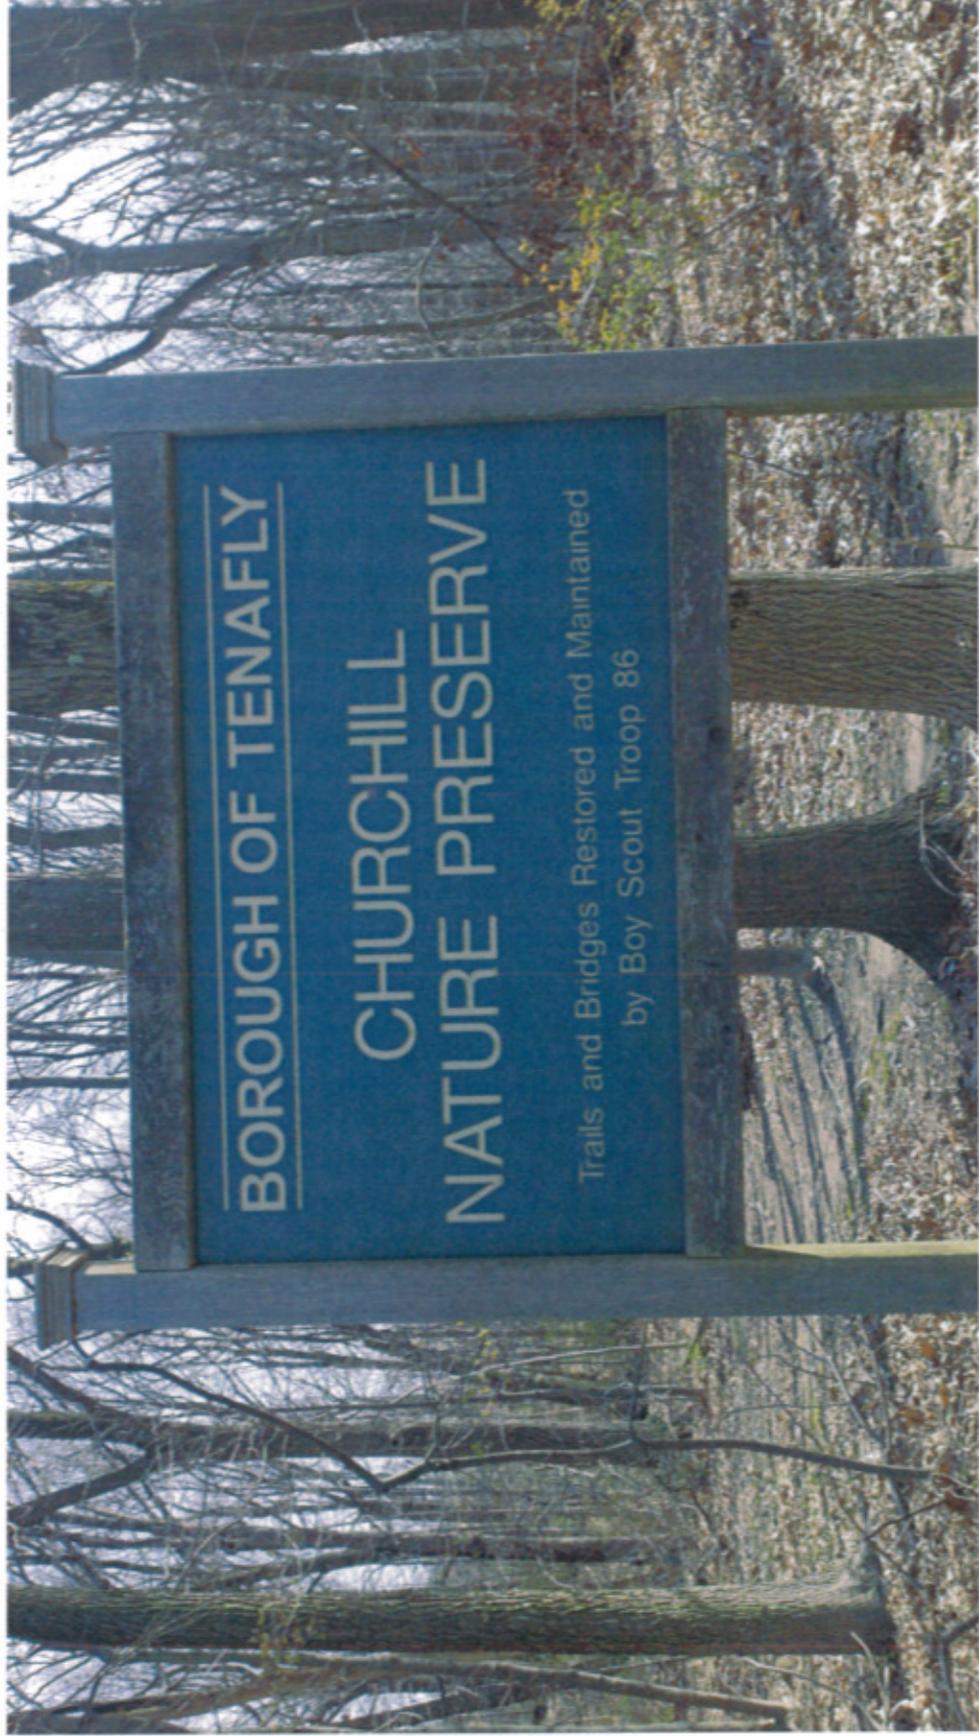
CHURCHHILL NATIVE PRESERVE

REMOVE ROOTS FROM WALKWAY TO AVOID TRIPPING HAZARDS

PROVIDE SAFETY BARRIERS ALONG BRIDGE

1. Although the accessible routes cannot be made to conform to the general criteria for ADA compliance, safety requires a common sense approach. The pathways should be increased in width to 5', cleared of any vegetation, and exposed roots should be cut and removed.

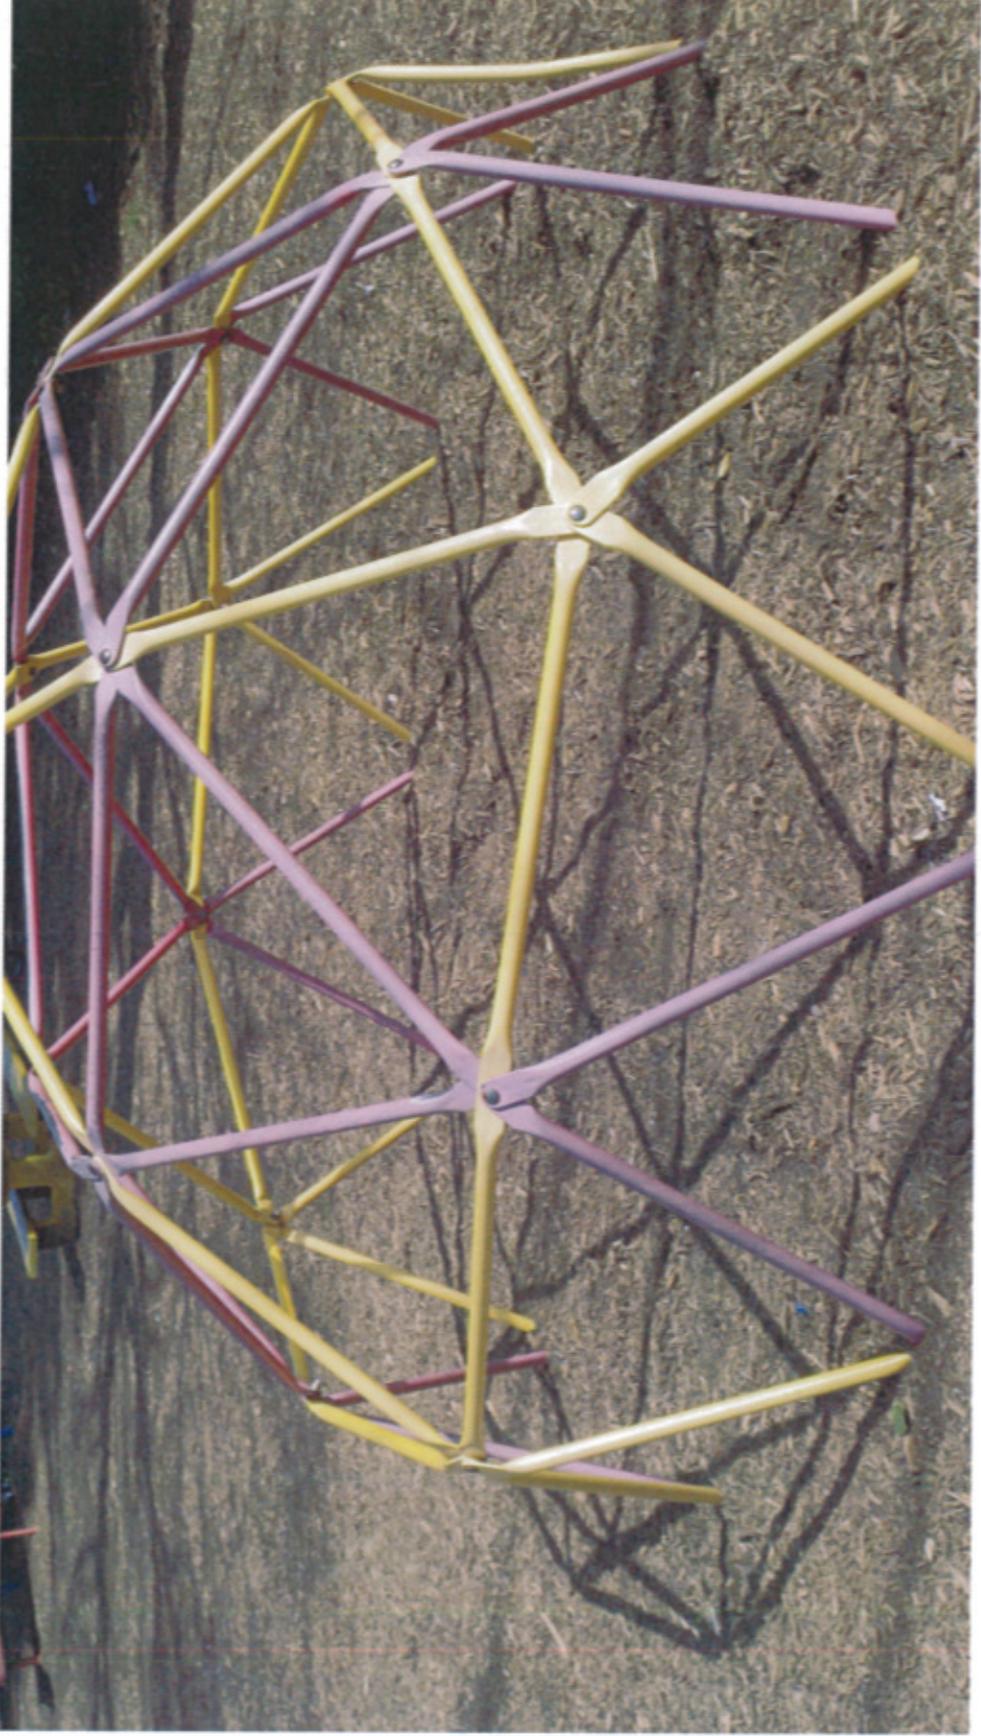
FROGGY PLAYGROUND

TREES LEANING BEYOND AN ACCEPTABLE STANDARD, SHOULD BE REMOVED TO AVOID A HAZARDOUS CONDITION

LOOSE BOLT AND STRIPPED BOLTS THROUGHOUT PARK

DAMAGED SPIRAL CLIMBER WITH LOOSE BOLT ATTACHMENT

1. There are several dead trees and trees in poor condition that should be removed as soon as possible. They present significant hazards to park patrons.

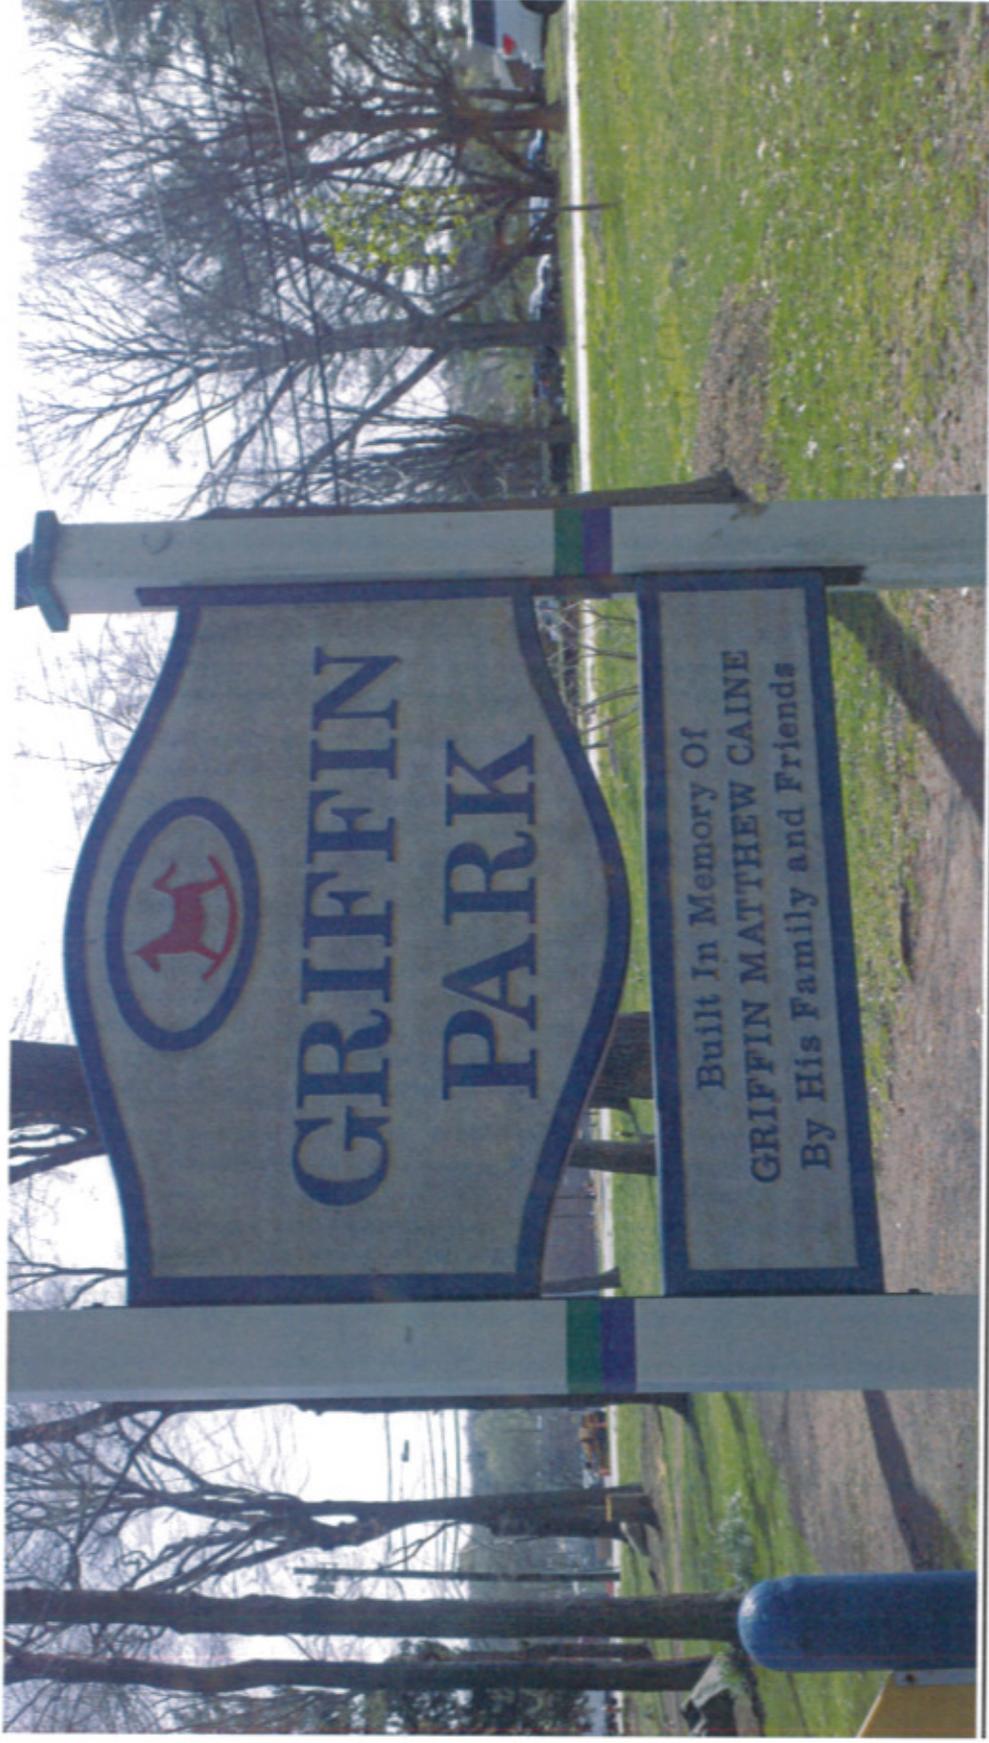
GRIFFIN PARK

REPLACE NUT ON CLADDER BRIDGE CHAIN

REPAIR OR REPLACE FENCING AROUND PLAYGROUND

PROVIDE PROPER FOOTING FOR BENCHES
